871 - Pt100 fault main bearing - NM72,NM82,V82 Mk1-5

Replace the PT100 in the main bearing

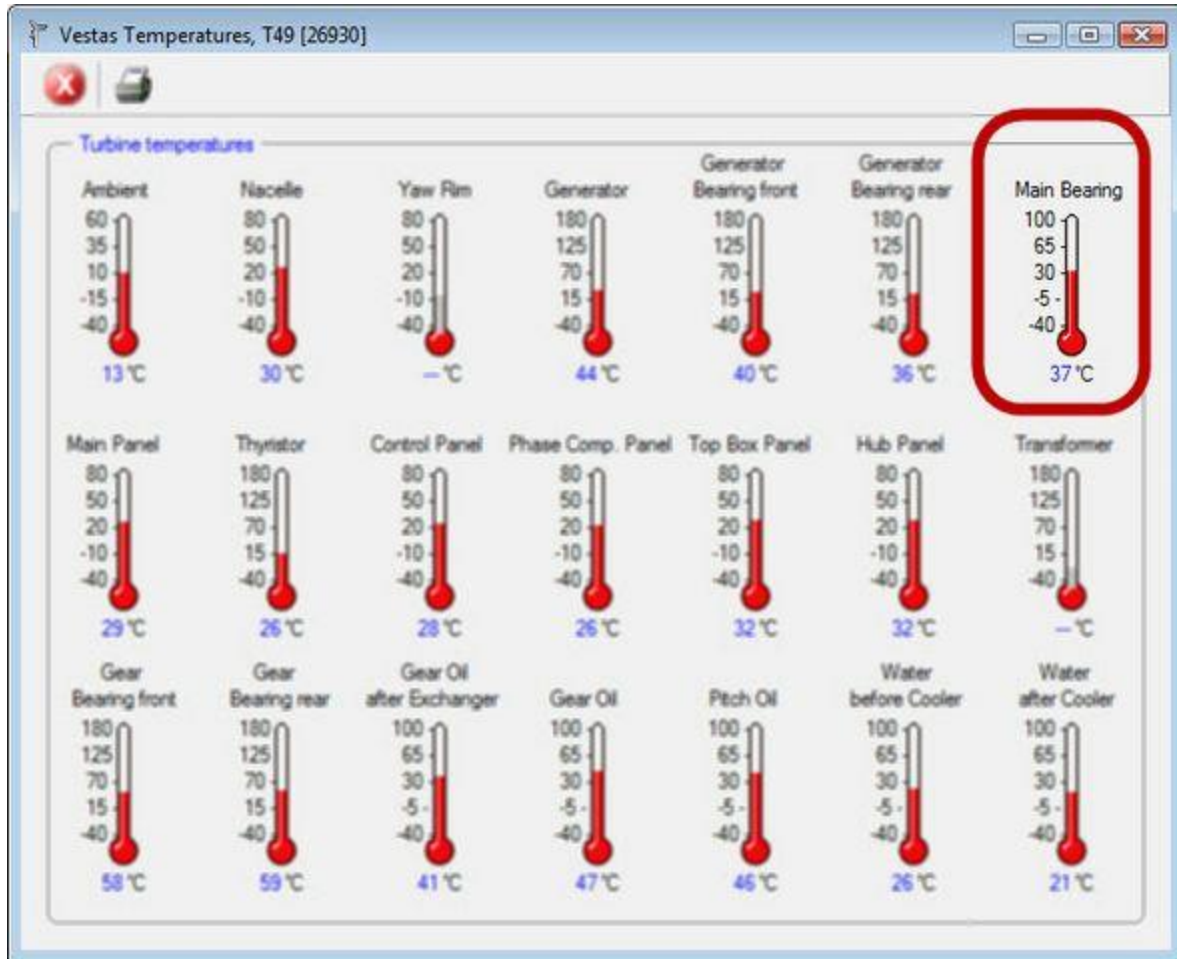
Measure the resistance across the Pt100 sensor and compare the temperature given by the TAC controller to the actual temperature derived from measuring the resistance across the sensor.

If the temp is -40°C, you should troubleshoot a line to line short. Disconnect the Pt100 and test the circuit for continuity. If the circuit passes the test, replace the Pt100.

If the temp is at the upper limit (200-245°C), you should troubleshoot an open in the circuit. Perform a pull test on the wires to ensure any opens are not due to loose connections. Disconnect the Pt100 leads in the AN11 (AN1 for Mk1&2) and test for continuity through them. If they are open, then the sensor is defective and needs to be replaced.
