Initial	Function	Input 615-623
9	FLT	Project title	Top Panel +AN1 - V82-1.65MW - 50/60Hz

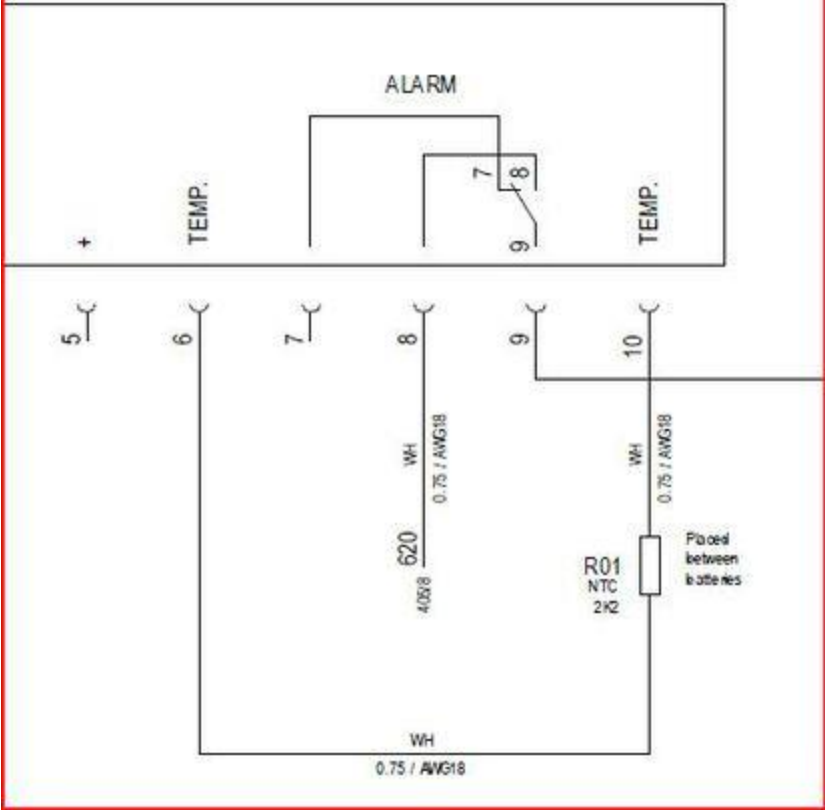
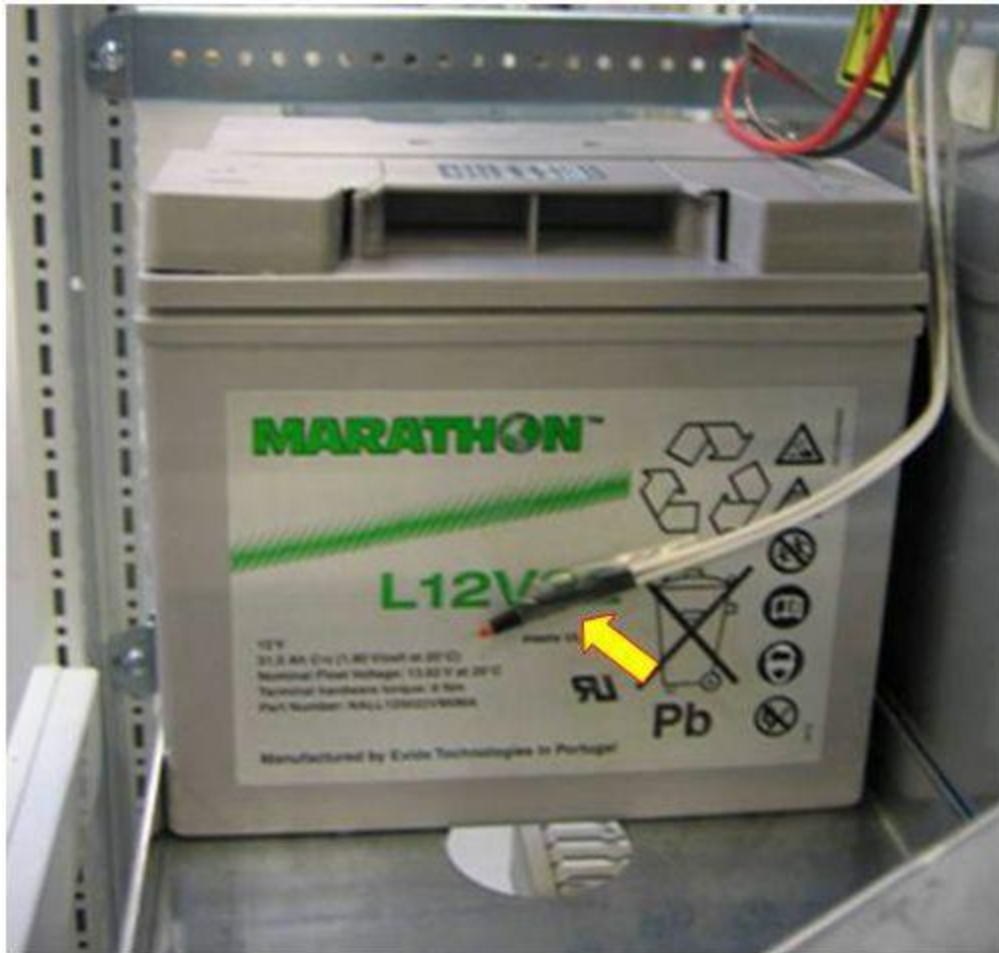
Check the temperature sensor (POS : R01) which is place in-between batteries

Replace the defect temperature sensor

If defect replace the new sensor

Relevant spare parts	
Description	Item No.
TEMP SEN BAT CHARGER ADC5483	60000720

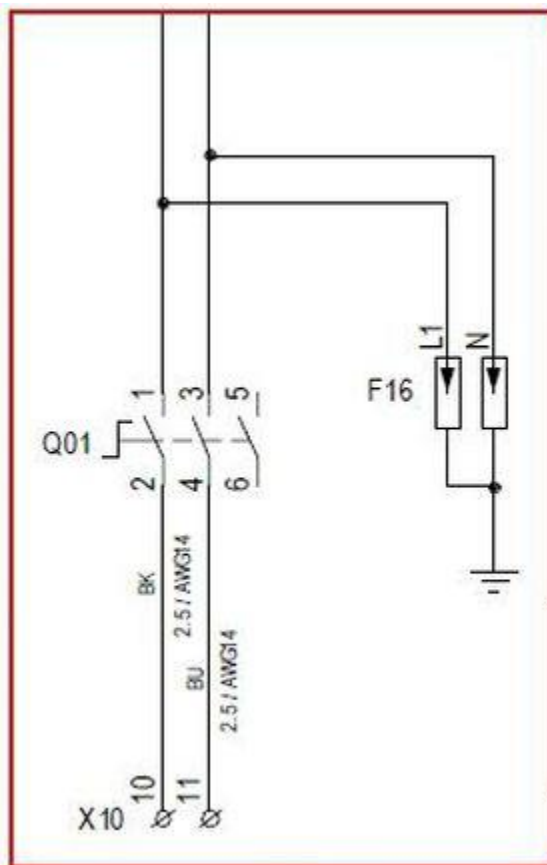
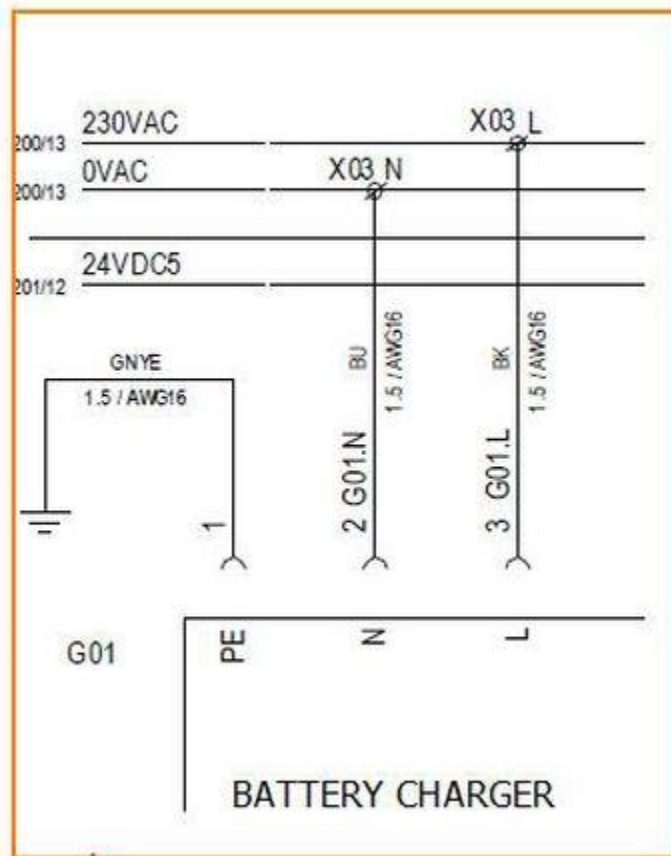
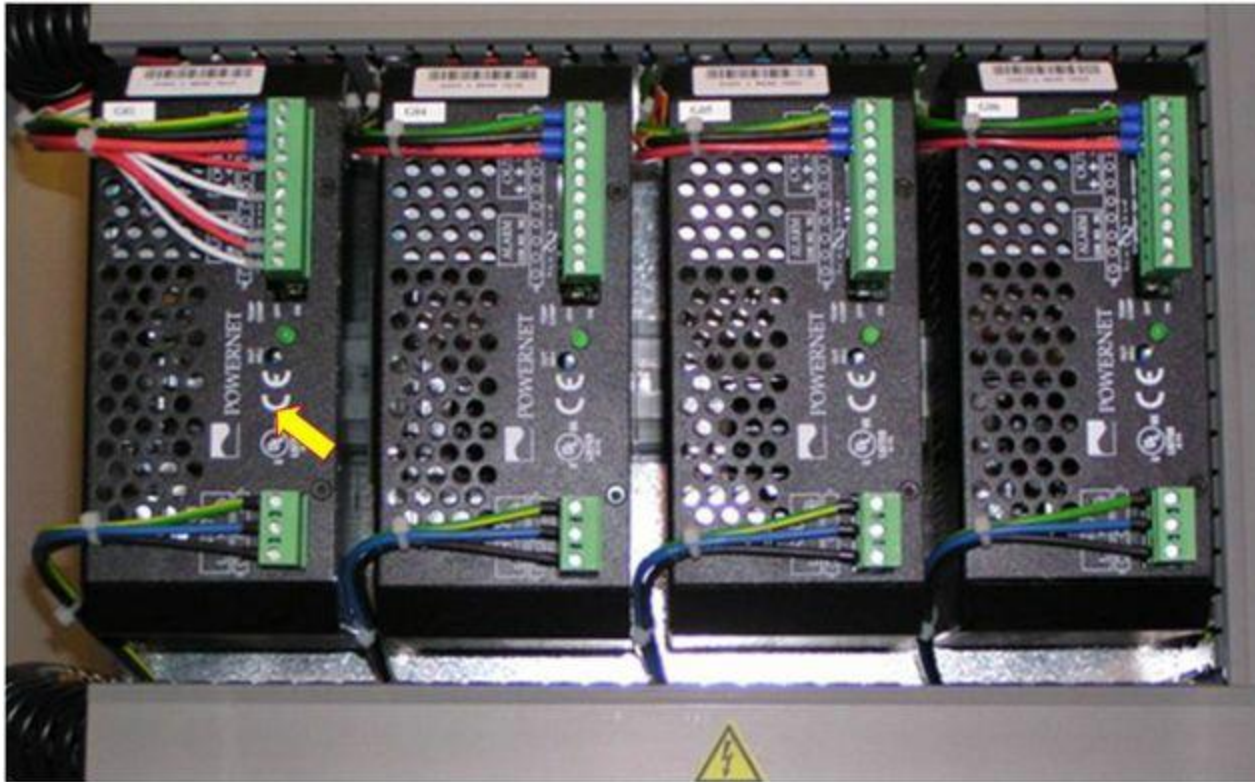
Check the Power net if any loose connection,

Check the INPUT /OUTPUT voltage, If 230V present in INPUT but OUTPUT 0V means likely power net defect,

If not present input voltage check the supply line.

Replace the defect Power net

If defect power net replace with new.

Relevant spare parts	
Description	Item No.
PS ADC 5483R-3 10A-27,4 NM PIN	188453

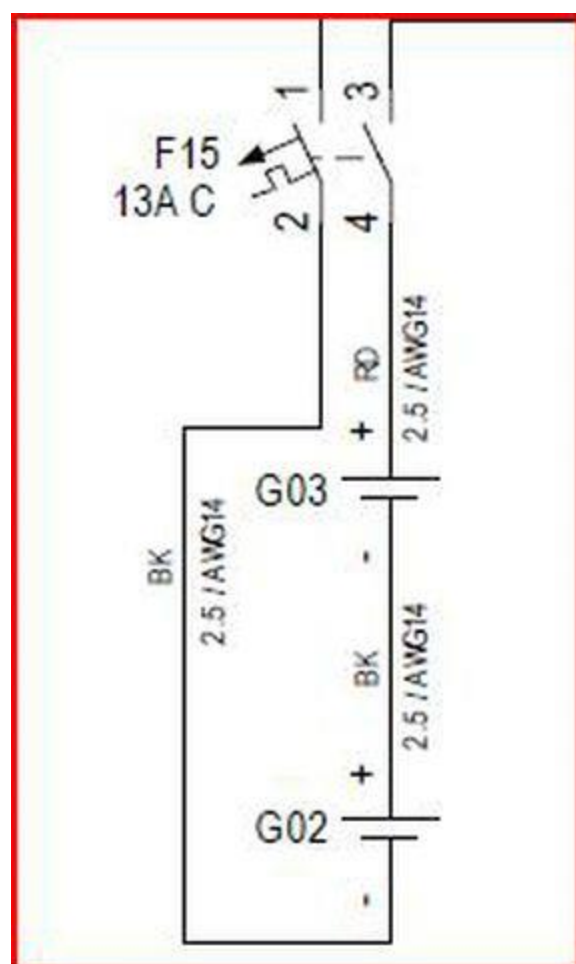
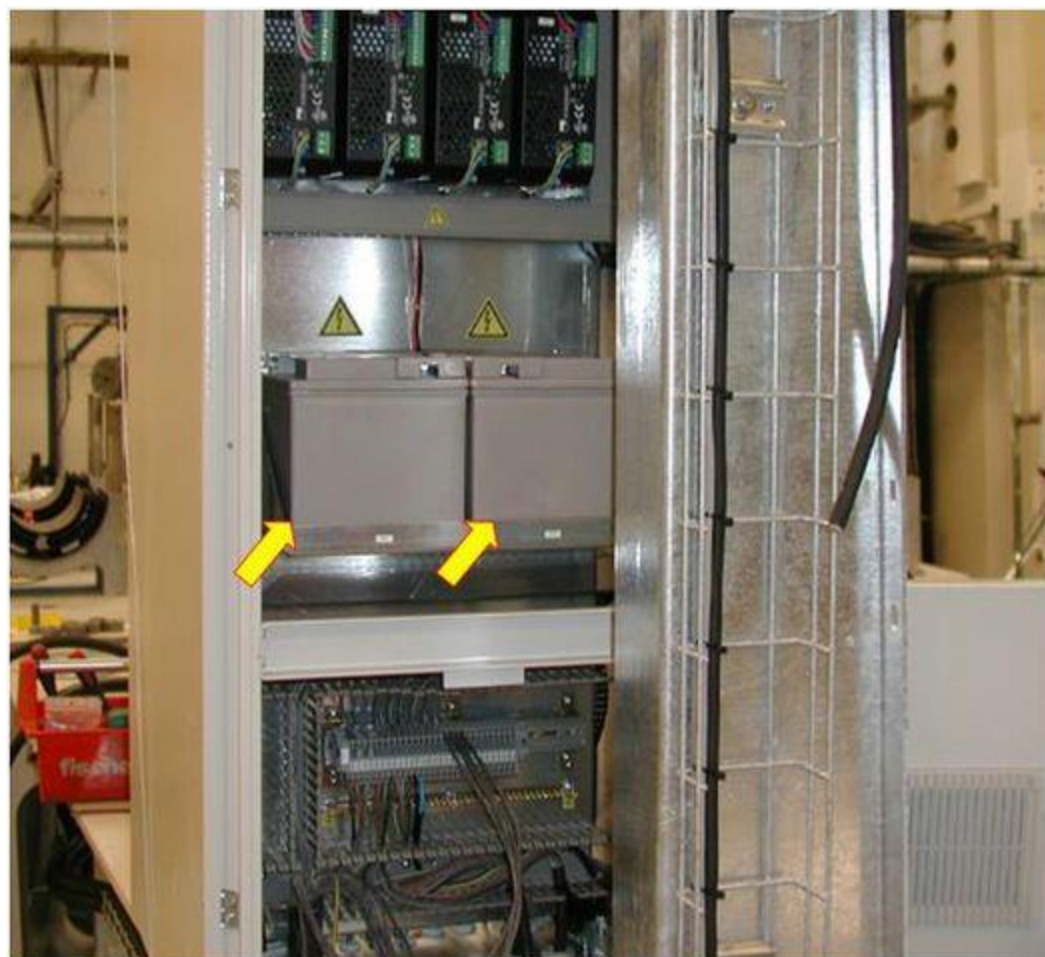
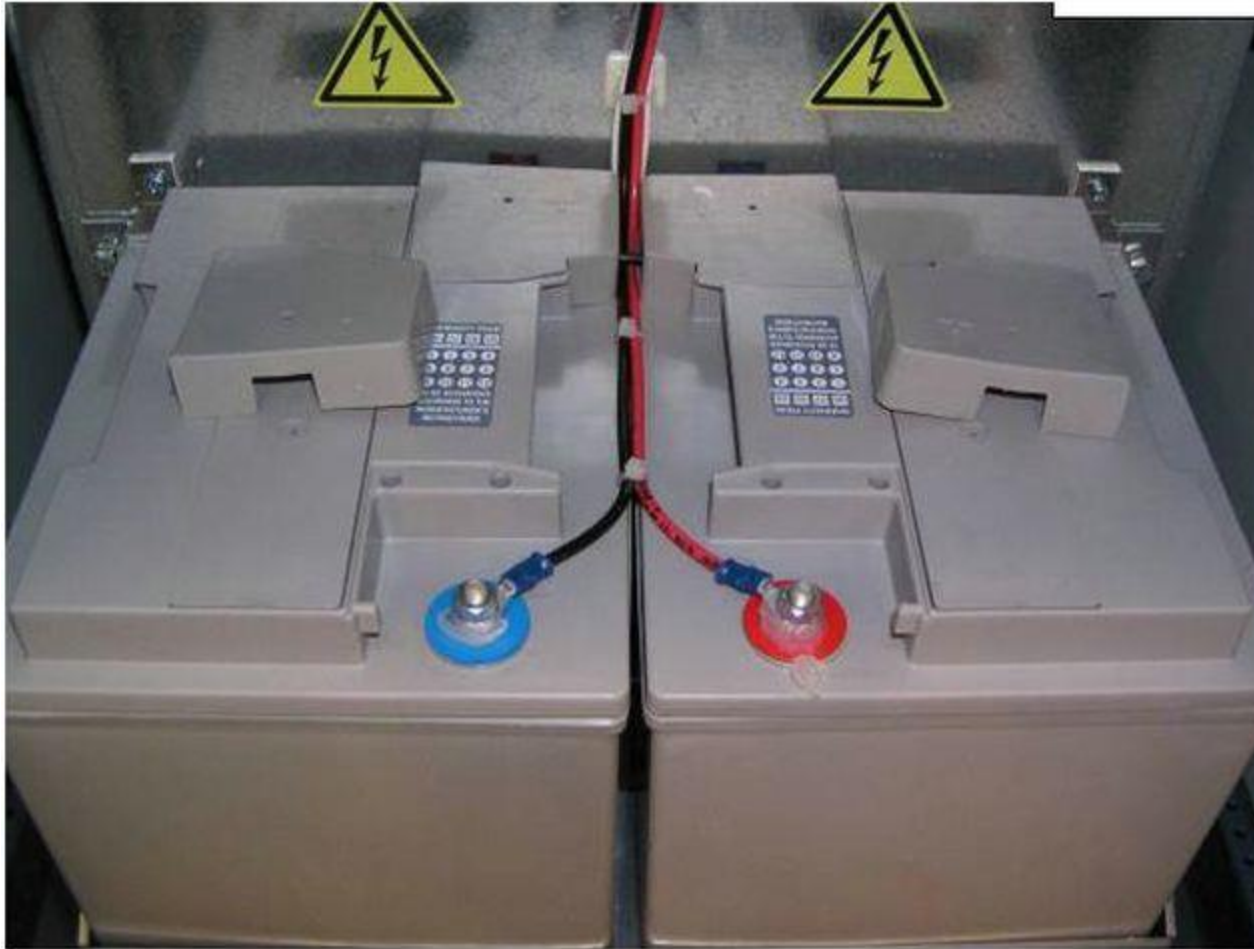
Check the battery visually any abnormal and healthiness,

Check if any loose connection,

Check the battery terminal connection if any rust due to battery acid,

Replace the defect batteries

If defect replace the batteries (G02, G03)

Relevant spare parts	
Description	Item No.
BAT H4 12V 32Ah	60000711

If found any rust rectified apply recommended flux.

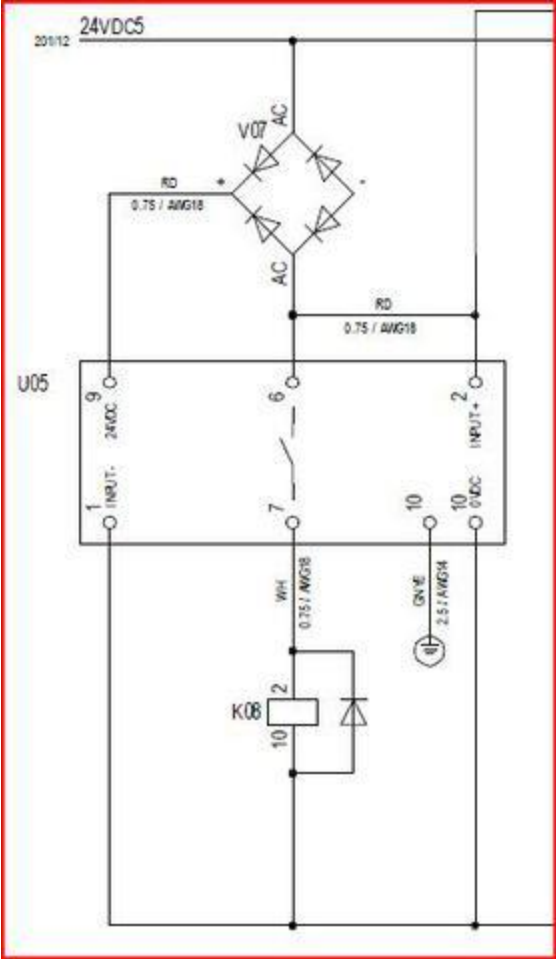
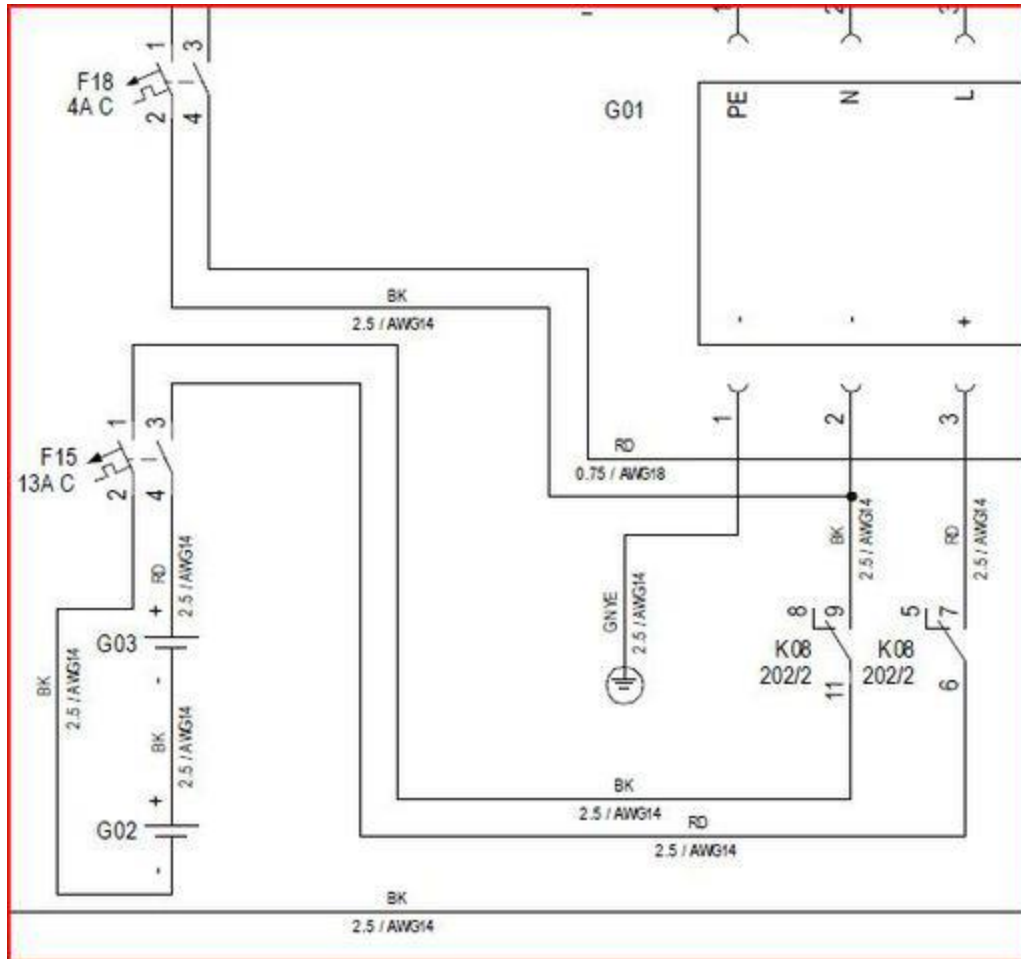
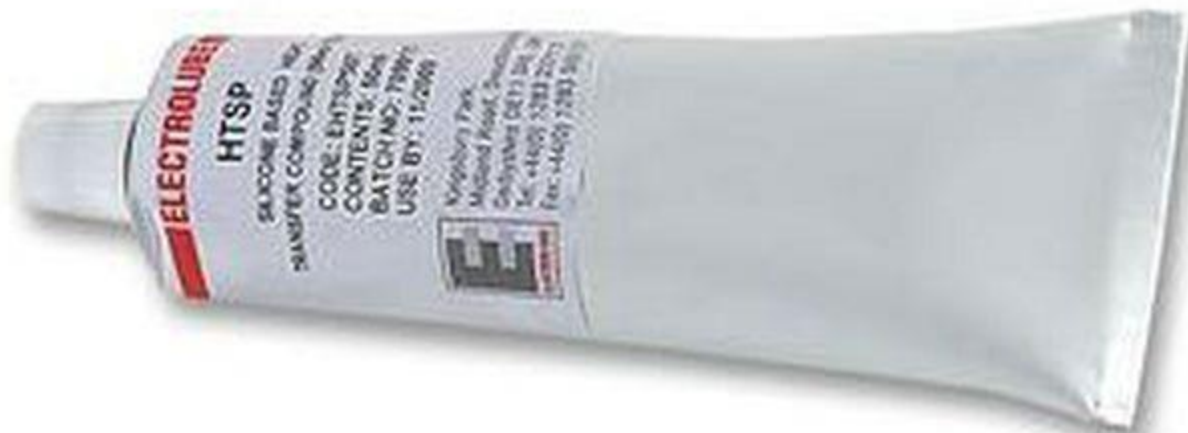
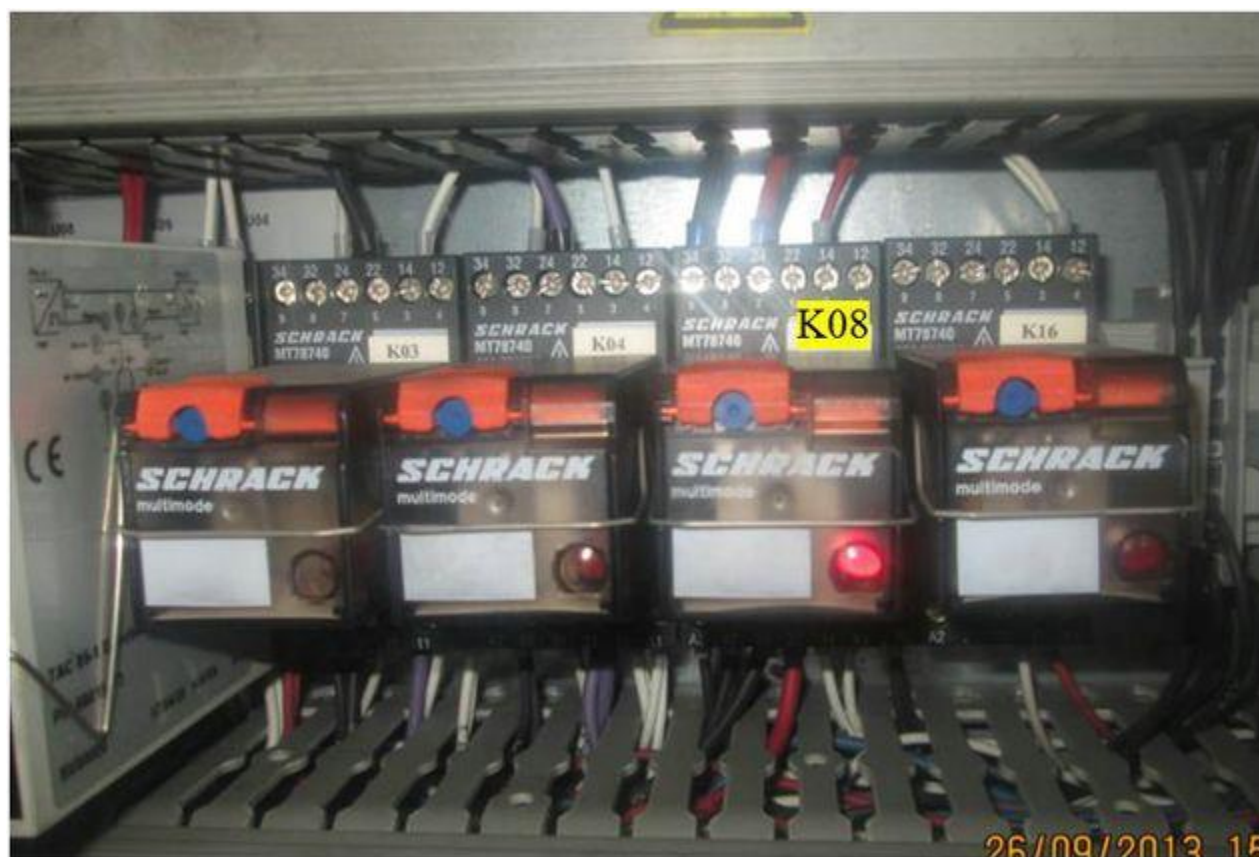
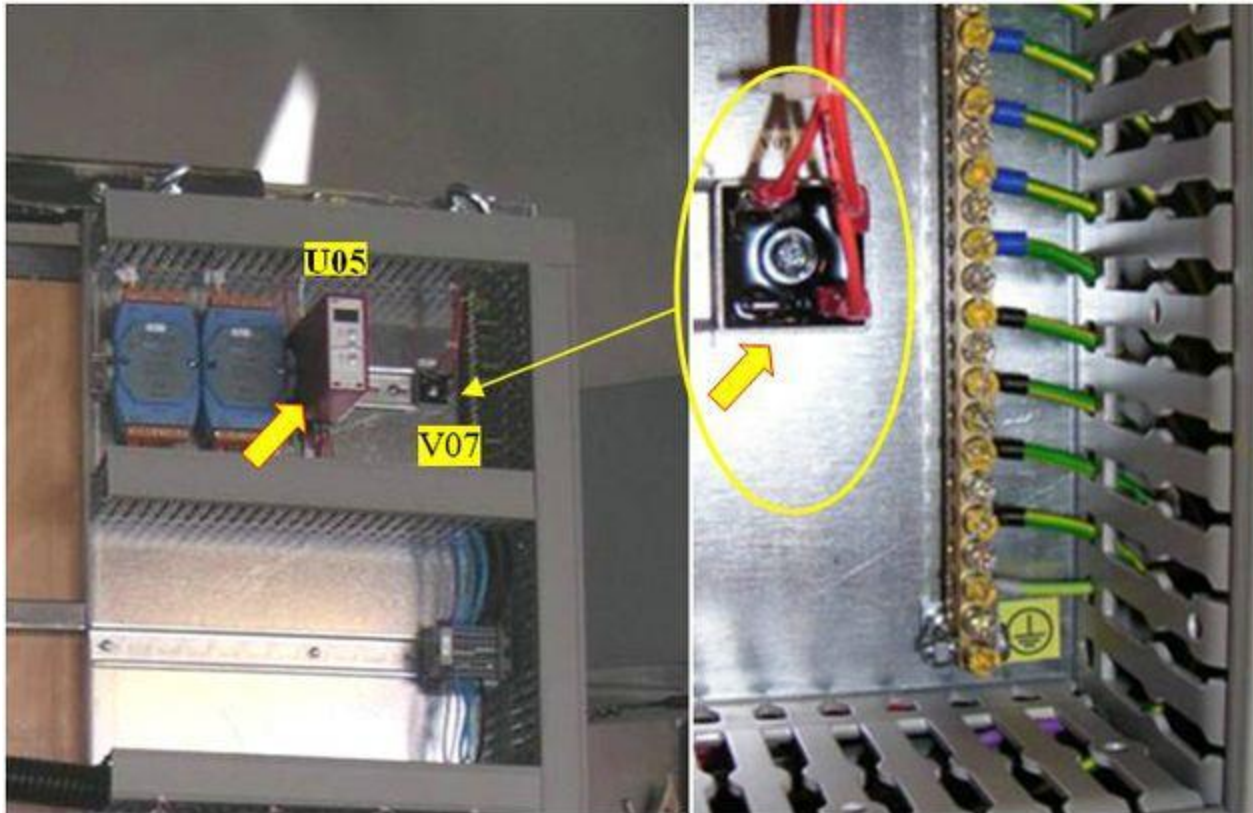
Check the K08 relay operation and INPUT/OUTPUT voltage,

Check the Trip amplifier and Bridge rectifier,

Check if any loose connection in the circuit,

Replace the Defect components

If defect replace the failure components.

Relevant spare parts		
Description	Item No.	Position
TRIP AMPLIFIER 2231D-1050	60004924	U05
DIODE BRID KBPC3506G 600V 35A	60000980	V07
RELAY MT3230C4 10A 24V 3P	60004532	K08
COOLING COMPOUND HTS35SL 35ml	60014555

While replacing the Bridge rectifier apply the cooling compound to the surface.

It will increase the cooling efficiency

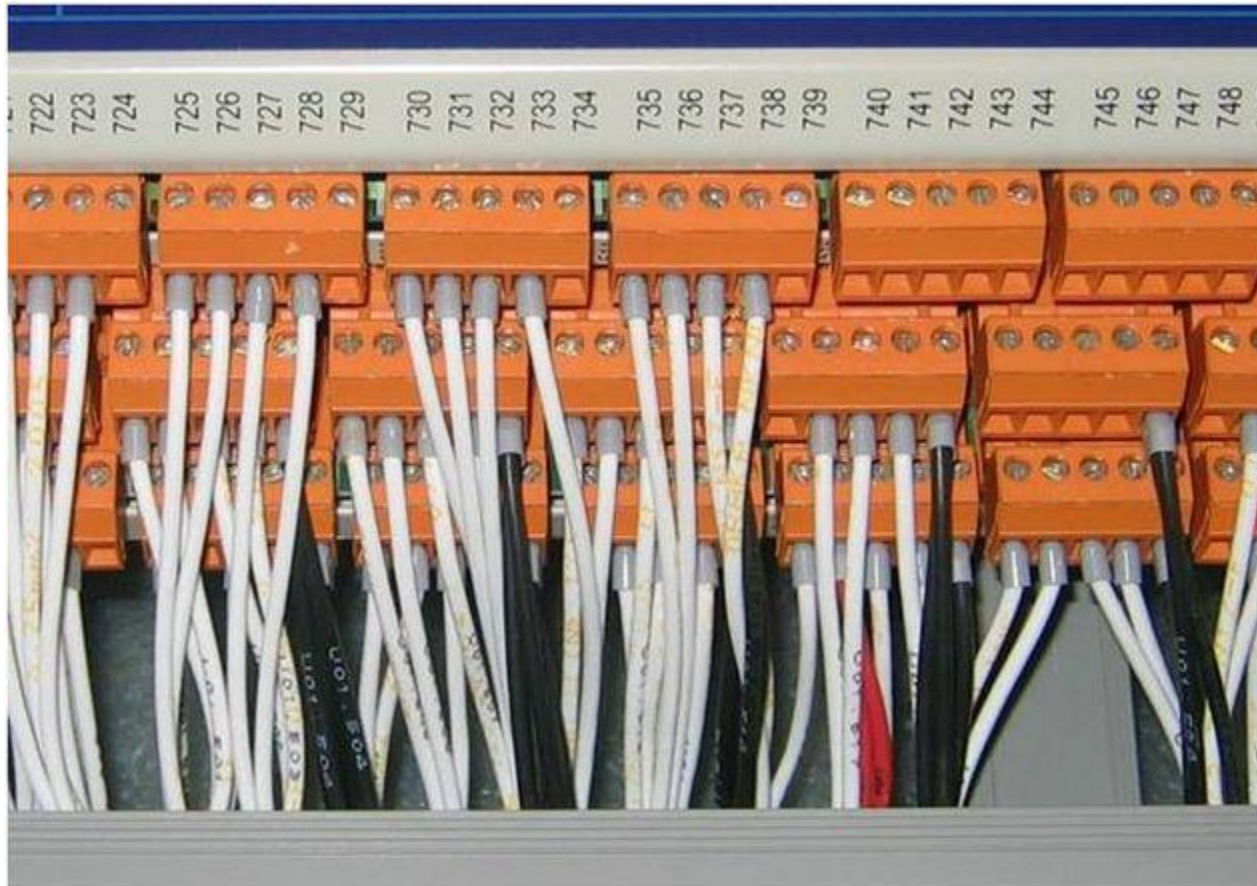
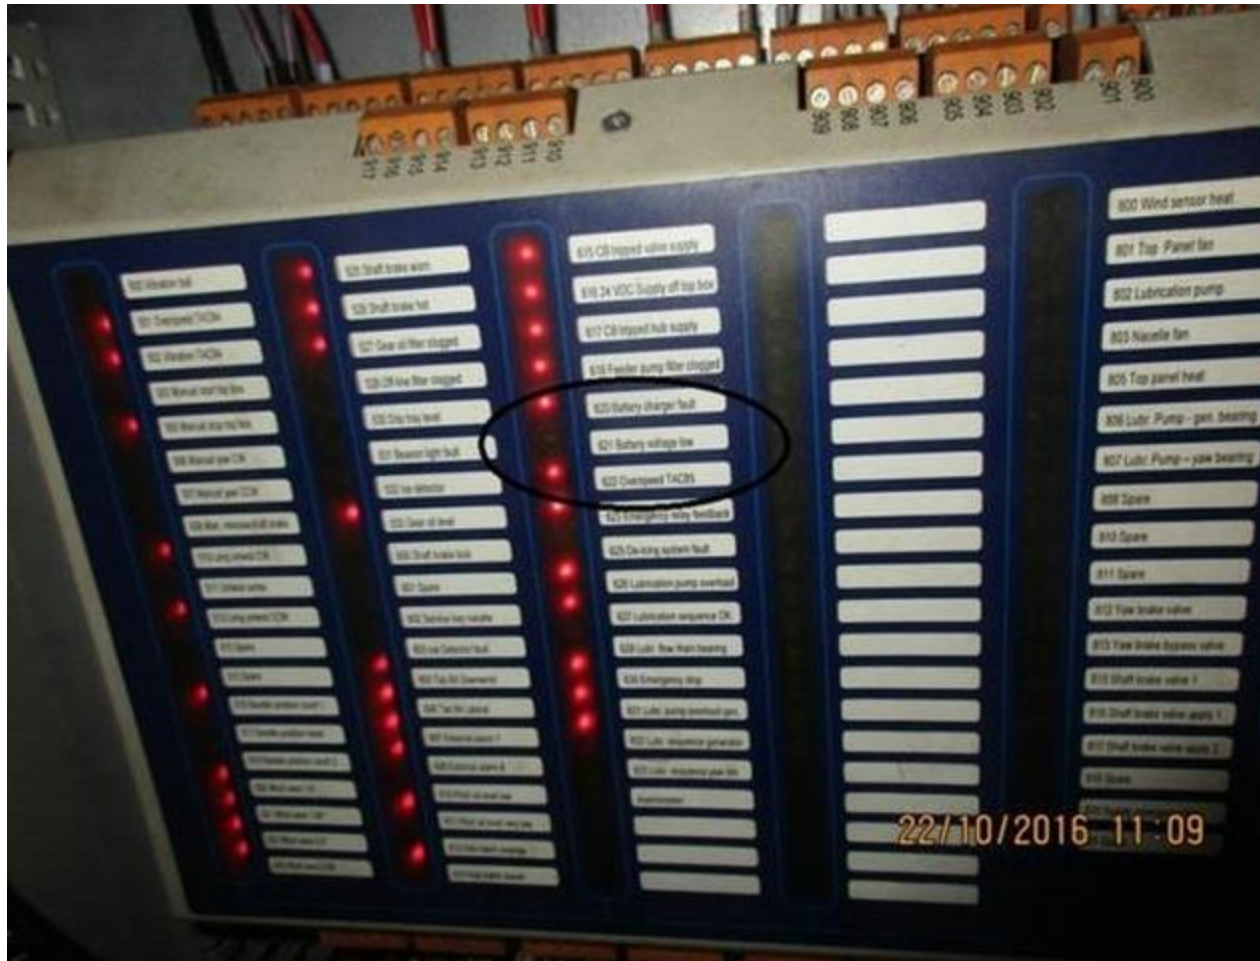
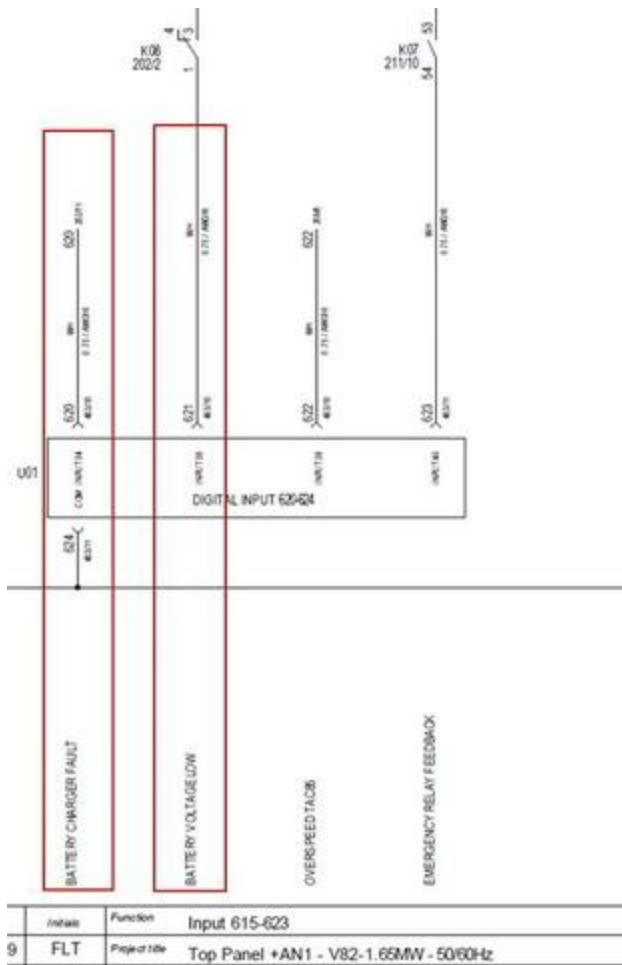
Check the loose connection and Input Signal for Battery Charger fault (620) and Battery Voltage Low (621) in TOI.

If signal is not present likely TOI defect

replace the defect TOI

Relevant spare parts	
Description	Item No.
TOI-II INTERF EXT POC	51701601
