**Replace the defective pressure transmitter**

**Replace the defective pressure transmitter cable.**

**Replace the defective hub computer**

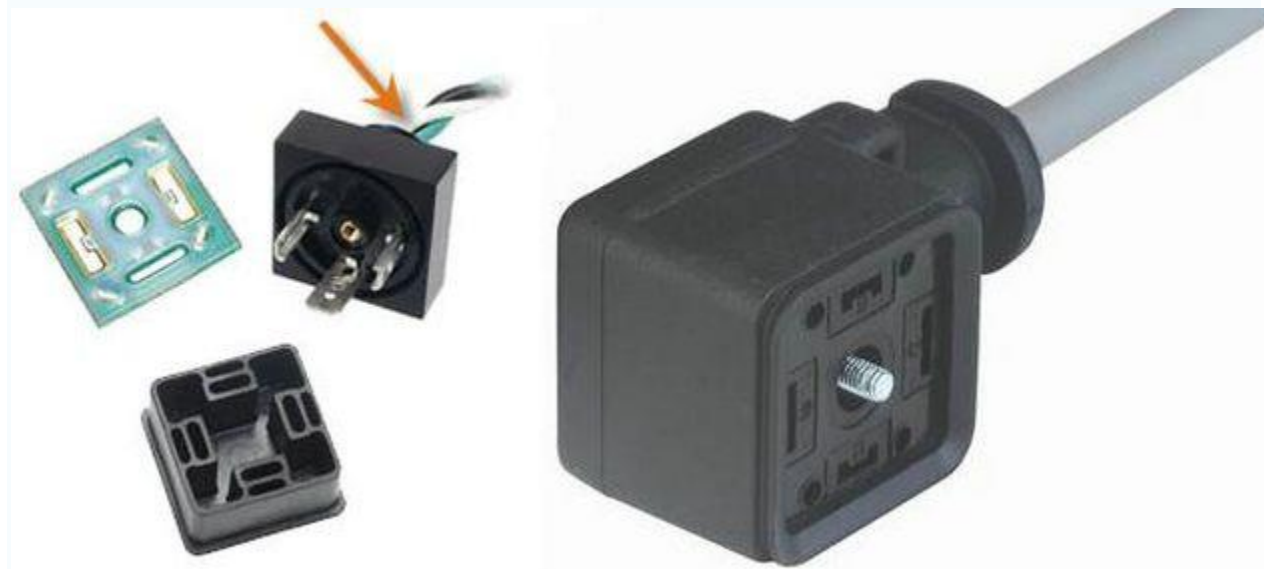
Check the cable routing in the hub W919 cable.

Visually Look for cracks or wear on the cable.

Check for any loose connections on both the ends.

Check that the pressure transmitter connection DIN pin is not loose.

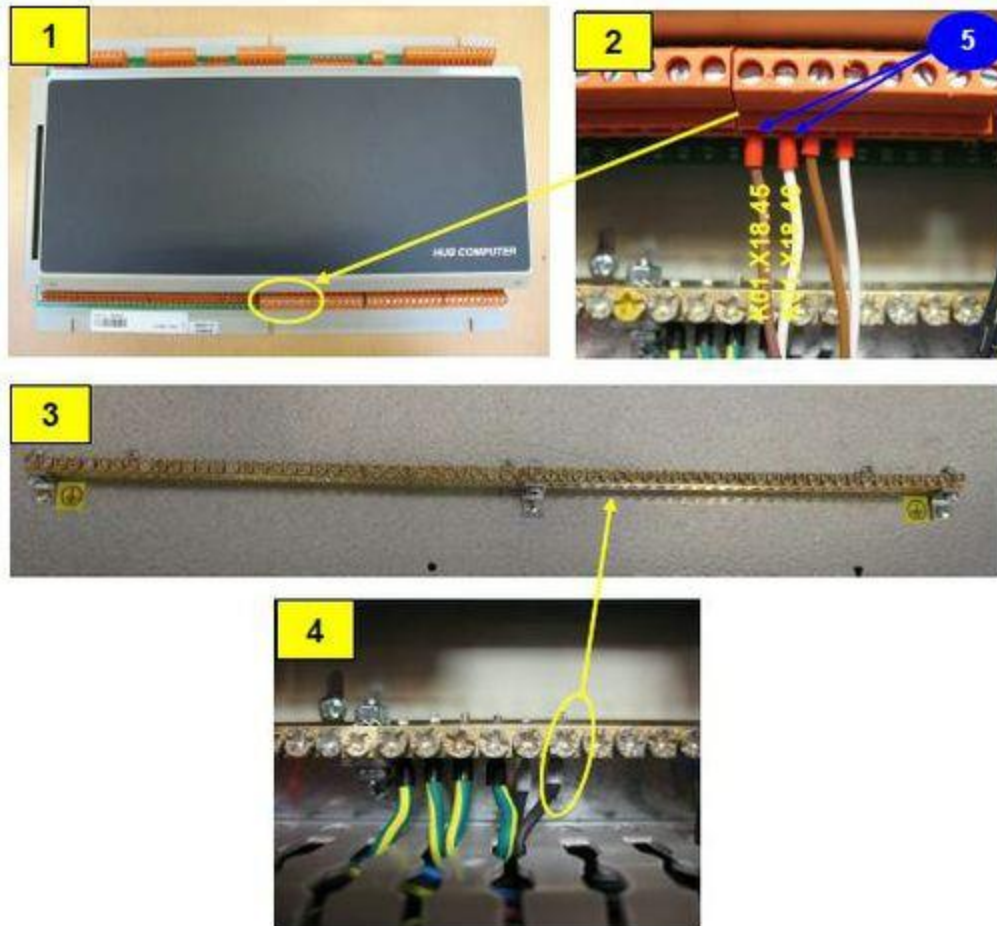
Check loose connection in the hub computer X18 – 45 & 46 and ground terminal. Remove plug and check for any burning or corrosion.

If the cable is found to be defective, replace with new.

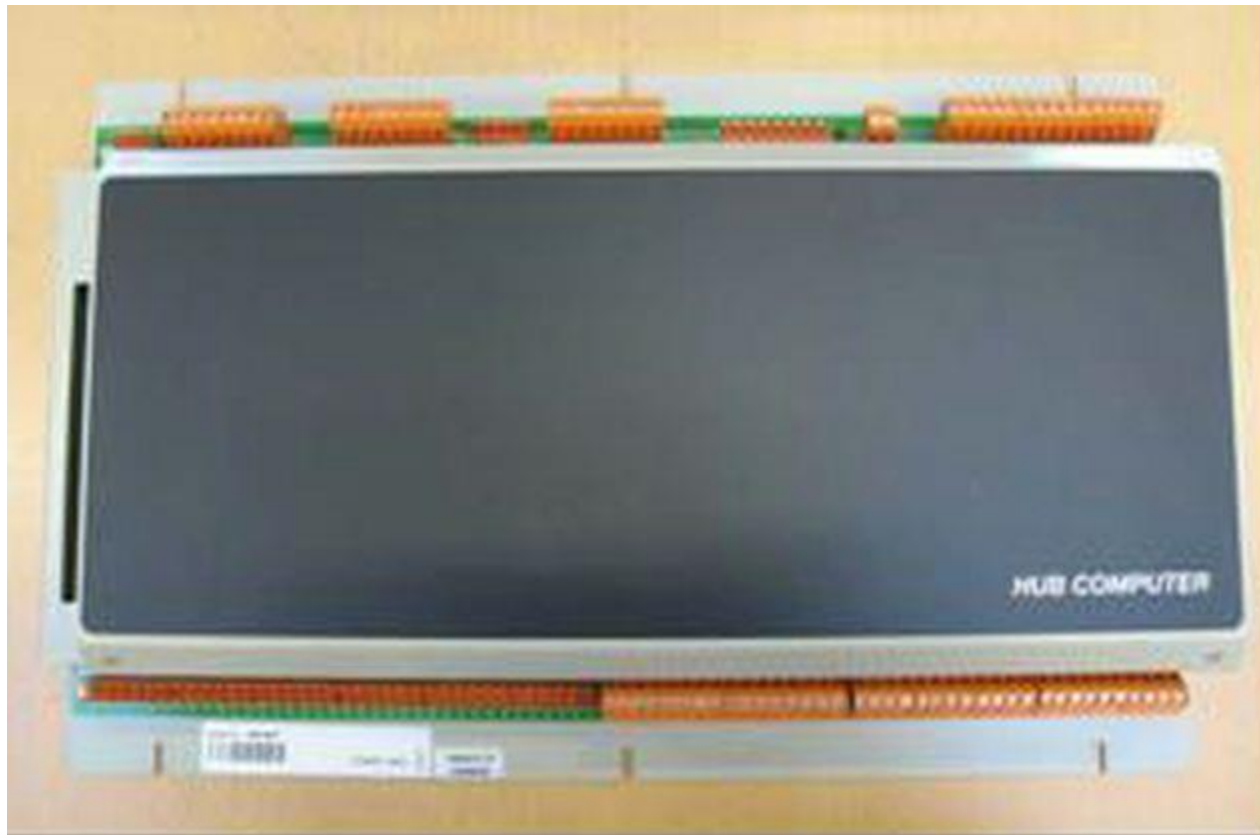
If after the pressure transmitter and cable have been verified okay, the fault still persist it is likely that the hub computer is defective.

Replace the hub computer with new.

Hub Computer Part Number: [51701801](#)
