Replace defective RS232/RS485 CONV I-7520 ICP

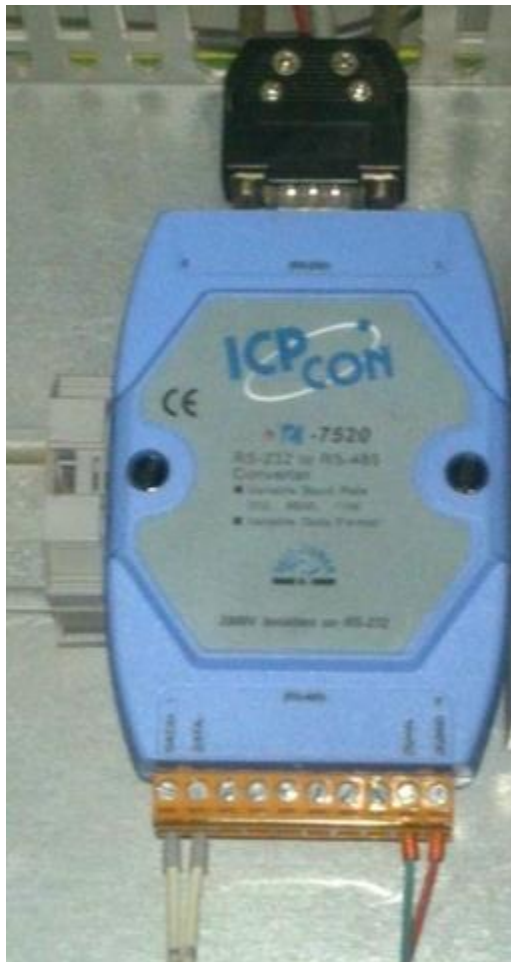
Check the connections at the ICP RS232/RS485 converter in the AT2 panel. Check for loose wires and plugs or corrosion at the converter.

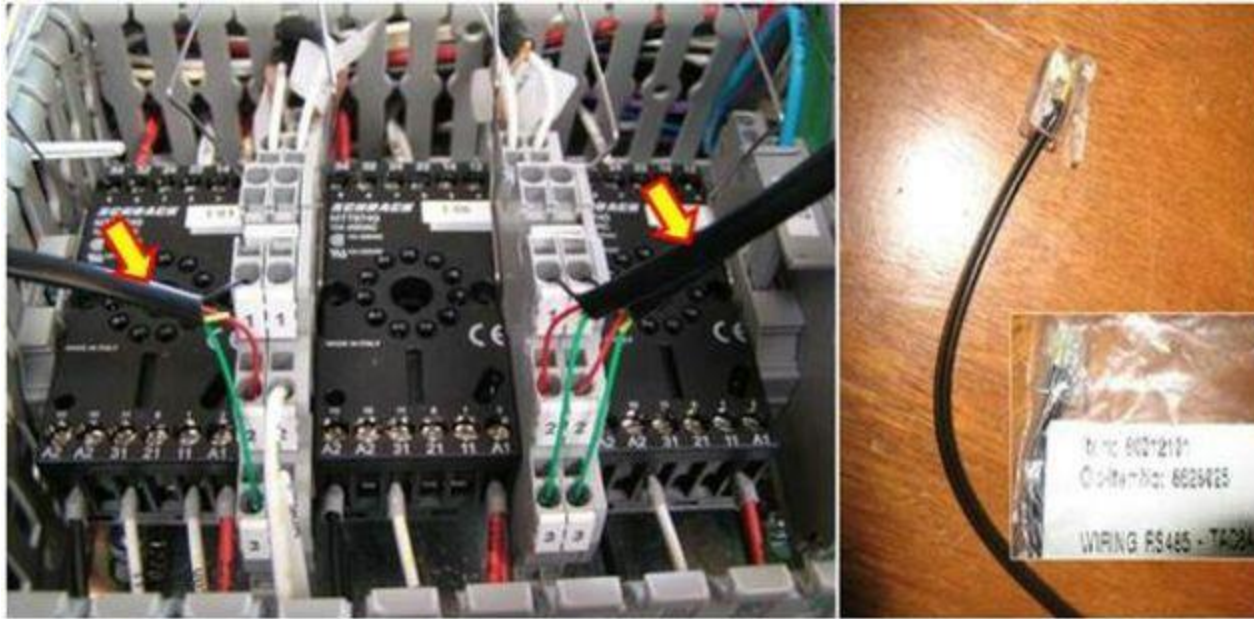
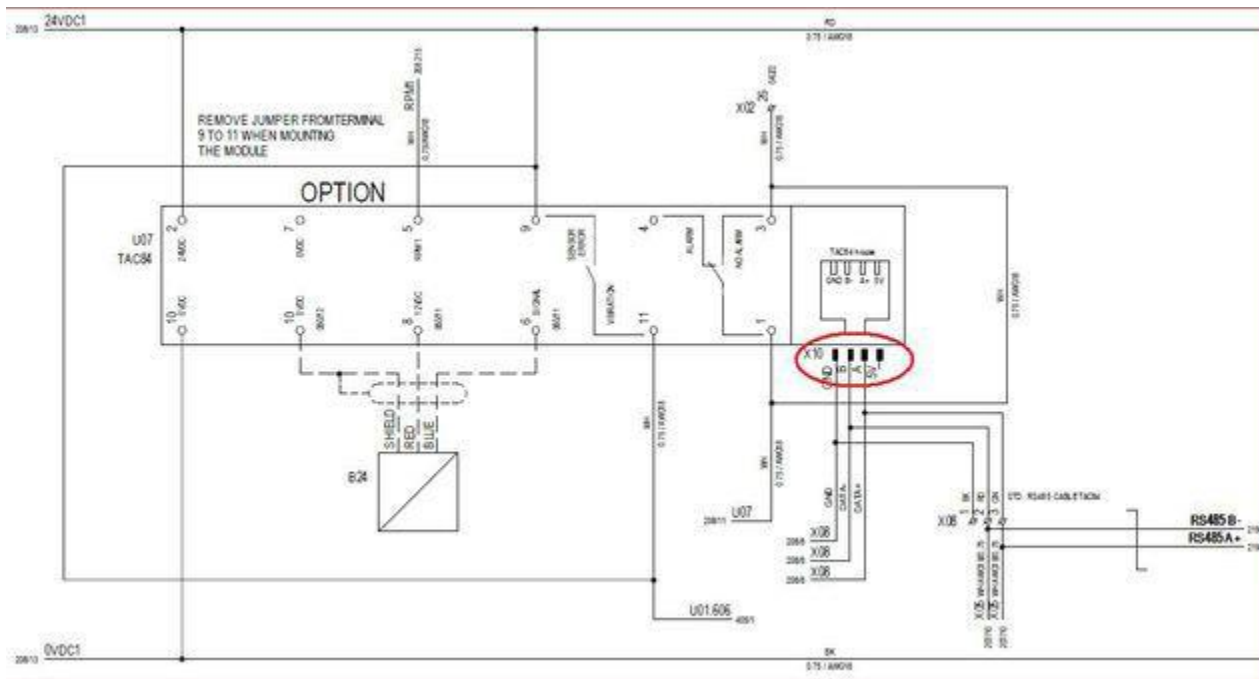
Check for poor cable connection on the TAC 84 communication cable.

Check the continuity of B3 & B4 cores in cable W500 and replace with spare core, if no continuity.

If necessary replace the cable.

If found cables interchanged, then this should be corrected at the other end at connector terminals.

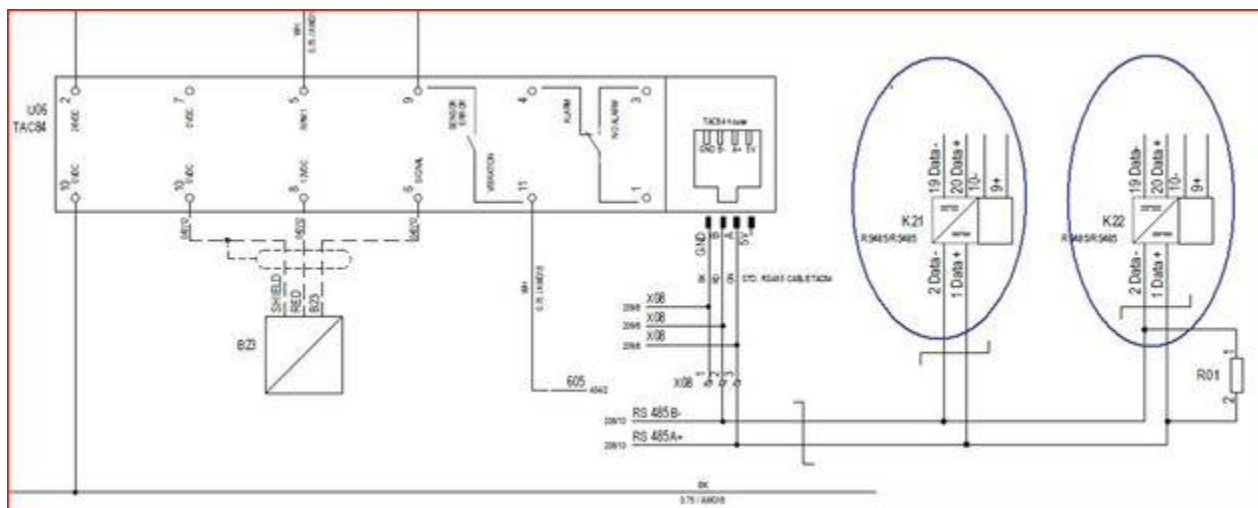
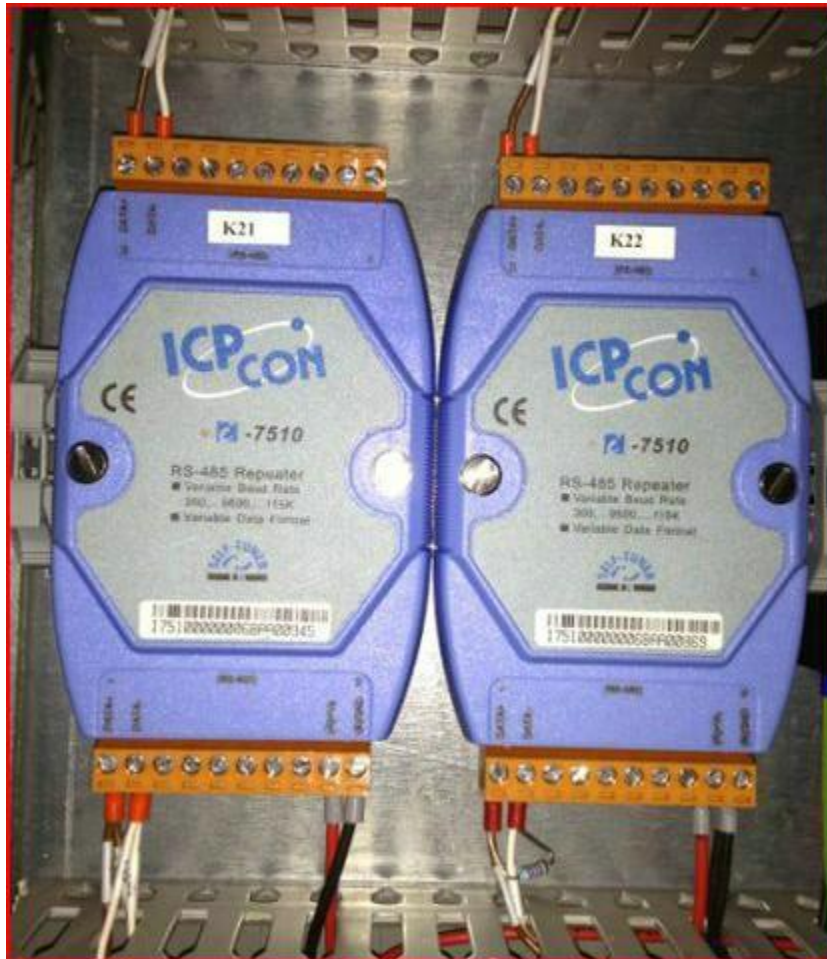
Check the connections at the ICP RS485 repeaters (K21 & K22) in the AN1. Check for loose wires and plugs or corrosion at the repeater.

If there is still no communication, switch the ICP RS485 repeaters to see if the communication returns. If communication returns when the repeaters are switched, replace the faulty repeater.

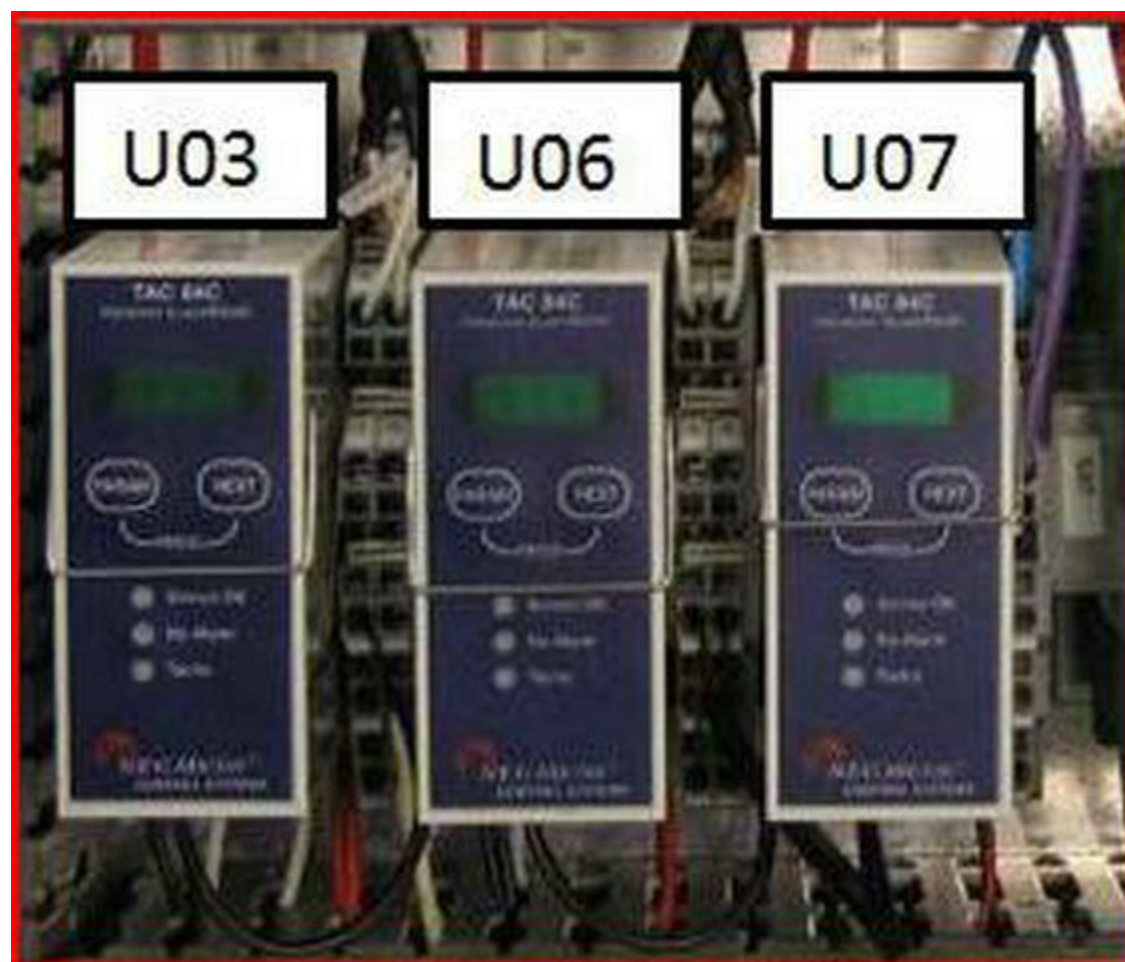
- Explanation**
 If the communication cannot be restored by manipulating the com plug, replace the module. Update parameters as per TAC 84 settings.

Replace U07 TAC 84 Module
