Replace Thyristor

In this failure mode the alarm normally trips at 1000/1200rpm when the turbine connects to the grid. There are also current asymmetries in this failure mode which can be observed in the TAC display panel.

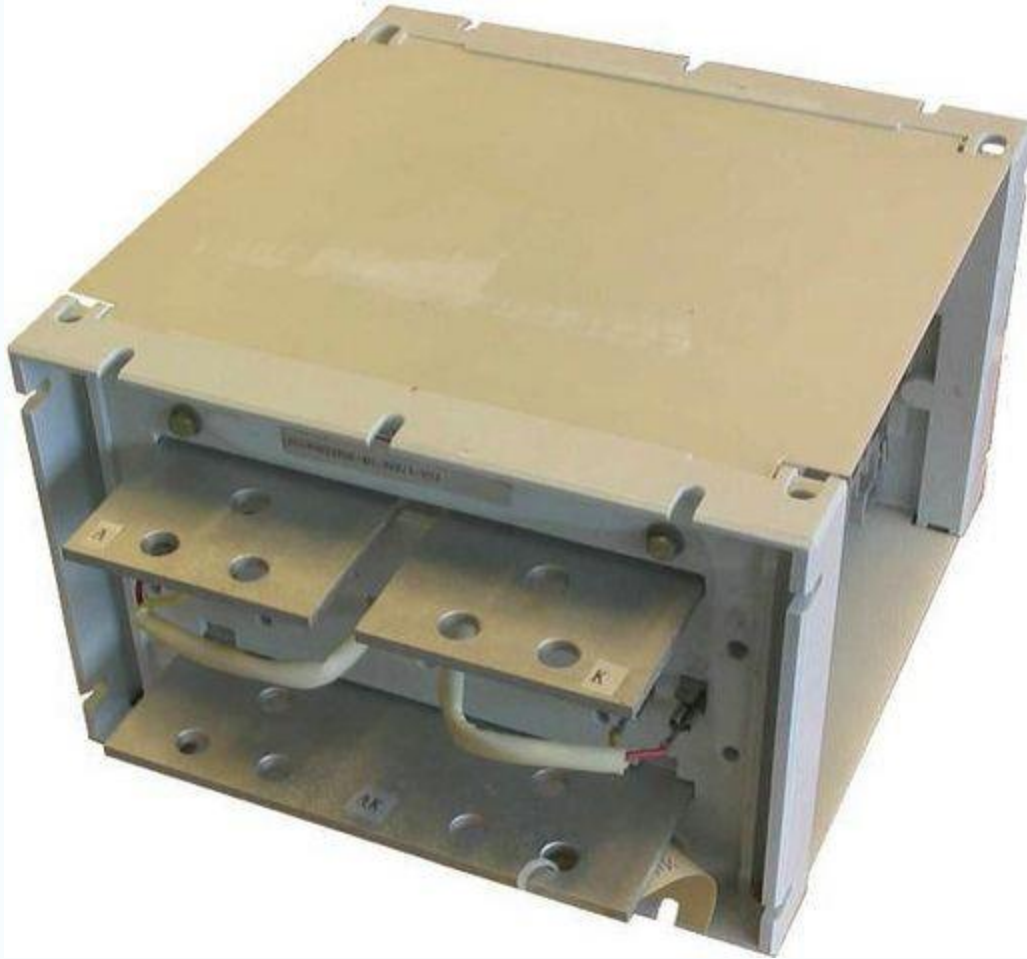
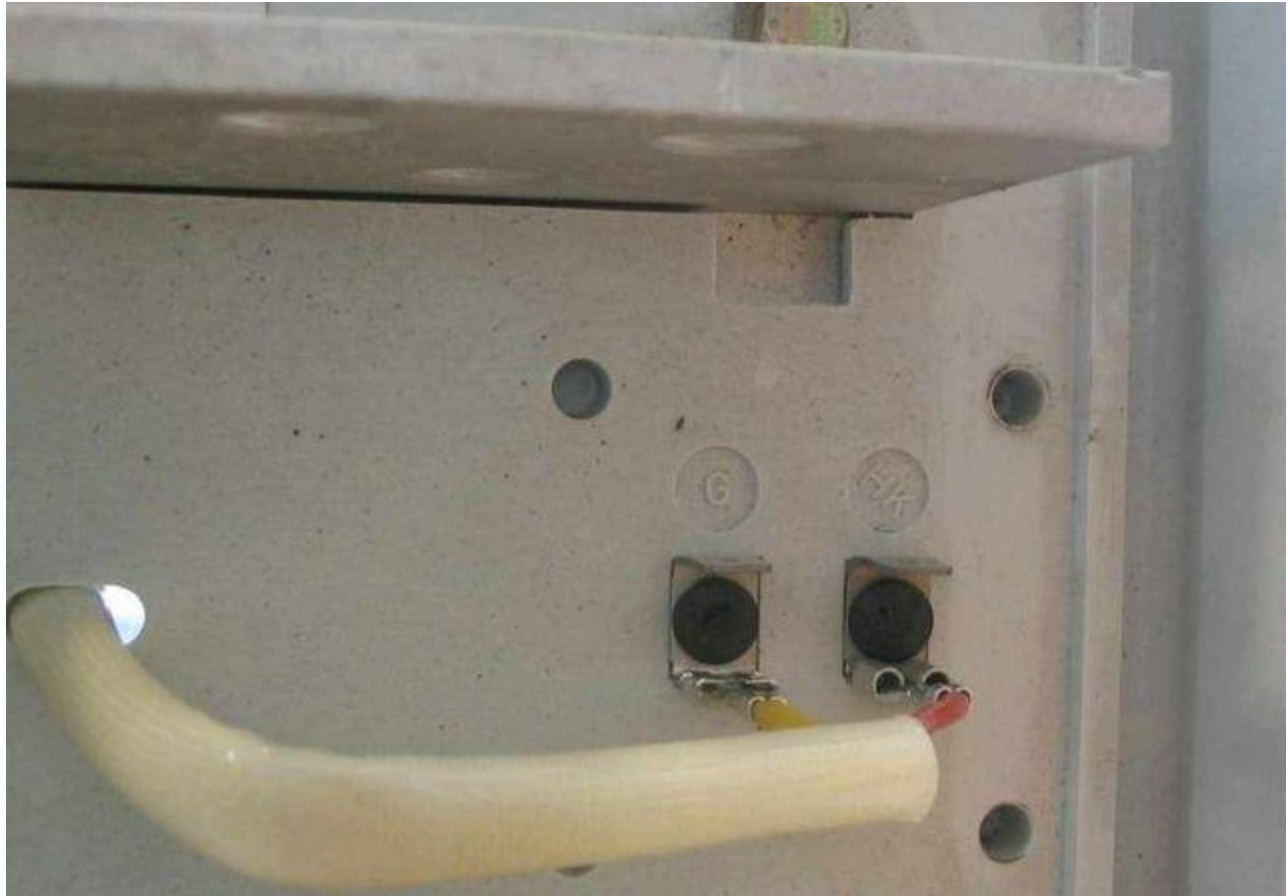
With the red multimeter lead on 'A' and the black lead on 'K' it is possible to measure approximately 1-2 M ohm.

If the wires are exchanged the resistance will be even higher.

If the thyristor is defective the measurements will be radically different, maybe 100 ohm or below.

The measuring is made on both thyristor halves, in other words from 'A' and to 'AK' as well as from 'AK' to 'K'.

Between 'G' and 'HK' the measurement should be approximately 10 ohm.

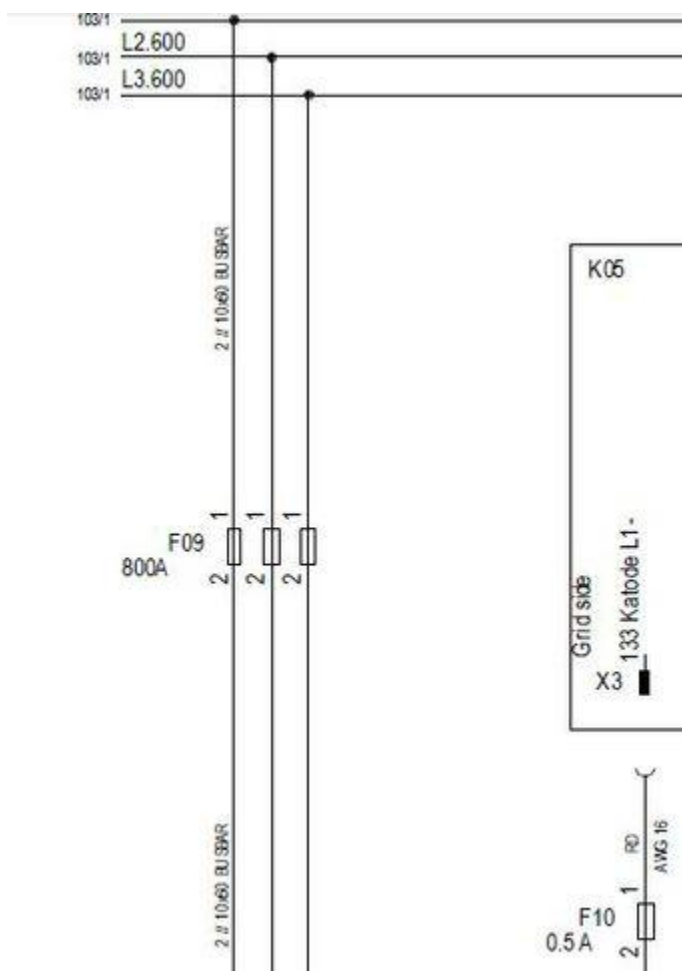
Note: Sometimes there is no (aux) feedback from the thyristor fuse to trip "alarm 563 Thyristor fuse blown" and it will show alarm 30 instead.

Replace fuses

If the thyristor fuses fail often in low wind, check the BIOS version in the TAC II Controller and update as necessary in accordance with: 1001826

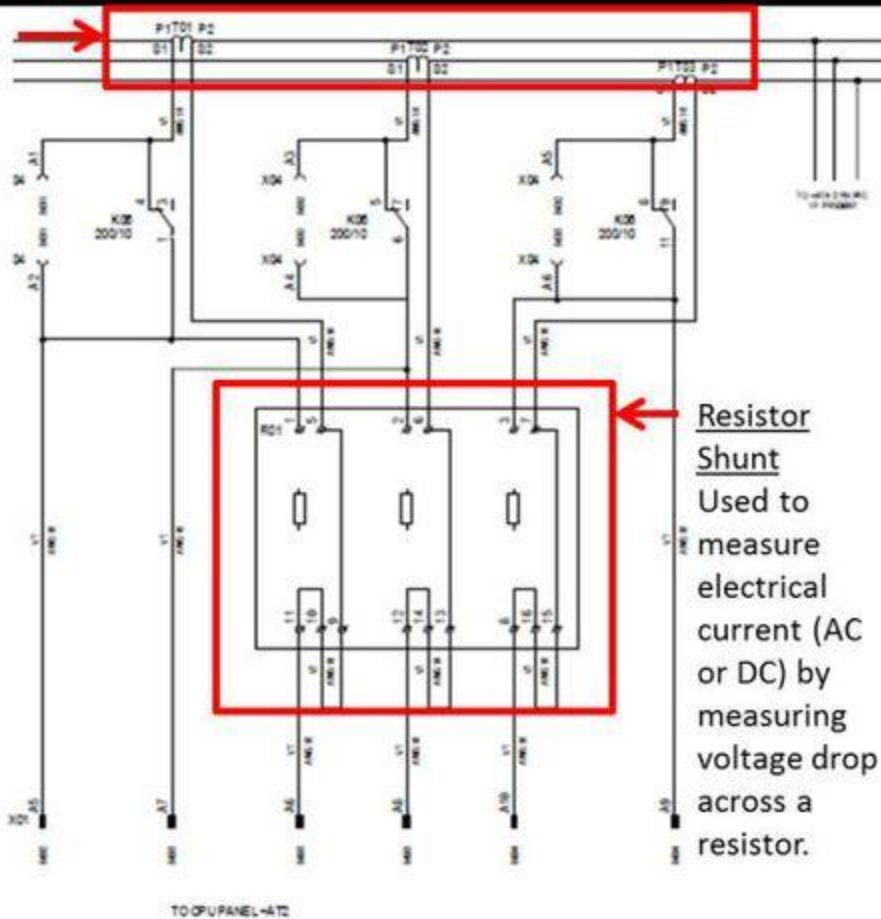
Current Transformer

Remove wires from CT's and measure resistance. A good CT should measure about 7 ohms.

Put wires back on current transformers and test resistance with wires on. If higher resistance is found on faulting line problem is likely the Resistor Shunt in the AT1.

Check/Replace current transformer and Shunt Resistor

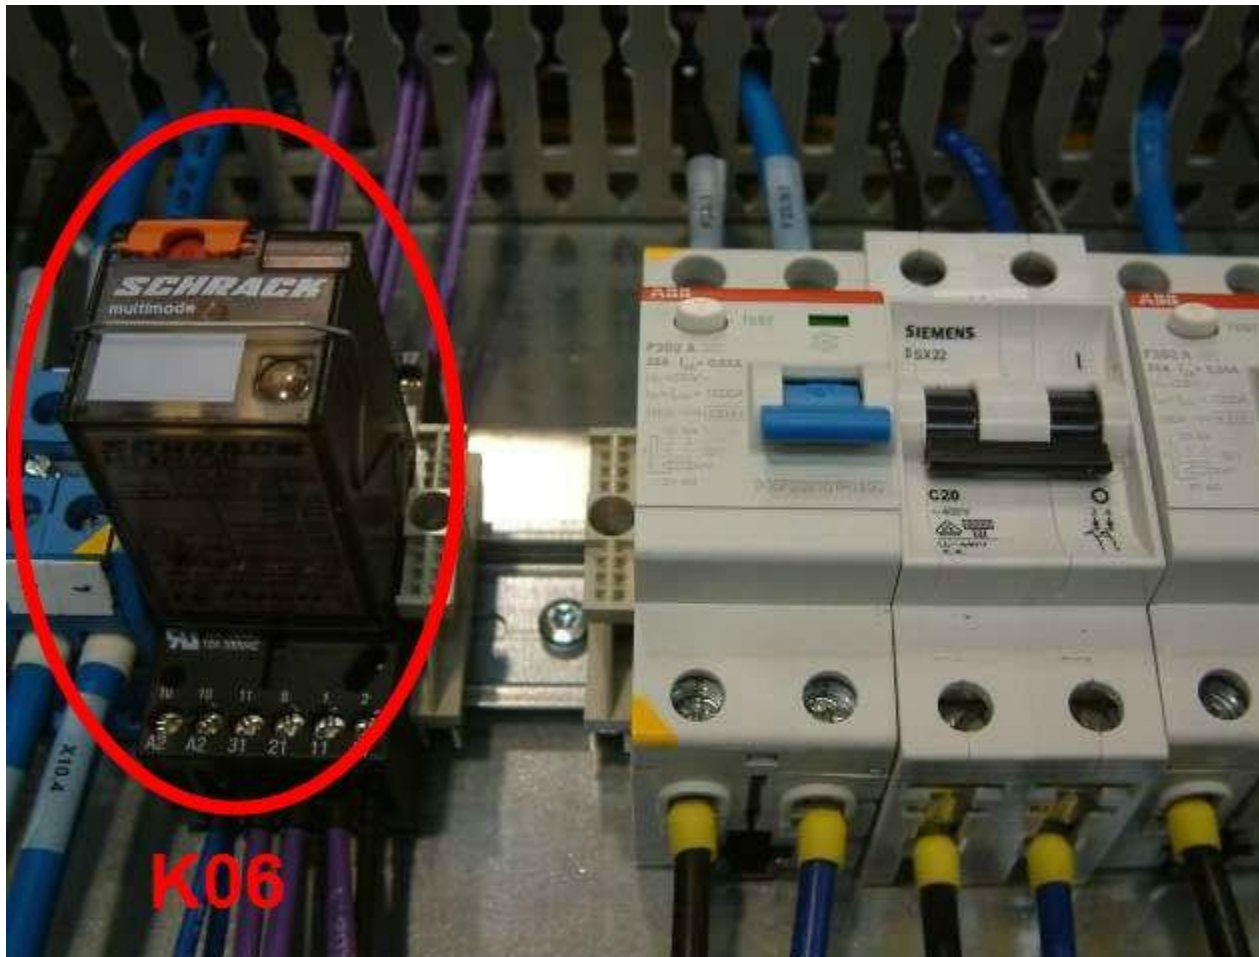
Check the K06 relay in the AT1 cabinet. Replace it if found to be defective.

Test the contacts by manually closing them with the orange tab (lift) on top of the K06.

Inspect/replace K06 Relay

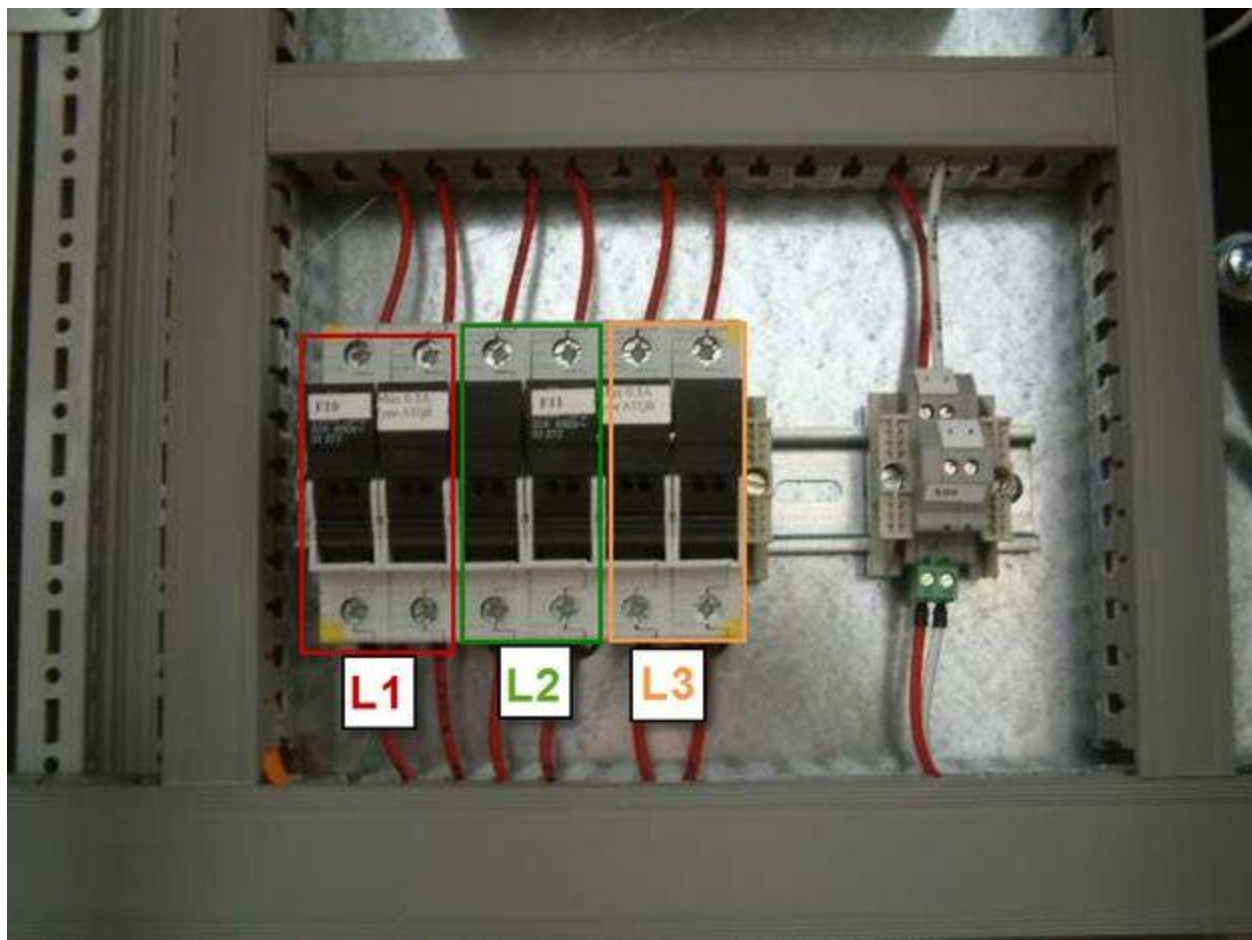
- Explanation**
 An asymmetry in the current could be due to the F10 or F11 0.5A fuses located between the TAC40 and the thyristors. This problem would exhibit itself before the K02 bypass contactor closes.

This will not cause alarm 563, thyristor fuse blown. That alarm is caused by the F09 opening.

Inspect/replace fuses

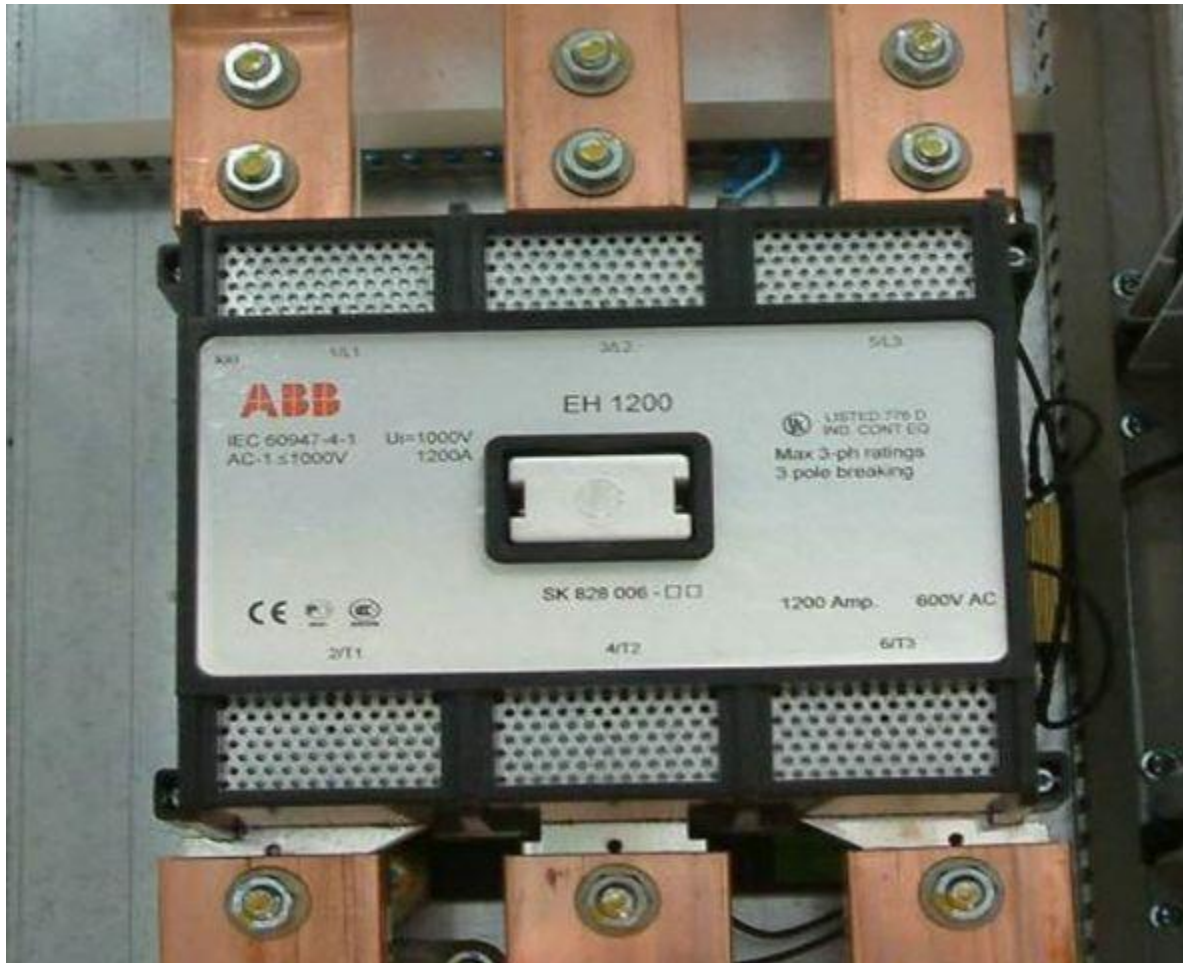
- **Explanation**
Check the K01 Grid Contactor. If it is not closing evenly, it could cause unevenly high resistance on two of the lines making one line look like it has high amperage. With the circuit LOTO, manually operate the K01 and confirm that it

works with a digital multimeter. Use the white pushbutton to manually close the K01 and then use a multimeter to test the resistance on each line across the contactor.

Test/Replace the K01 Grid Contactor

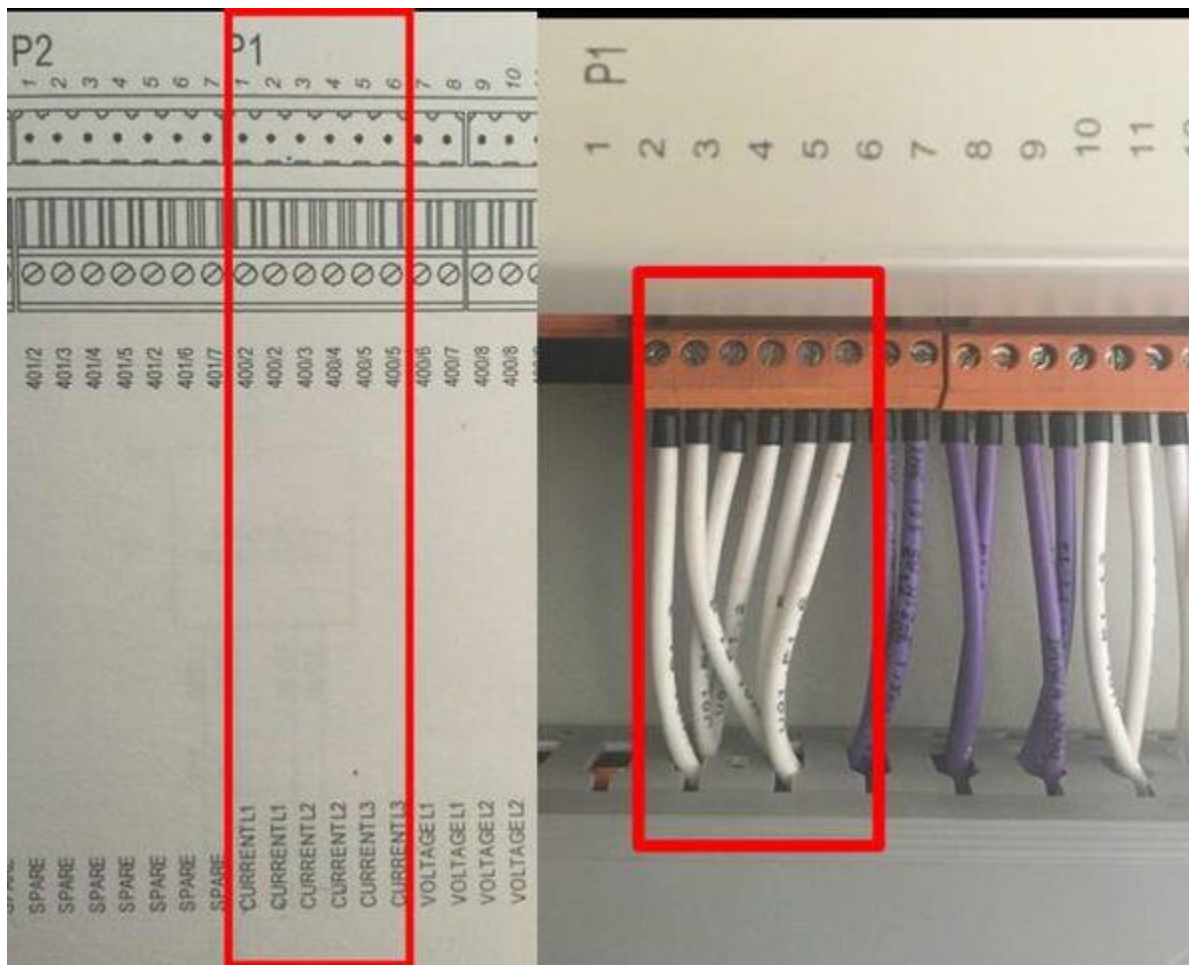
Verify the TAC II isn't defective. Look in alarm snapshot to see which phase is incorrect and switch to another phase at the P1 connector on the back of the TAC II. If the fault current stays the same, the TAC II is defective if it moves the issue is in another part of the circuit.

Check/Replace TAC II
