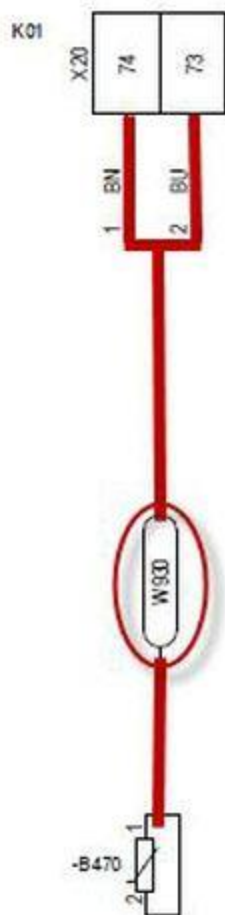
Replace the pitch oil temperature sensor cable if defect.

Remove the cable W930 wires from AK4 panel KO1 (hub computer) terminal 73 /74 and PT 100.
Check the continuity across the cable. If continuity fails replace the cable.

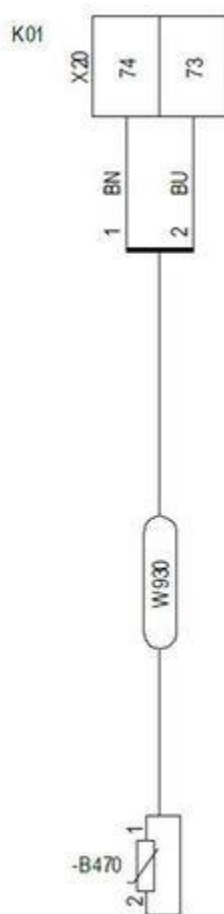
Check that the PT100 measurement is accurate.

1. If the sensor is suspected to be reading inaccurately, check the resistance of the PT100.
 1. Disconnect the wires of the Pt100 sensor from terminals 73 &74 in AK4.
 2. Measure the resistance of the PT100 across the leads.

3. Using the PT100 Ohm-Temp chart, determine if the sensor is operating within range.

Replace PT100

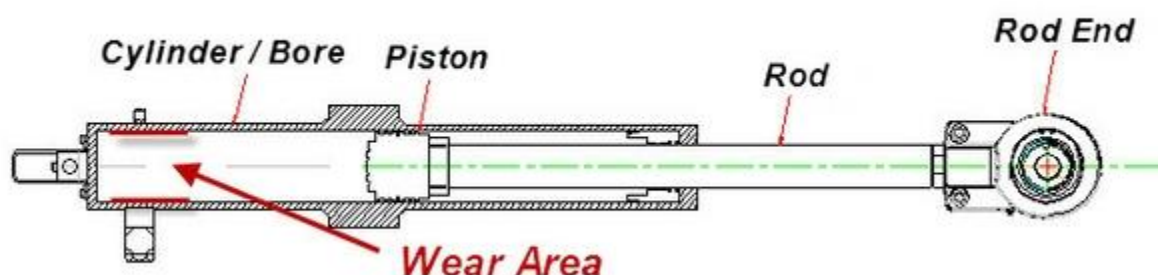
The back 250 mm of the pitch cylinder bore may be susceptible to excessive wear. This area of the cylinder is where the piston operates during production. When excessive wear occurs in the cylinder barrel, the piston seals are also subjected to accelerated wear, and internal leakage will occur in both run and stop positions. The effect of this leakage is excessive pump run time during operation as well as during stop which can lead to increased pitch oil temperature. In the event of a pump failure, grid outage or certain turbine faults, pressure within the accumulators will bleed off, and blades may be at risk of being pushed into the run position under high wind conditions. Check the back of the bore for abnormal wear.

Refer to DMS doc 0059-1574 for inspection instructions and criteria for running the turbine if wear is found.

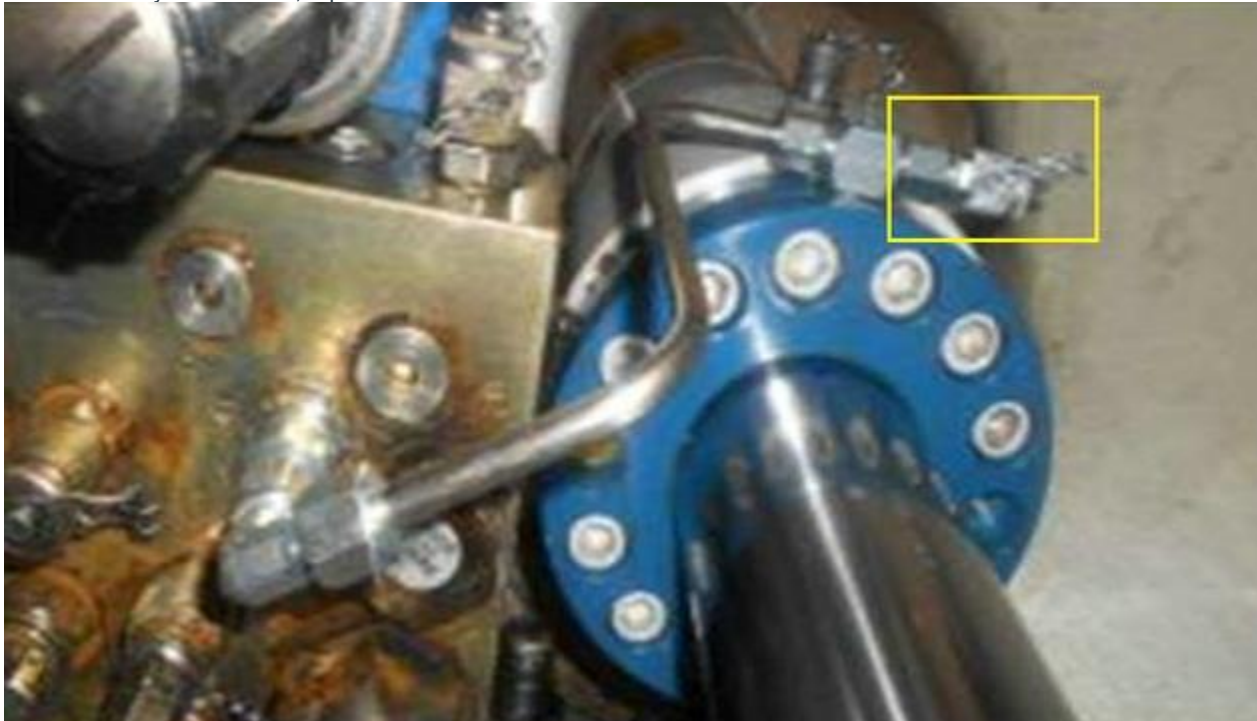
Check for oil bleeding from the test connector in the return line during pitch in time (Actuator Internal oil leakage, **only for PARKER System**)

If there are any leaks found, replace with new seal kit.

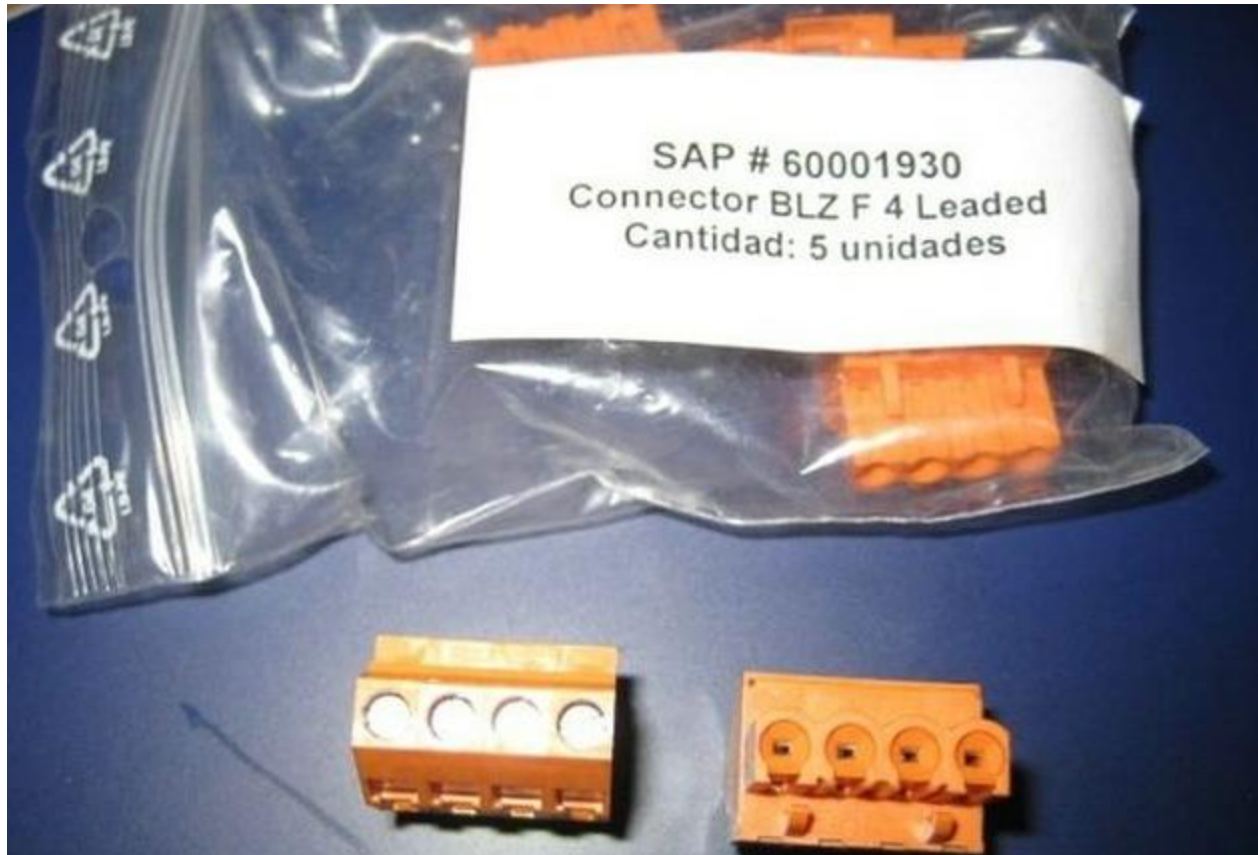
Check X20 connector for any damage and loose connection. Replace if the connector is found loose/damage

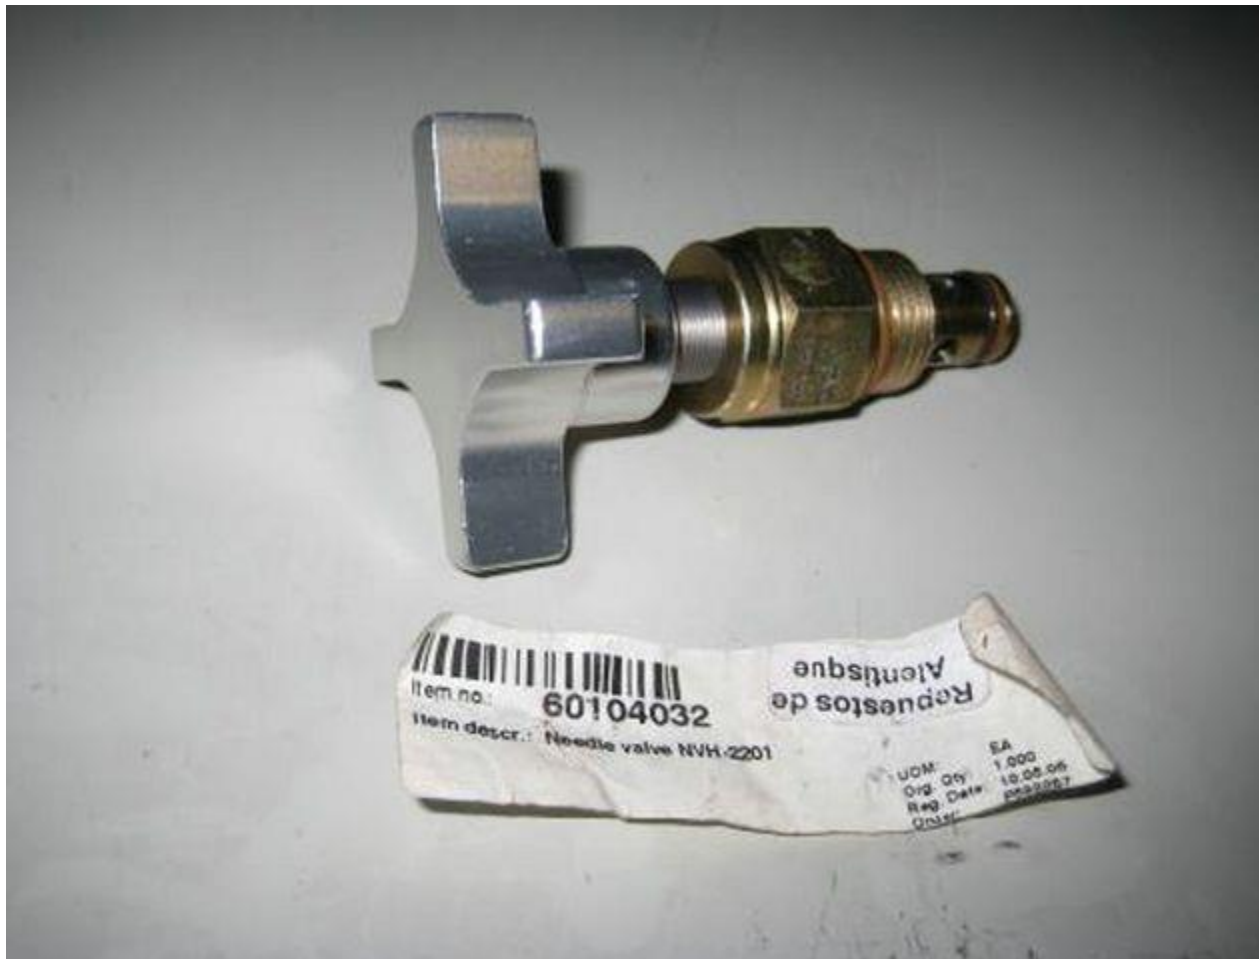
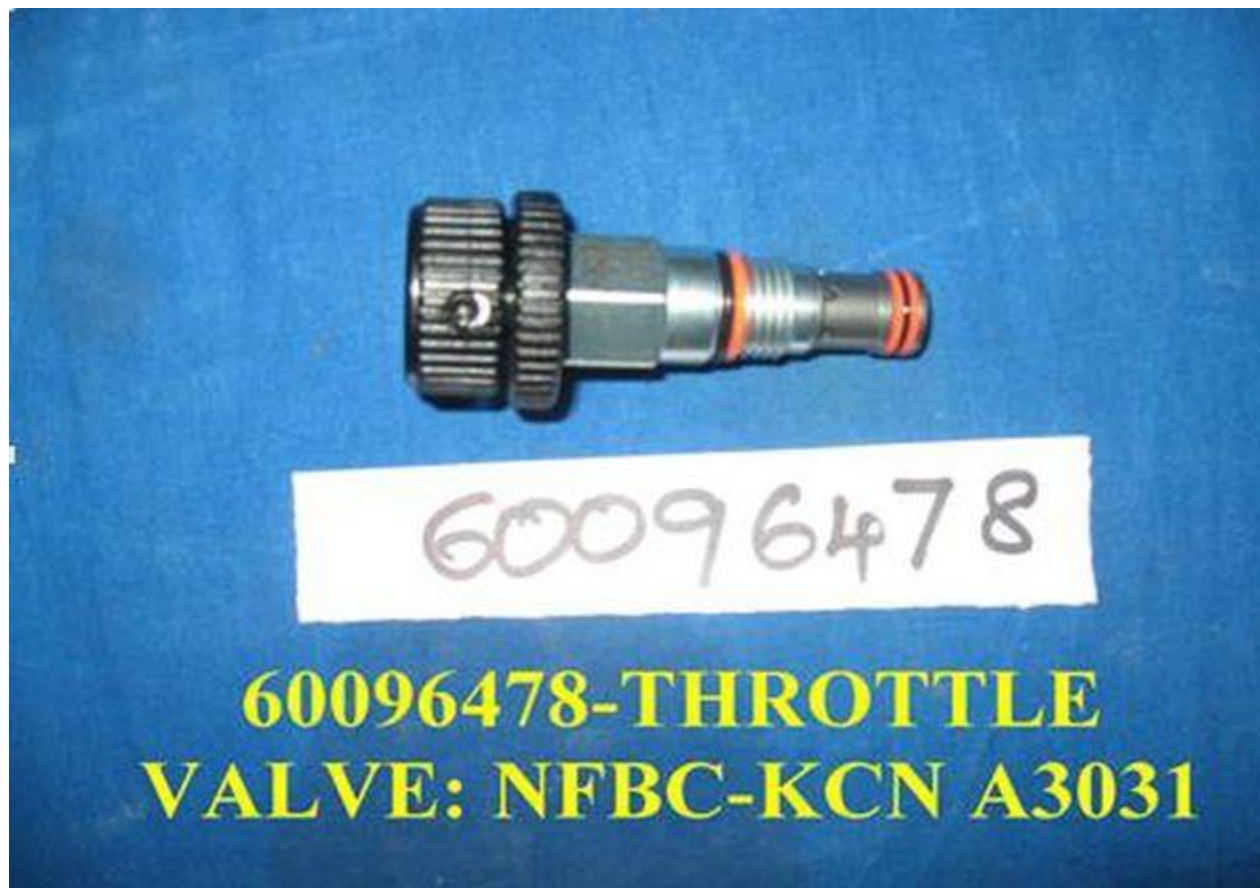
- **Explanation**
Check that valves 222 A, B and C are all completely closed.

It is possible that if the valve has been seated too tightly then the valve stem can bent and the valve can leak. This can also be accompanied by pitch pressure alarms.

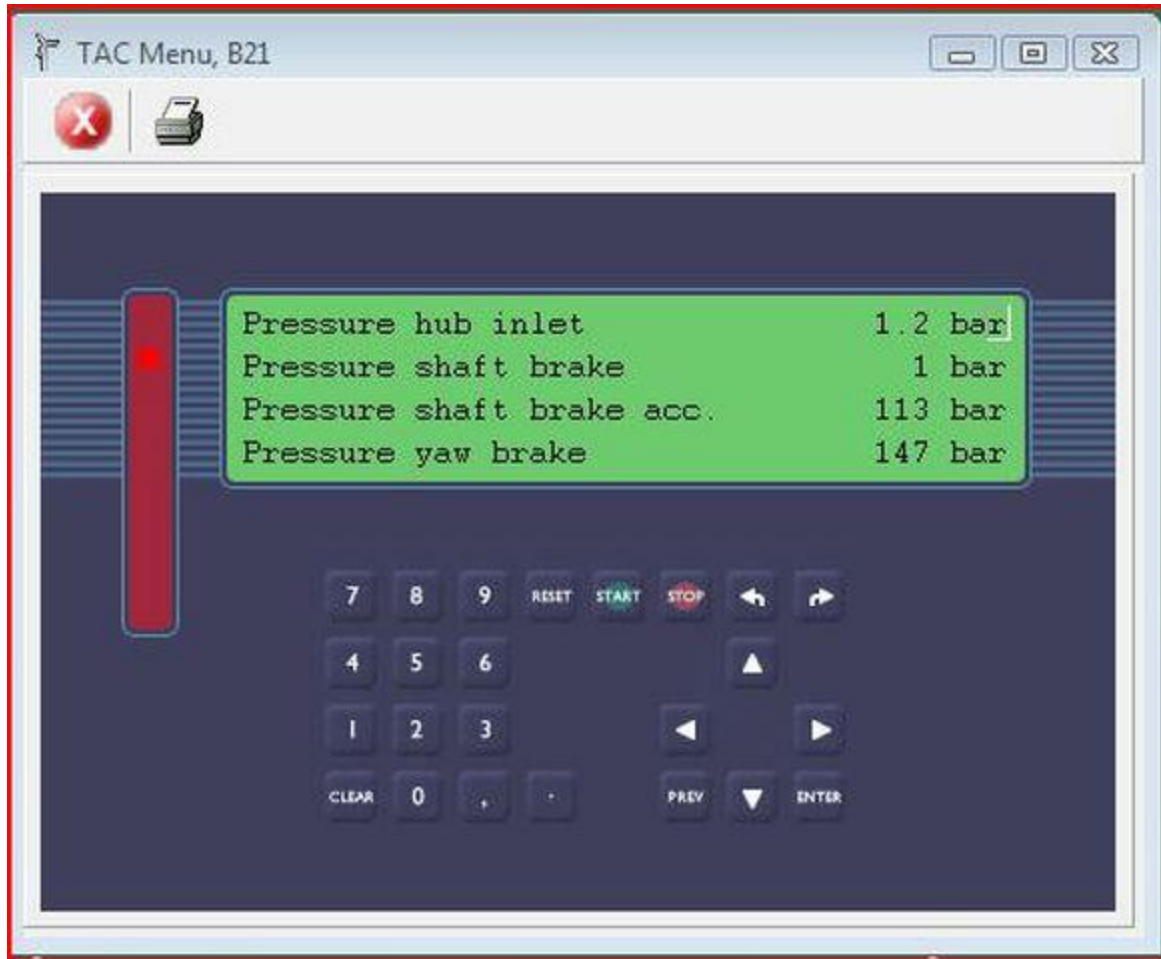
Check that valve 440 is completely open. This can be done by physically inspecting the valve for debris and proper operation.

Also, if 440 is stuck almost closed then hub inlet pressure will be higher than normal.

This can be seen in the Pressure menu in VOB.

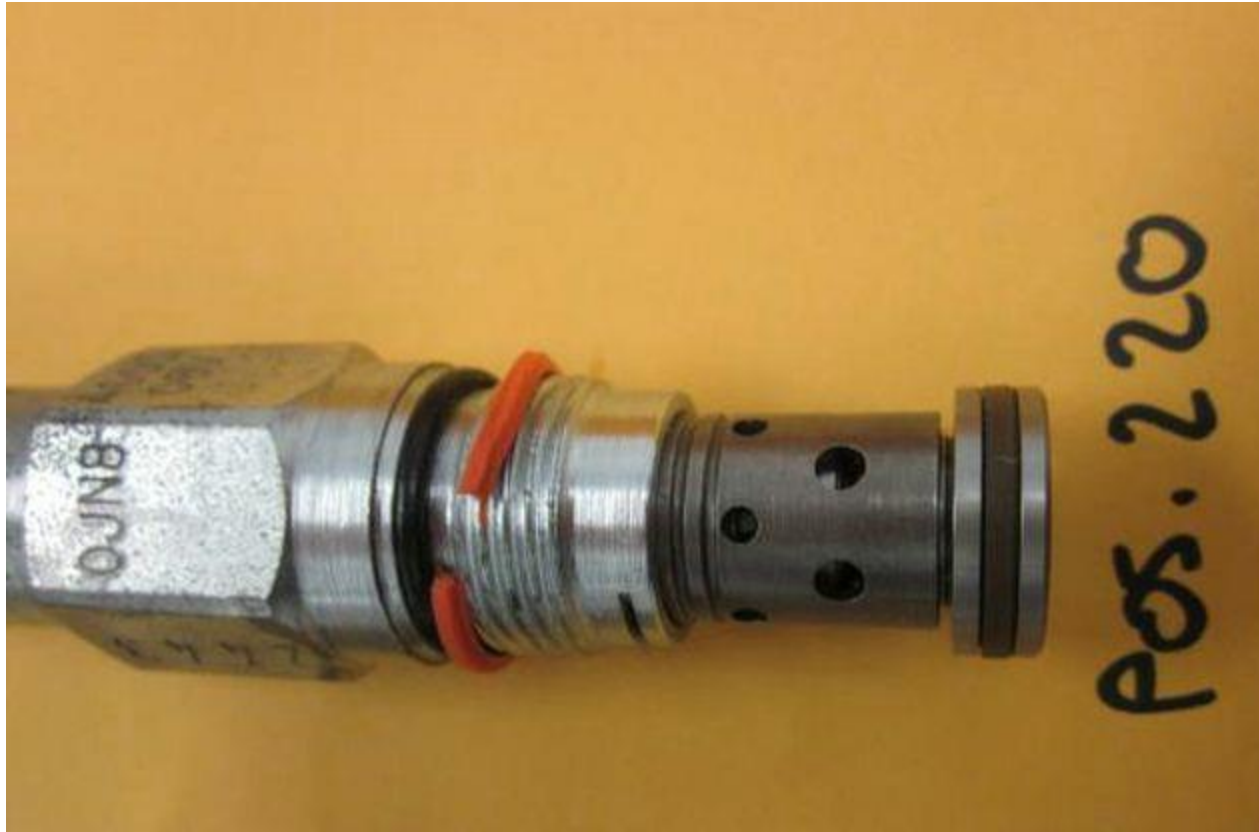
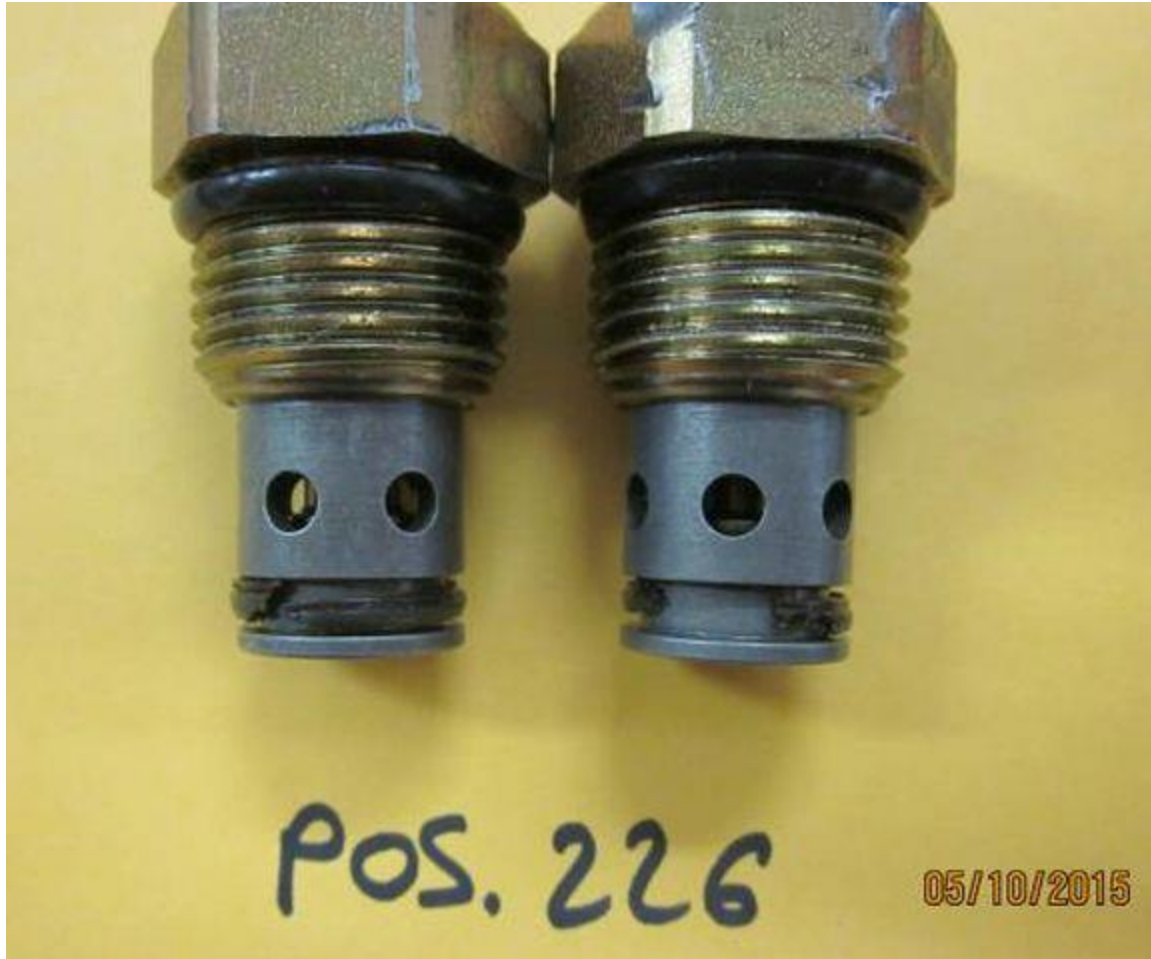
If VTM monitor 2095 (T4010 Pitch oil temp MinPod) appears it can be related to internal leaks on valve 220 and 226, where o-rings can be damaged :
