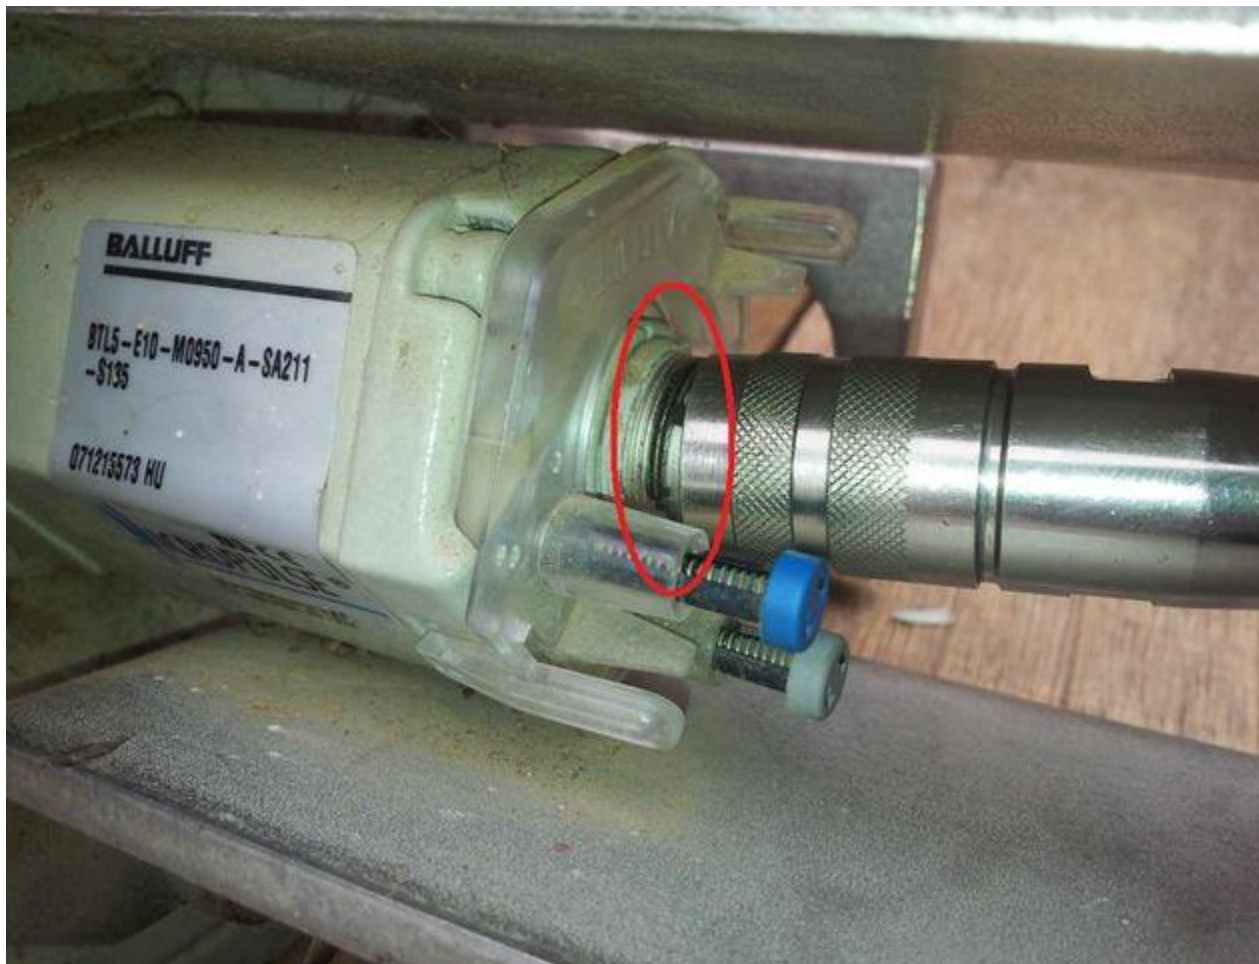
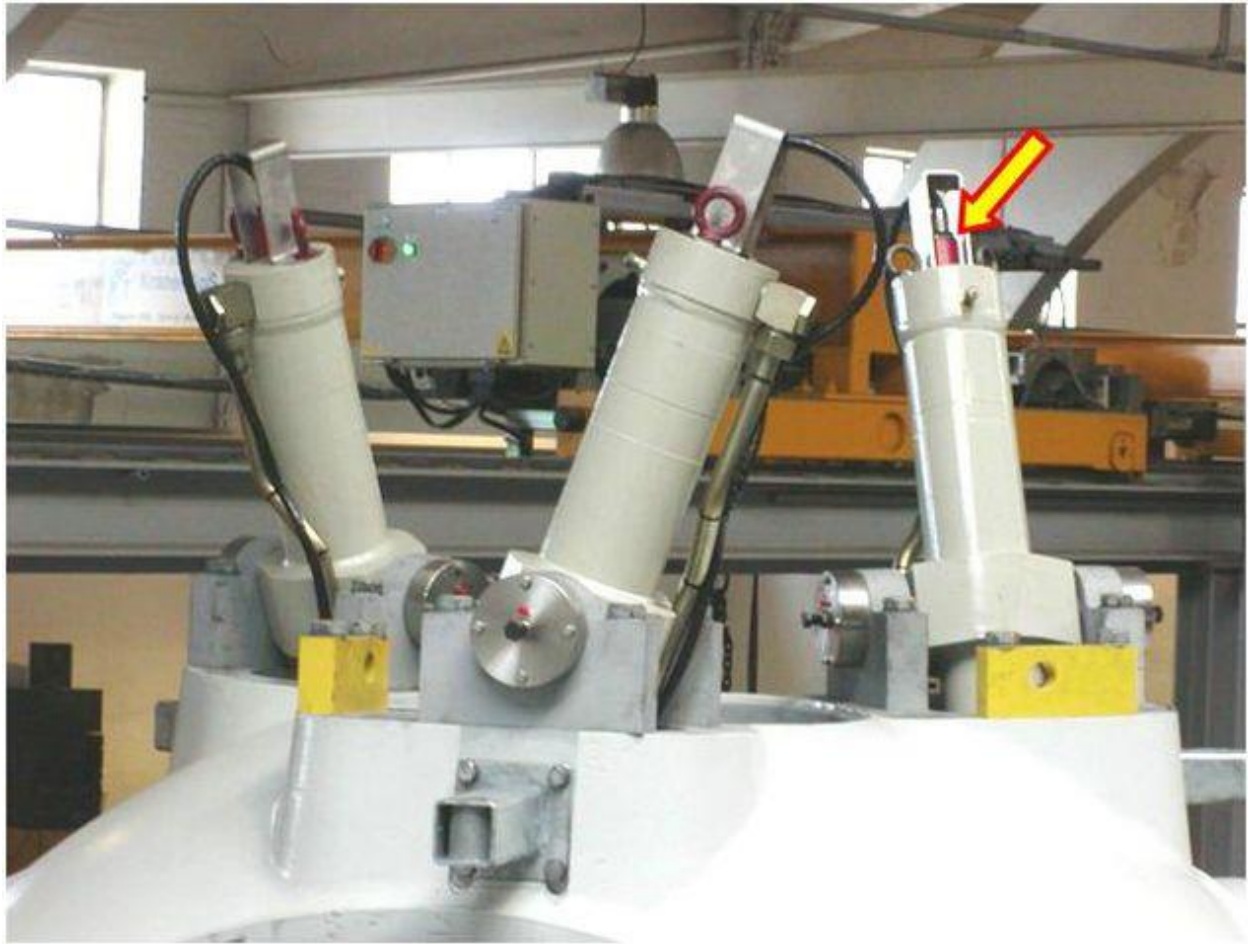
Check for any loose connections in the hub computer terminal X19.

Check for any loose connections for Blade1 position sensor.

Replace the defective pitch position sensor and defective cables

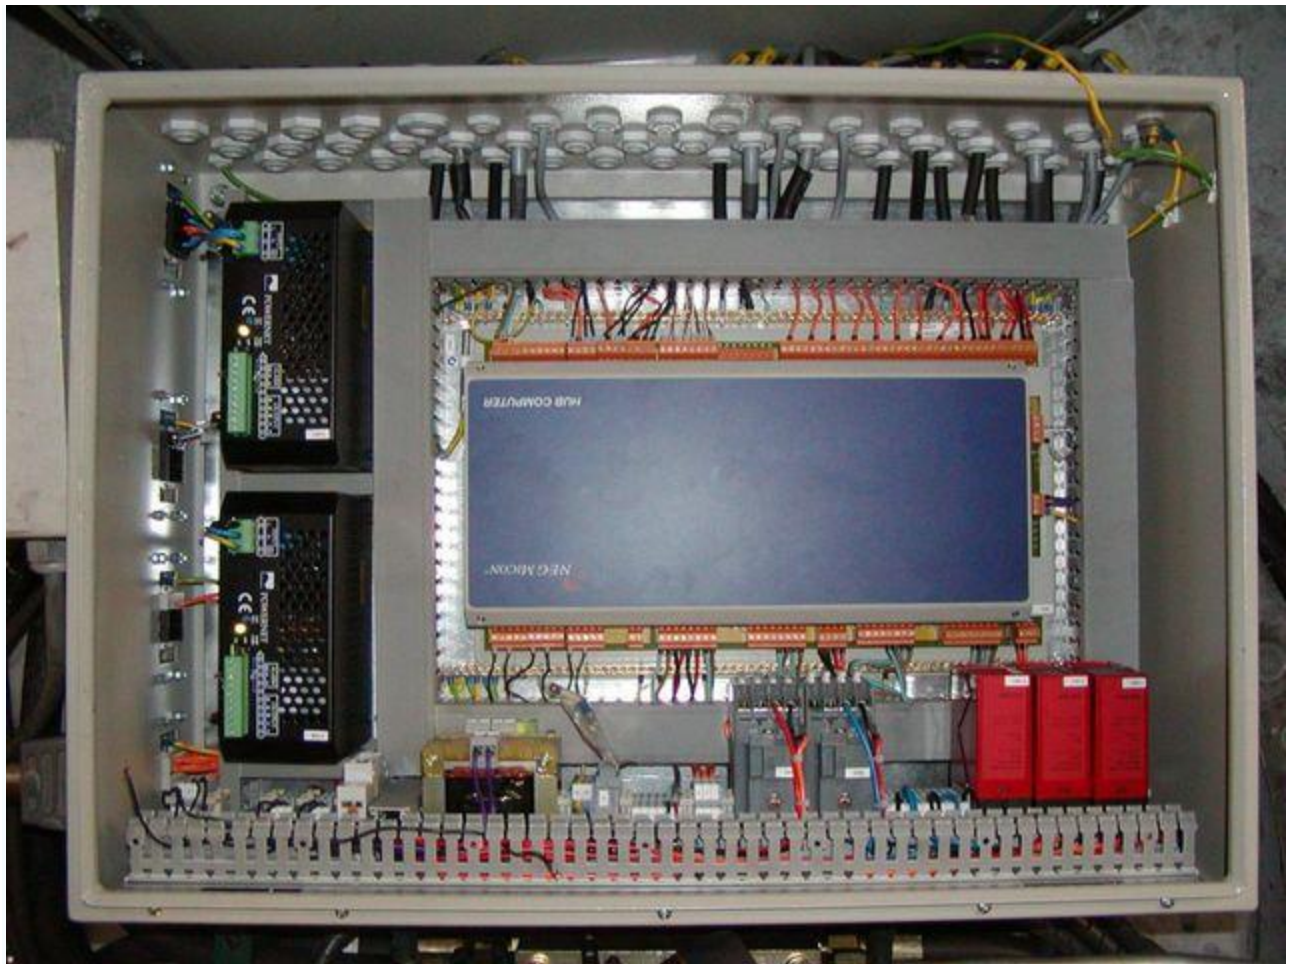
Swap the signal wire to the position transducer (Balluff) on the hub computer. If the fault follows to the new blade then the fault is either in the position transducer or one of the cables.

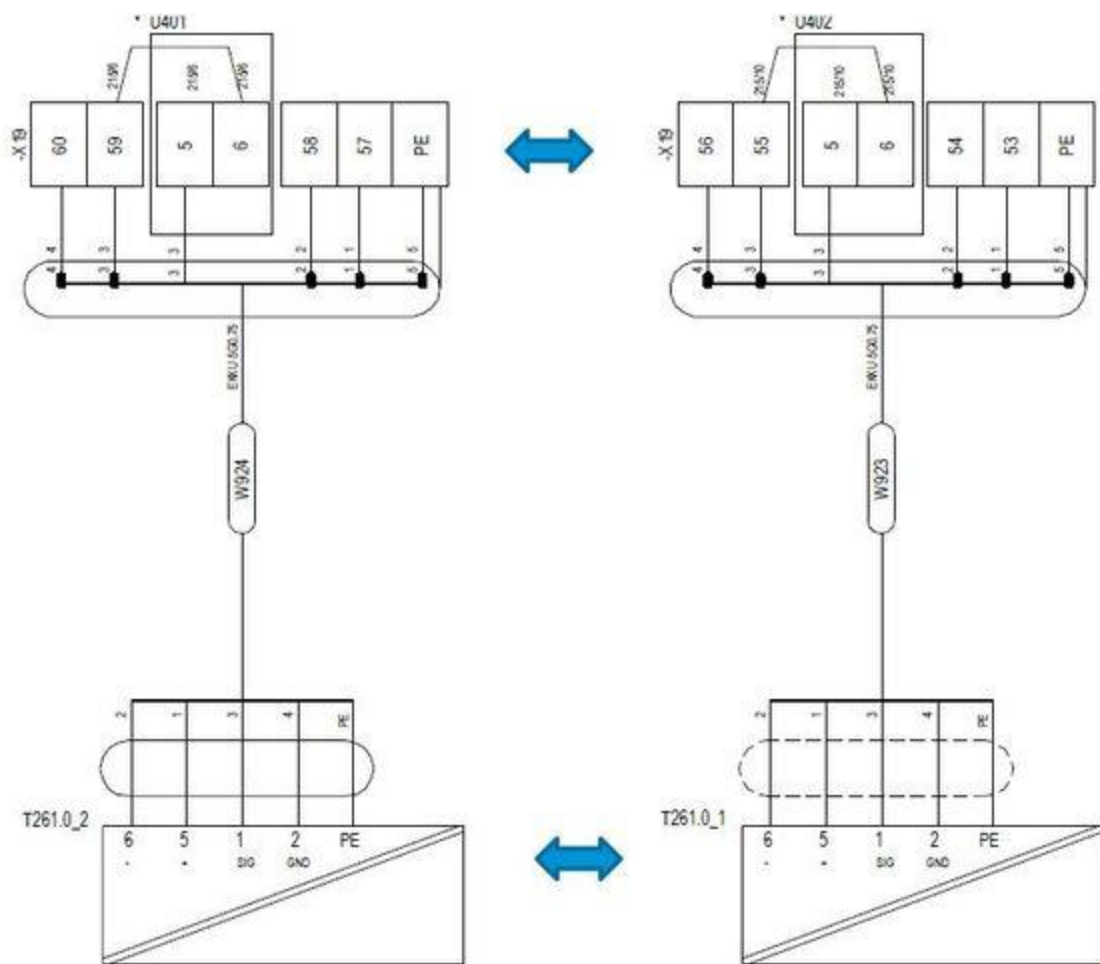
In the example below, we are swapping the plugs between blades B and A.

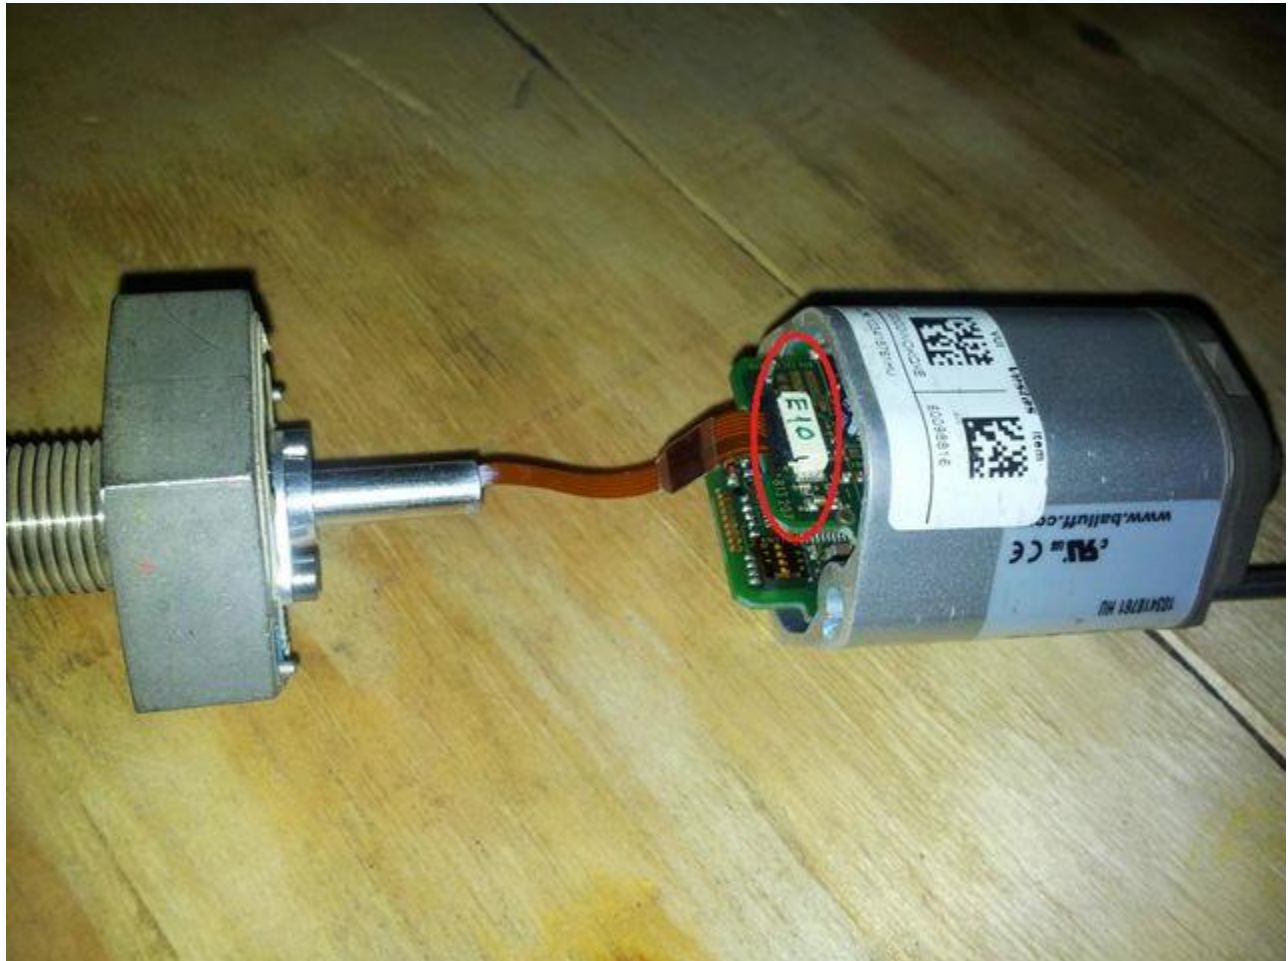
Check the cable for any or short due to the cable rubbing near hub casting or roughly tied and laid on the hydraulic hose may lead to this error.

Replace the cable if it is found to be defective.

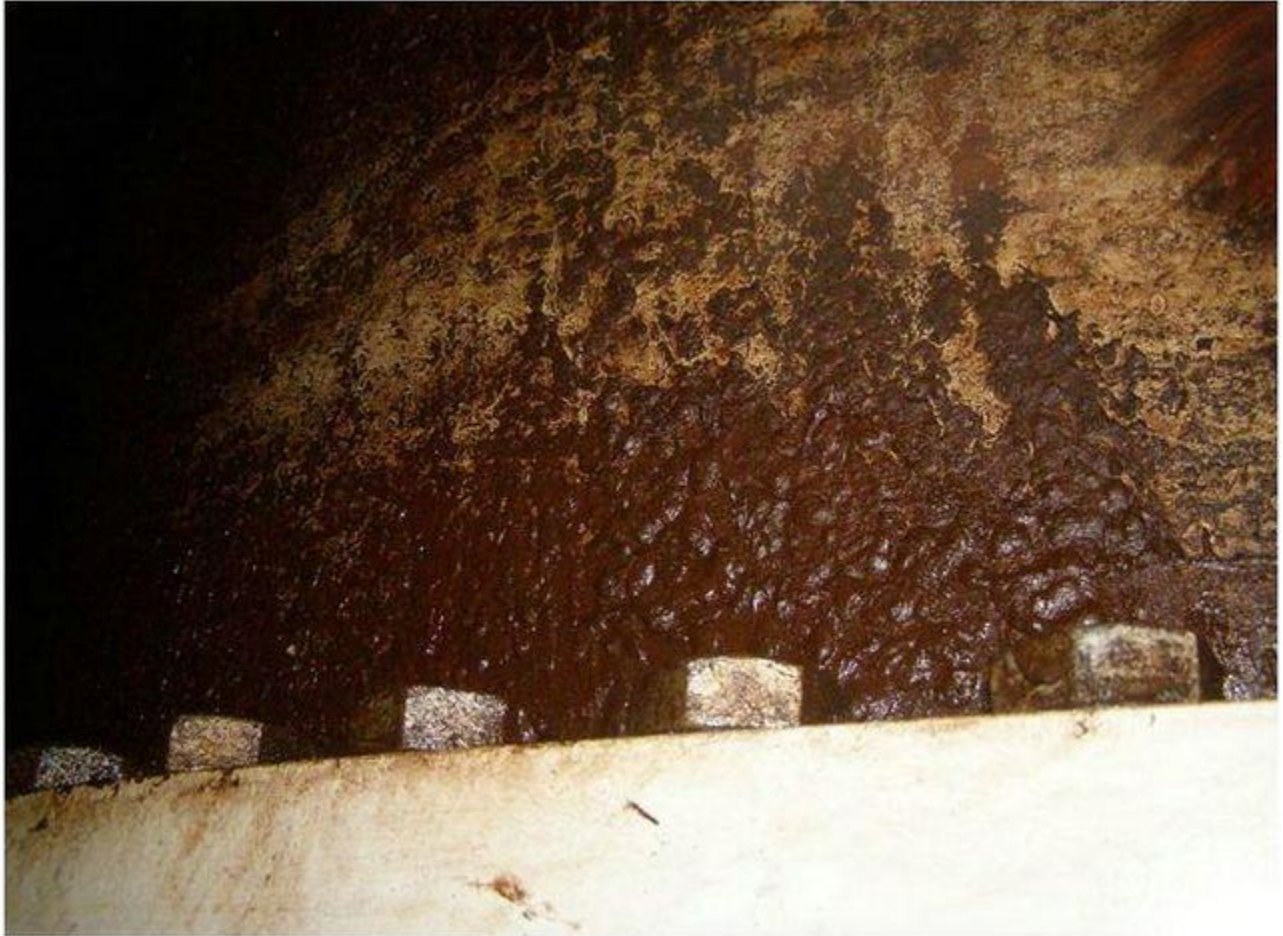
Check for blade bearing grease leak:

Check the all blade bearing for any grease leak.

Check the hydraulic system for any leaks. Repair any leaks in the hydraulic system accordingly.

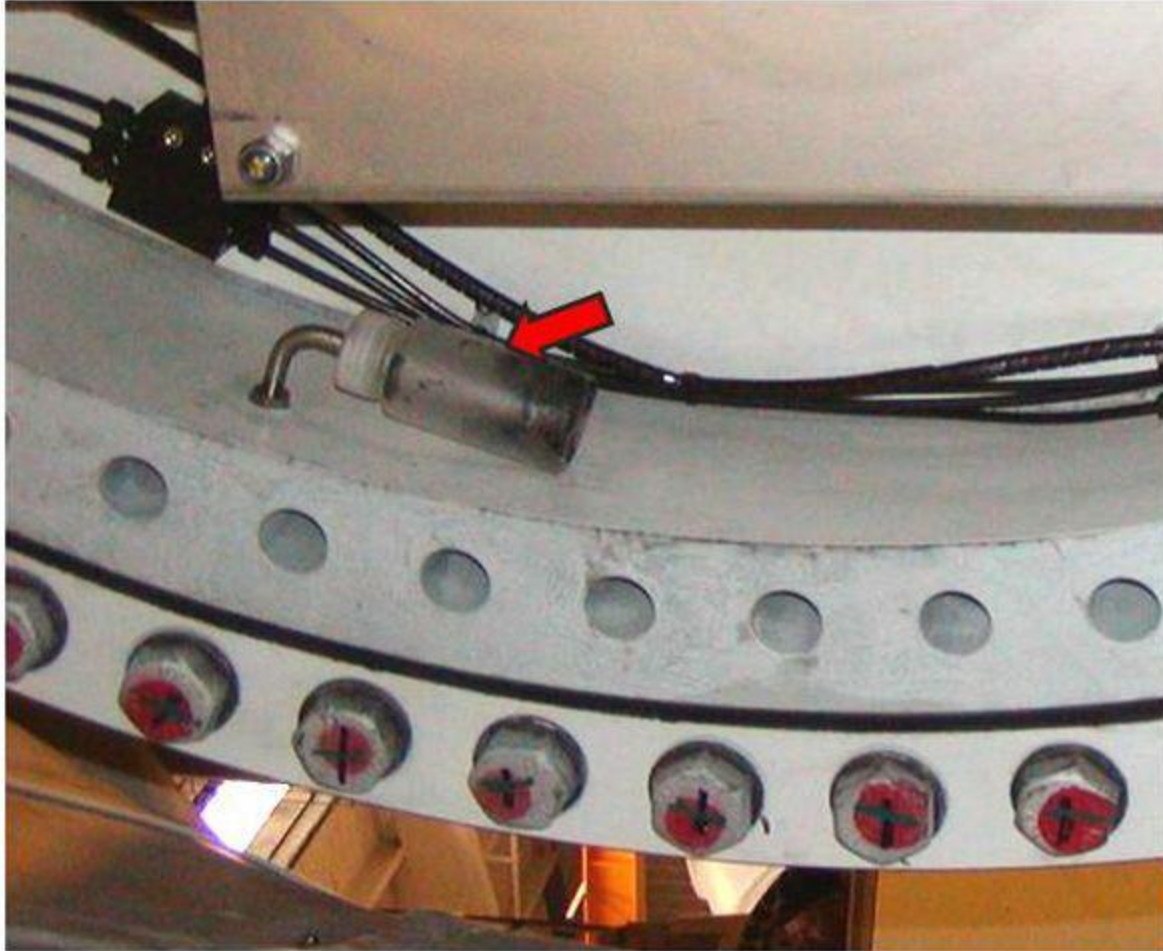
Check the grease collector bottles in all blade roots.

Apply the grease manually depending on the severity of the grease leak.

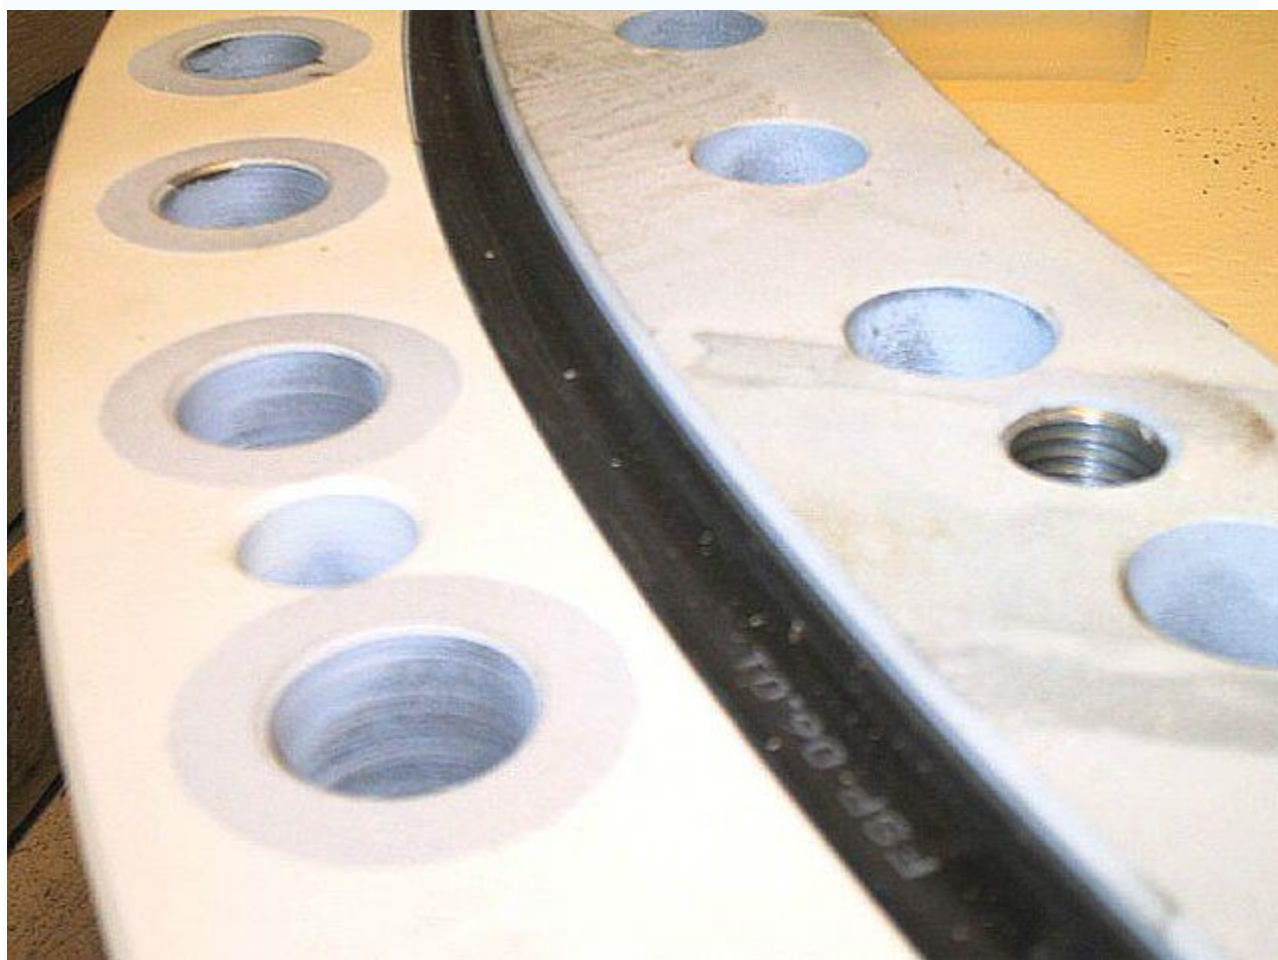
Check the blade bearing seal.

If any damage is observed or a heavy grease leak exists replace the seal (if possible).

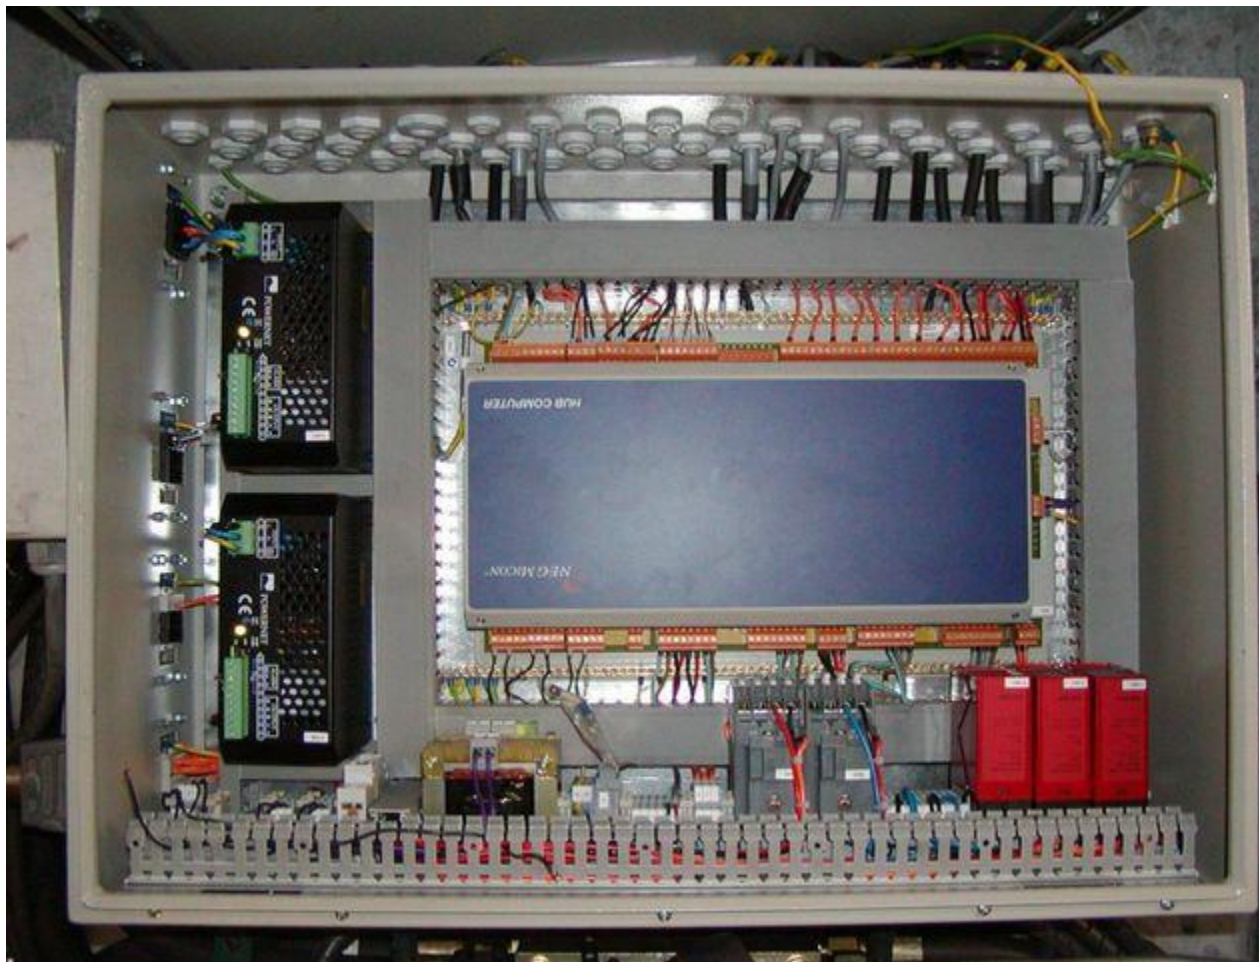
First swap the signal wire to the proportional valve on the hub computer.

If the fault follows to the new blade then the fault is either in the proportional valve or one of the cables.

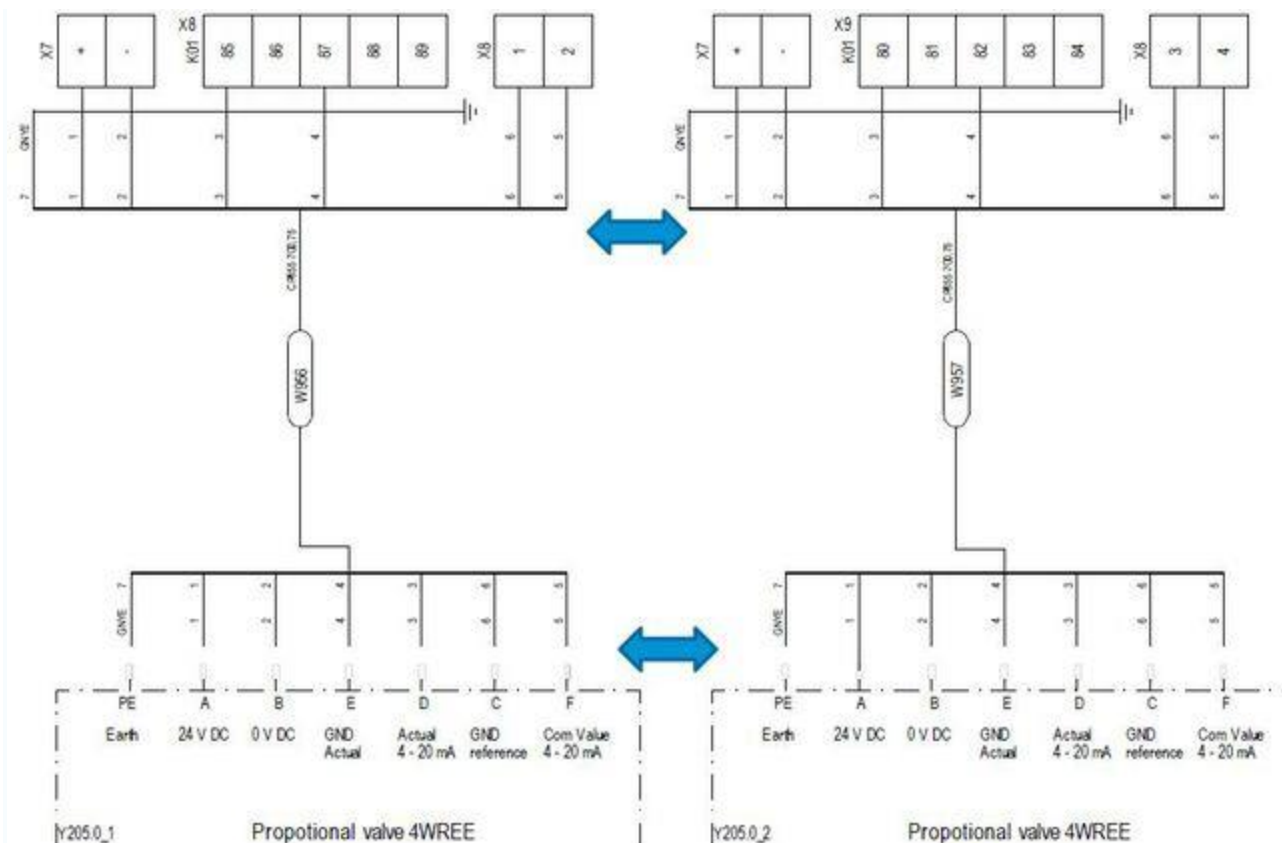
In the example below, we are swapping the plugs between blades A and B.

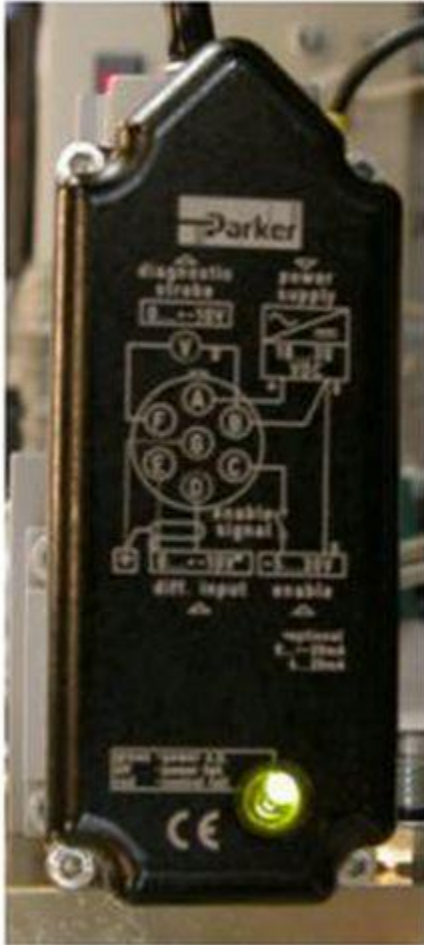
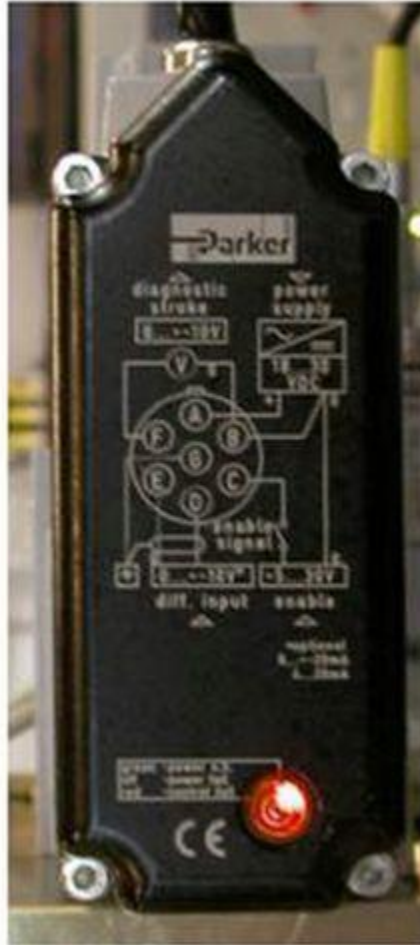
The LED should be green with the pitch system pressurized.

If it is red and there is pressure verified on test port MP, then the valve may also be defective.

Replace proportional valve using **SWI** below
