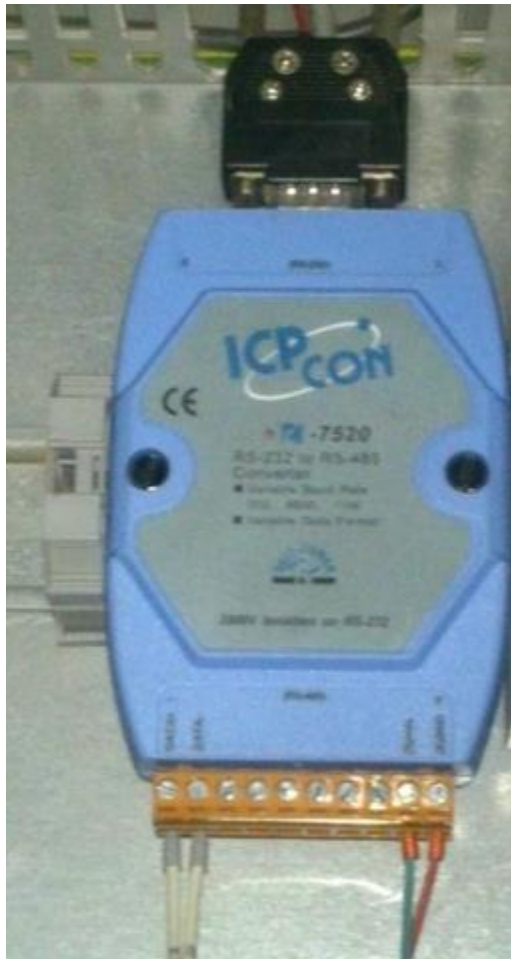
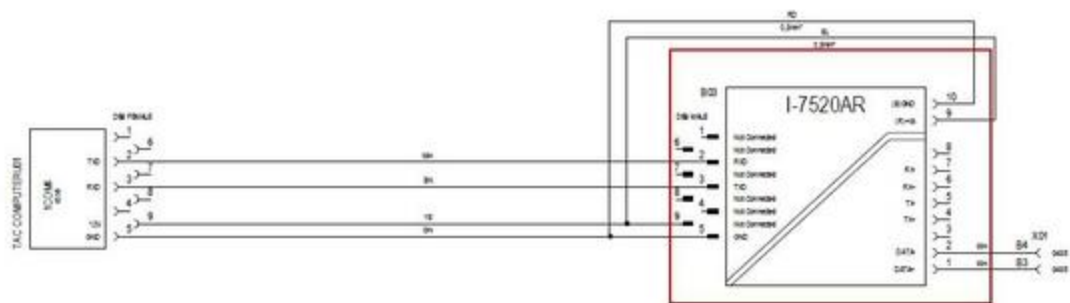
Replace defective RS232/RS485 CONV I-7520 ICP

Check the connections at the ICP RS232/RS485 converter in the AT2 panel. Check for loose wires and plugs or corrosion at the converter.

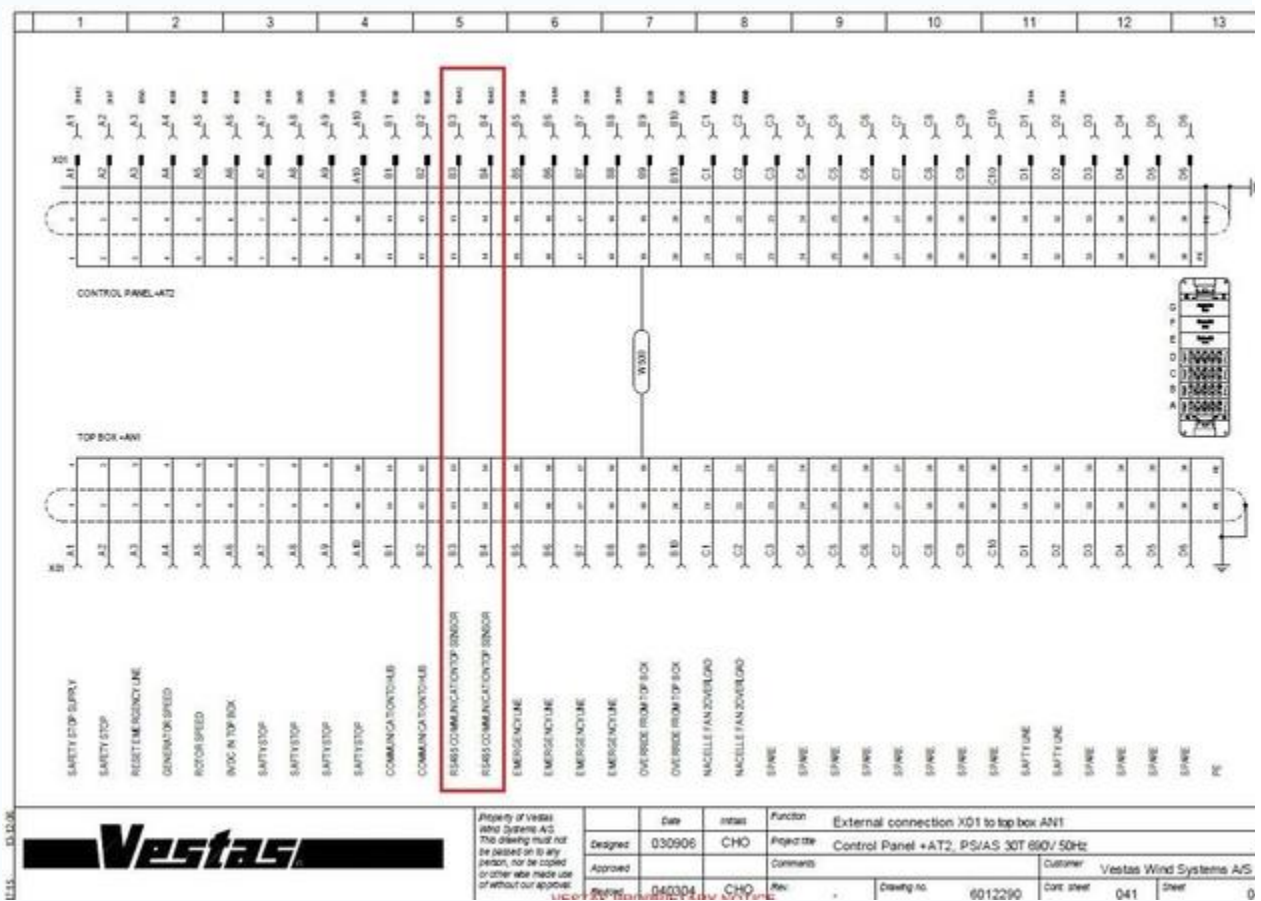
Check & repair cable connections

- **Explanation**
Check the continuity of B3 & B4 cores in cable W500 and replace with spare core, if no continuity.
