**Check the tower damper and top-up to required level**

**Replace the defective TAC84 module**

### Replace the defective accelerometer

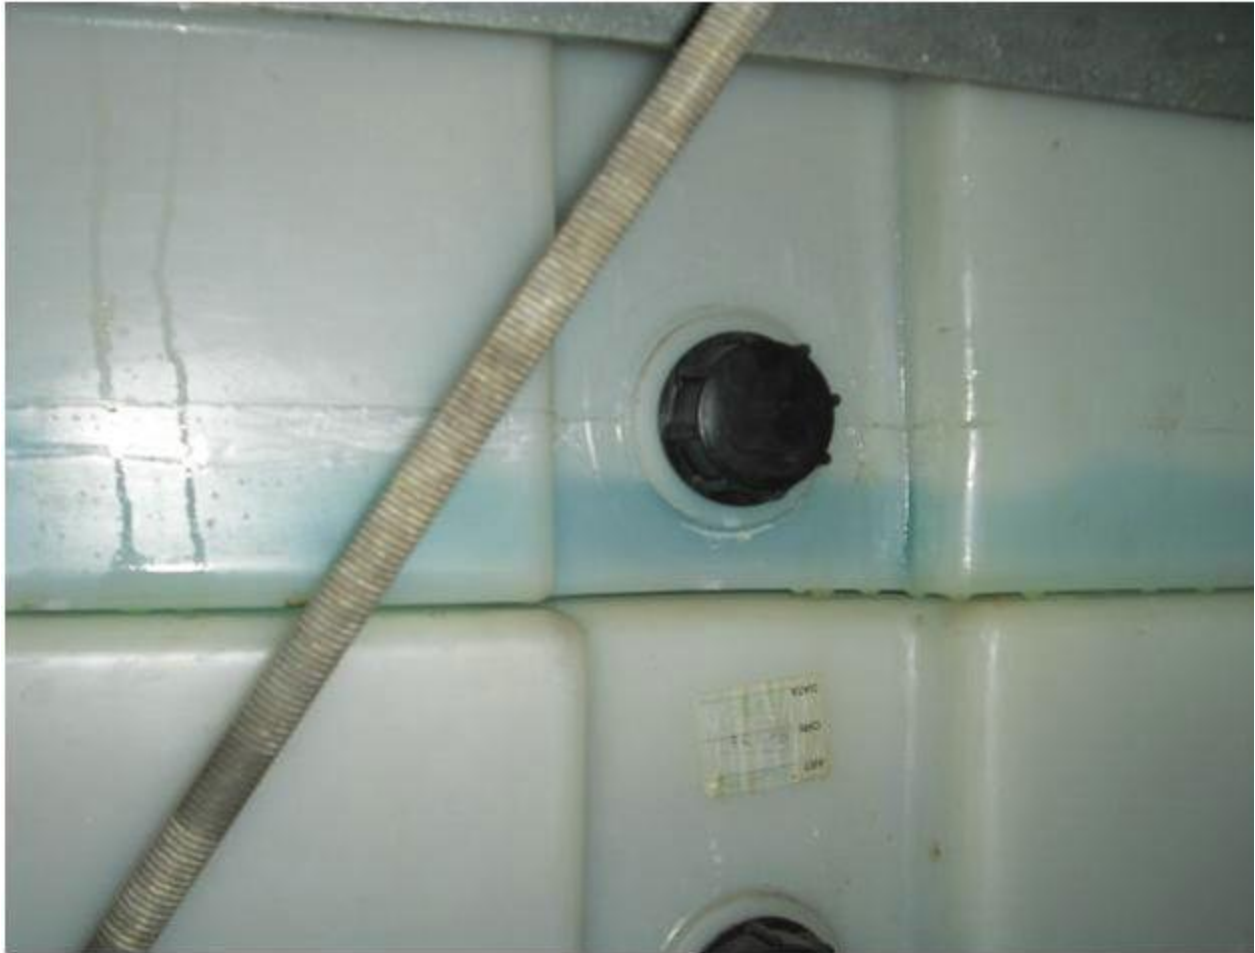
Check the containers for any sign of leakage in the tank and the closing cap.

If any caps are found to be leaking or damaged - replace both the cap and seal.

Ensure the seal is properly seated.

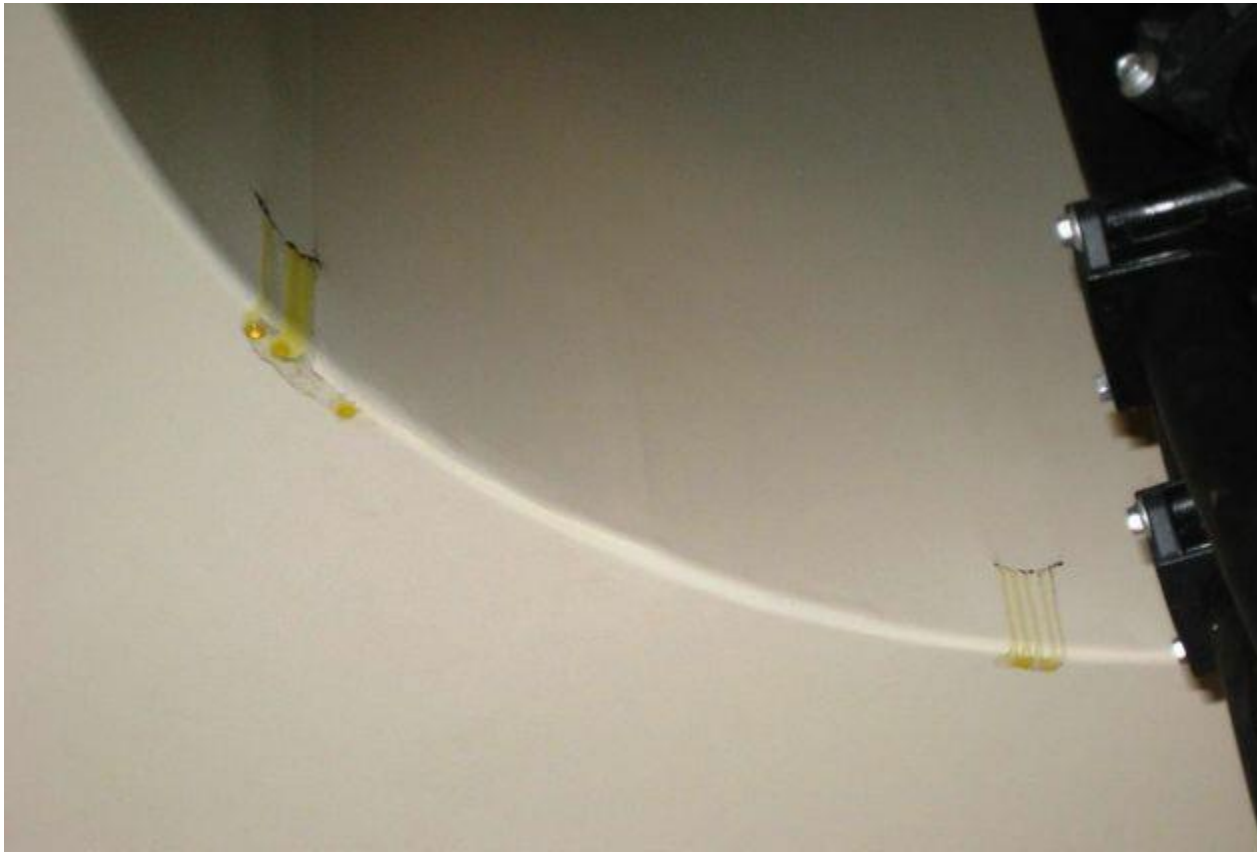
Damage to damper tanks:

Inspect the damper wall internal to the tower for cracks or leaks. If the pendulum is making contact with the tank wall, install larger fenders- **“80-mm Fender**

**Part # 78600140”** and contact the local engineering department for instructions to patch the tank. Top off the oil in the tank per the I&S Data.

Reference CIM [1838](#) (RCA Phase) for instructions on fender instillation (also reference the Commissioning Manual) and recommendations for tank repair solution.

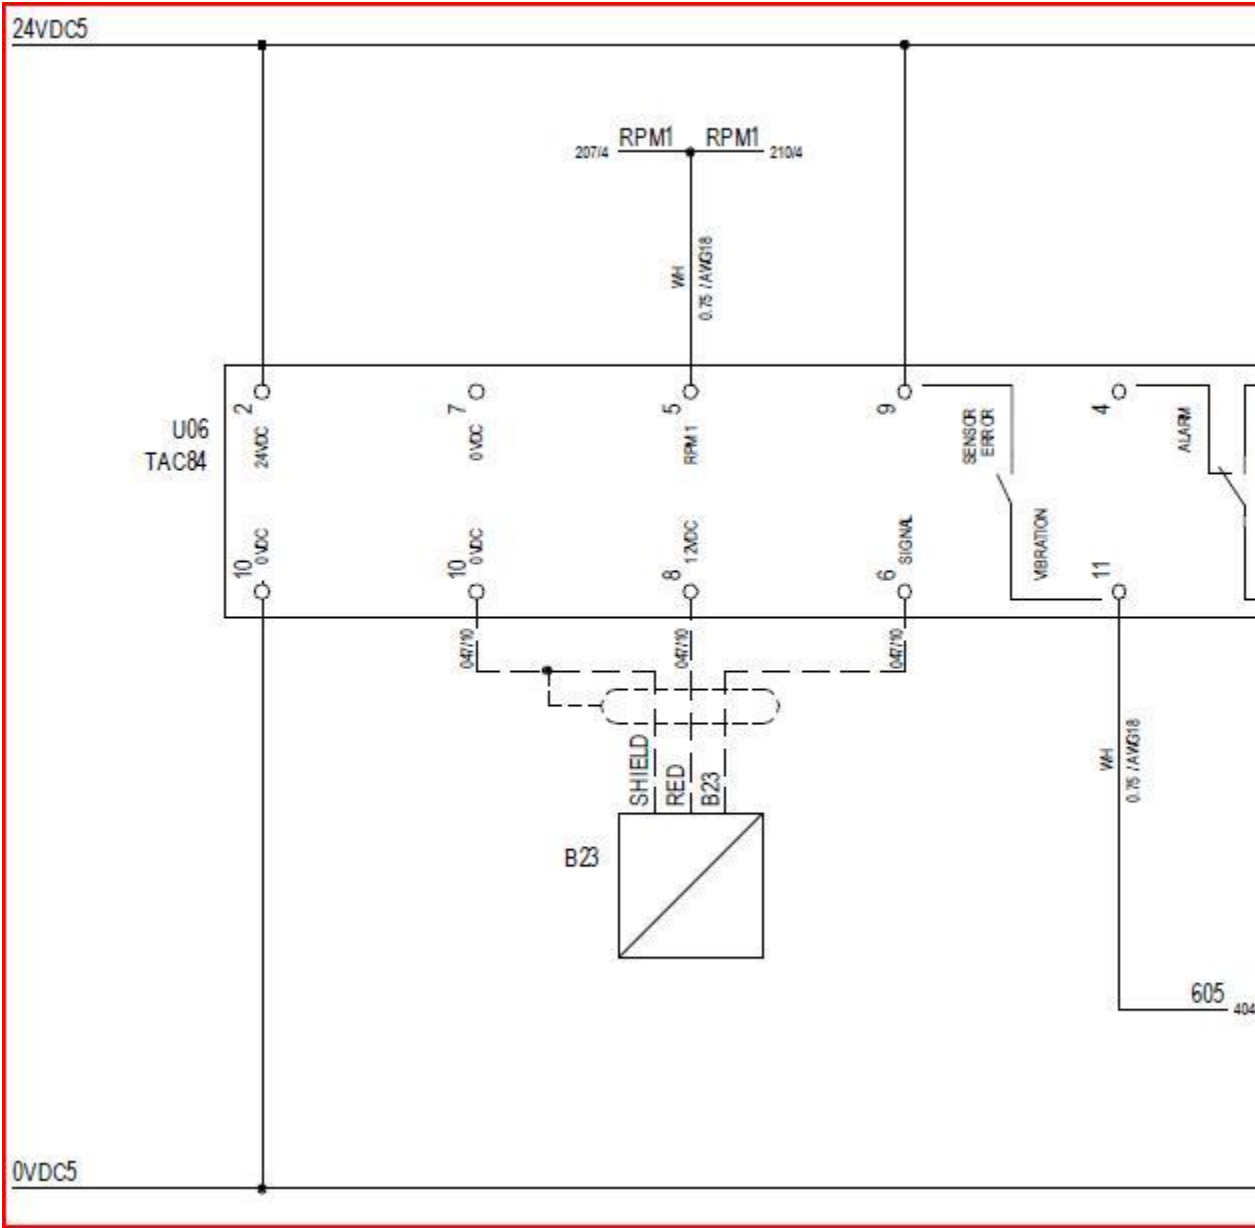
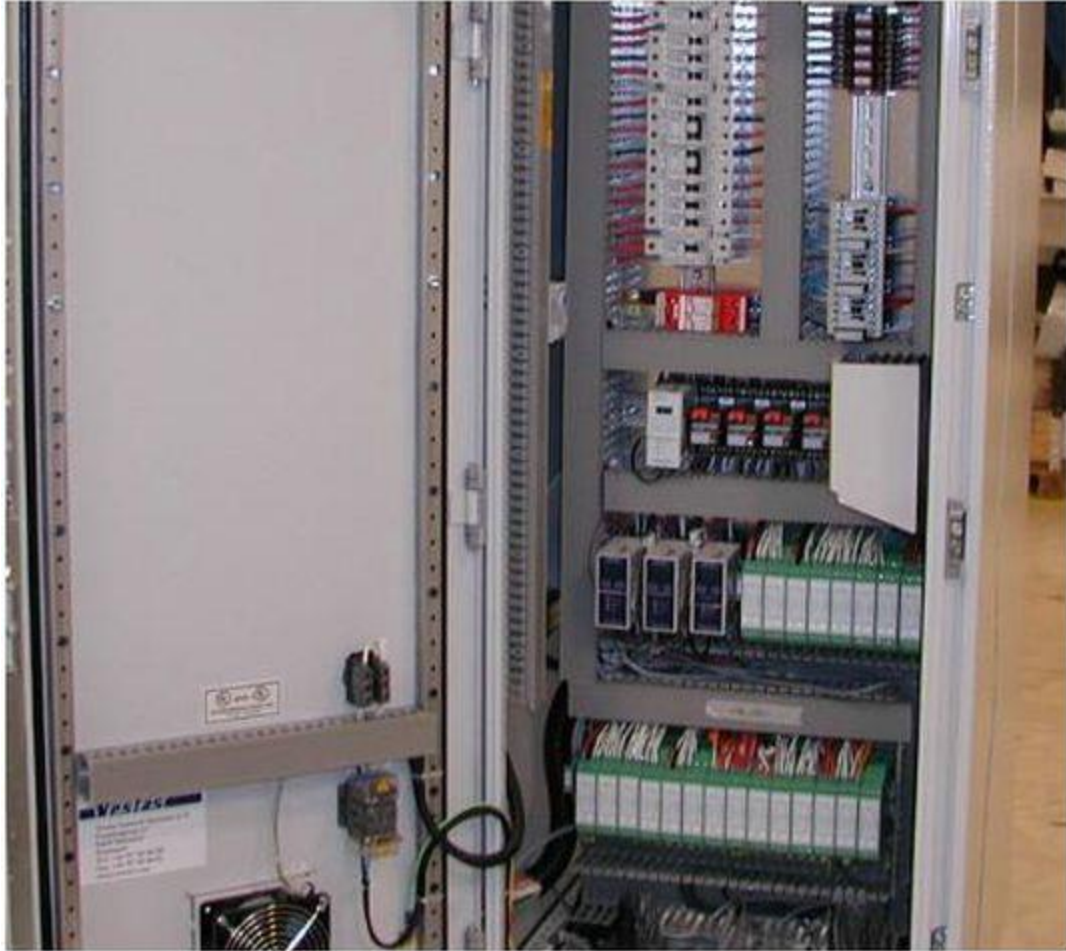
Check the TAC84 – Down wind module and related wiring for any loose connections.

Test the TAC84 module as per Commissioning Instruction.

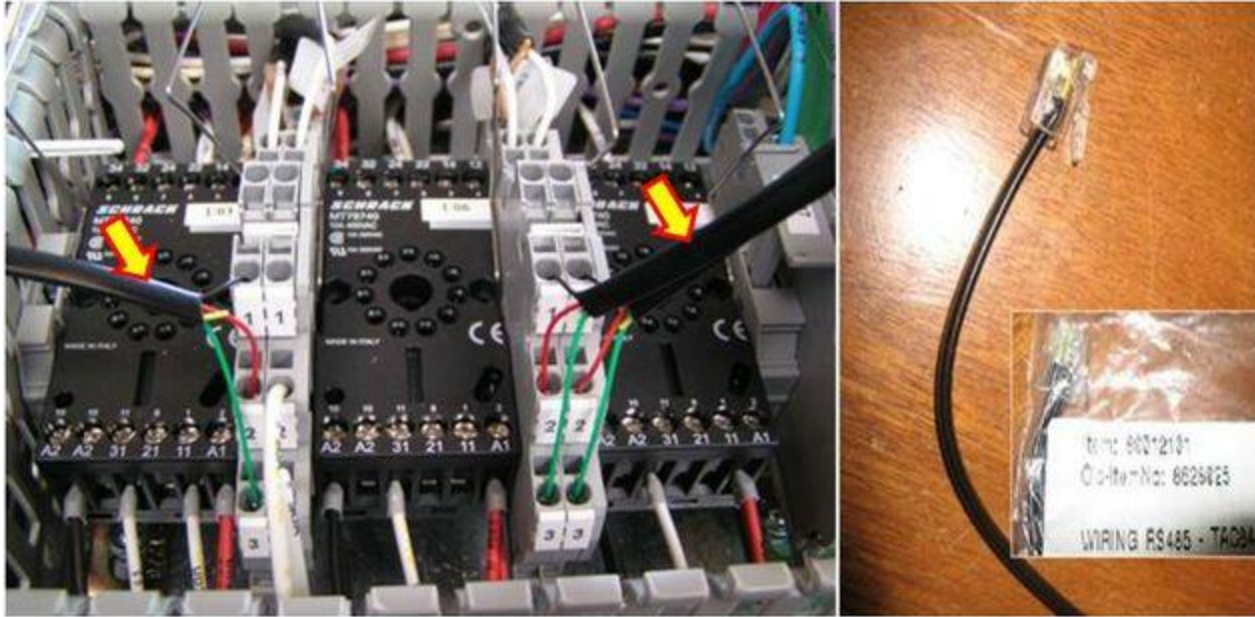
Check the RS485 cable for loose cable or damage.

If necessary replace the cable.

60012101 - WIRING RS485 - TAC84/85

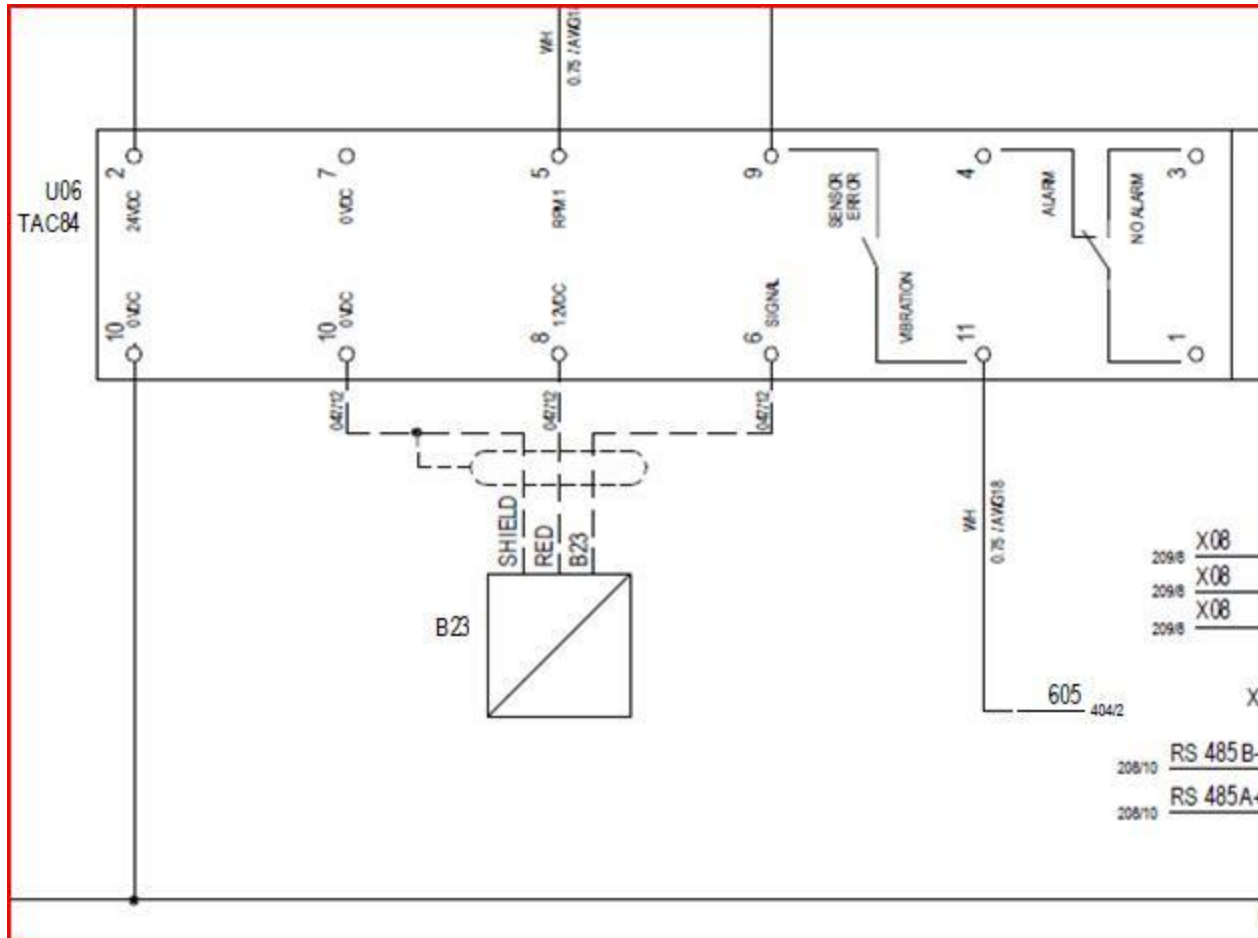
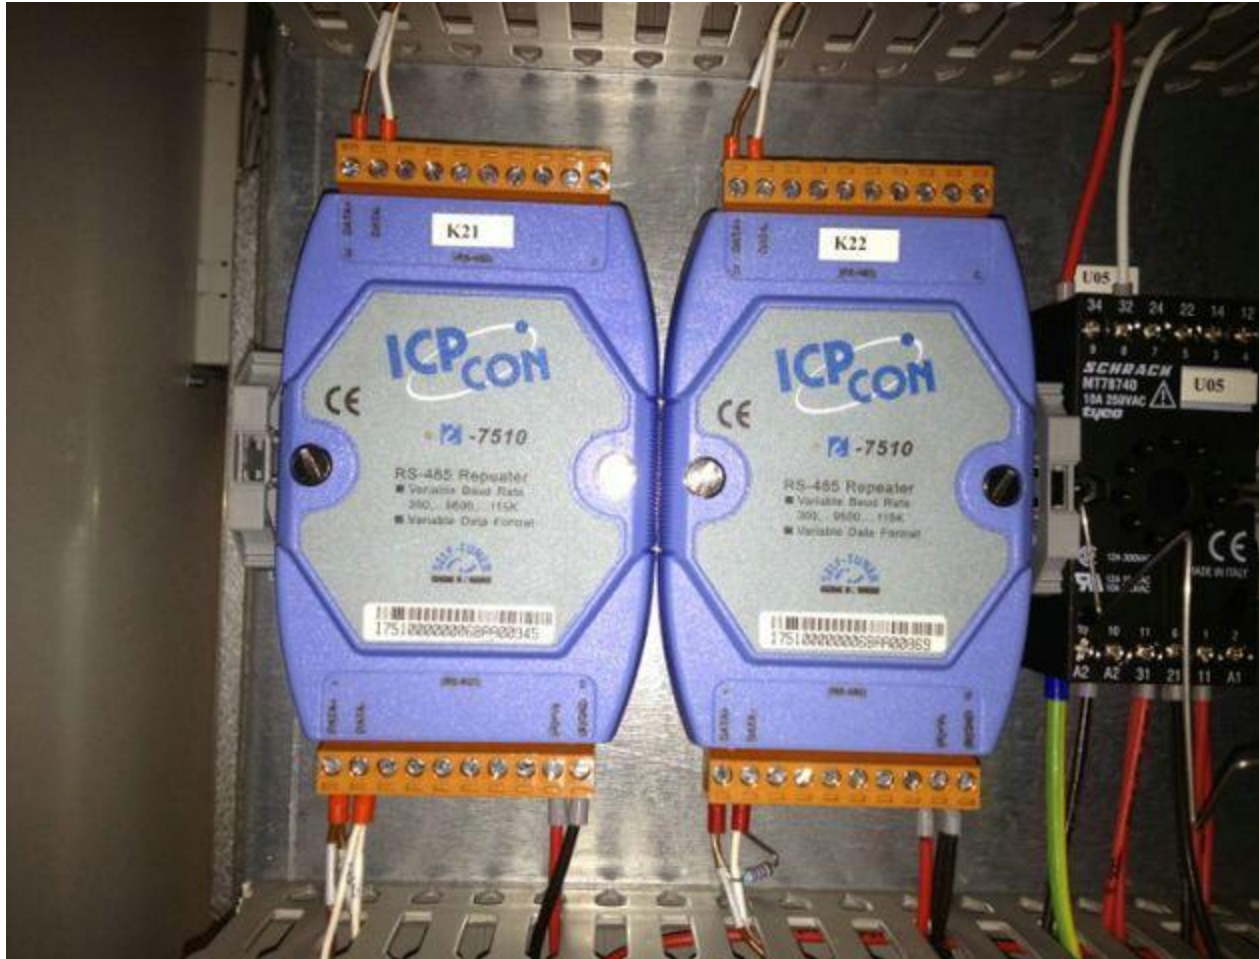
Check the connections at the ICP RS485 repeaters (K21 & K22) in the AN1. Check for loose wires and plugs or corrosion at the repeater.

If there is no communication on one sensor, switch the ICP RS485 repeaters to see if the communication returns. If communication returns when the repeaters are switched, replace the faulty repeater.

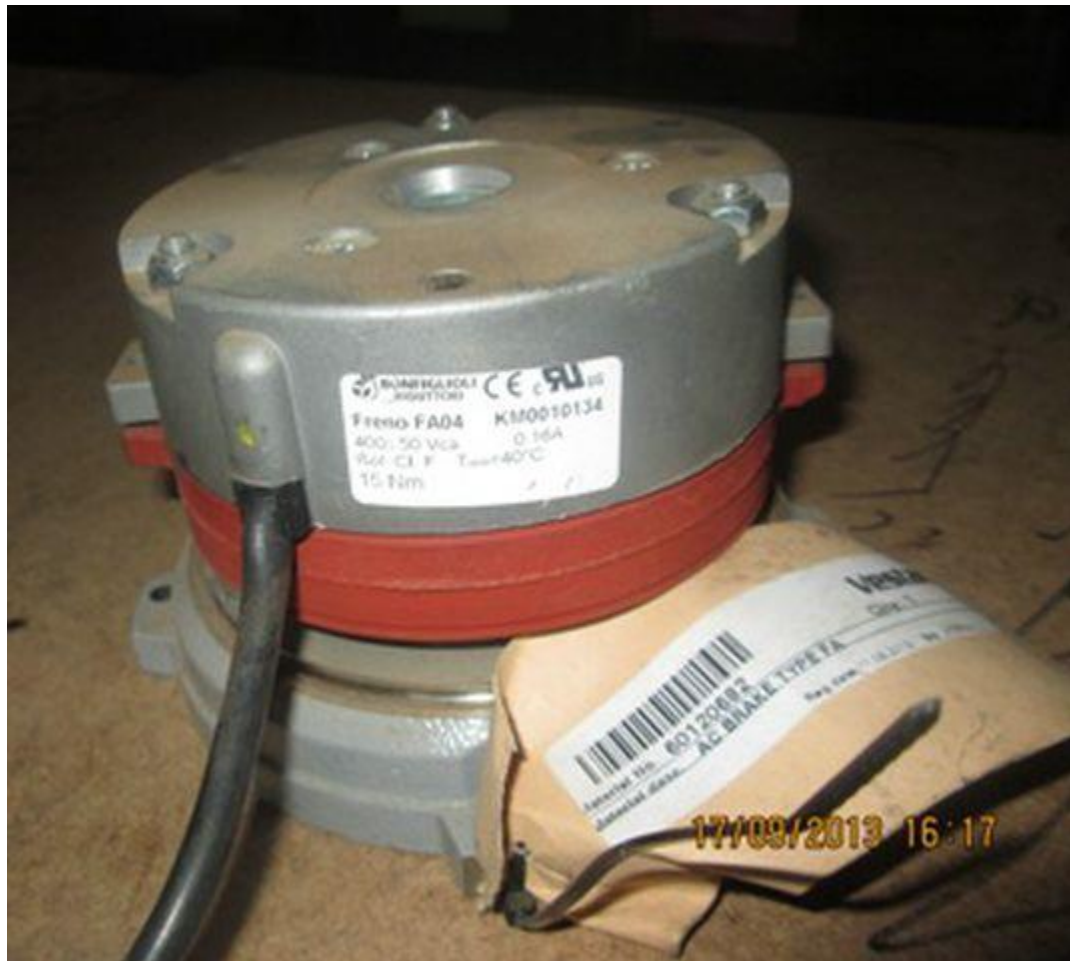
Yaw magnetic brake failure is one of cause of lateral vibrations.

Check all of the yaw motors for any bearing failure or brake failure.

If the Magnetic coil is found to be defective replace the magnetic coil.

60120682 - AC BRAKE TYPE FA
