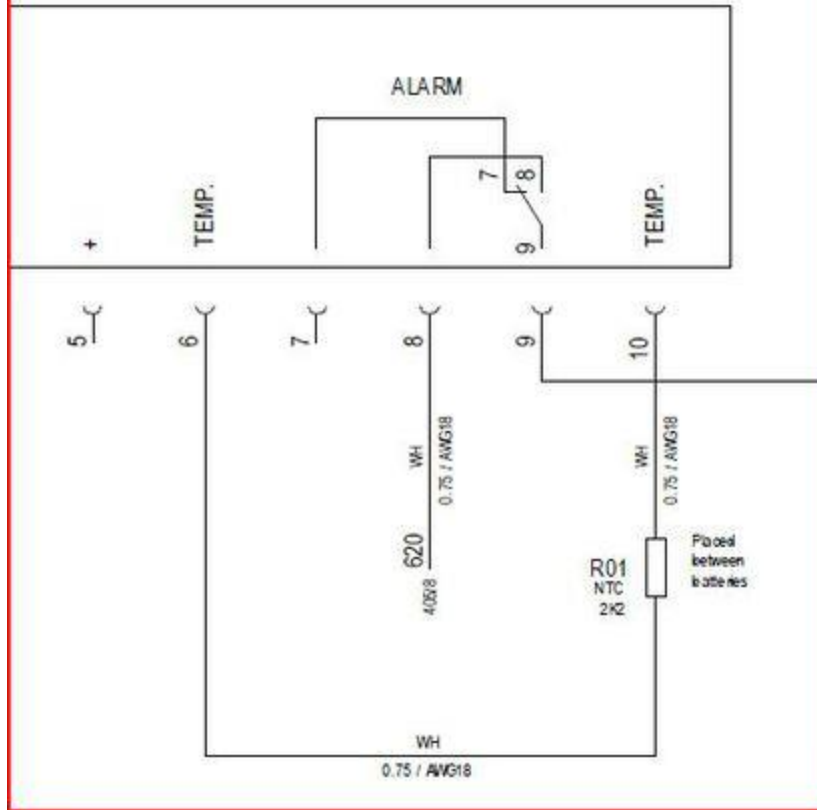
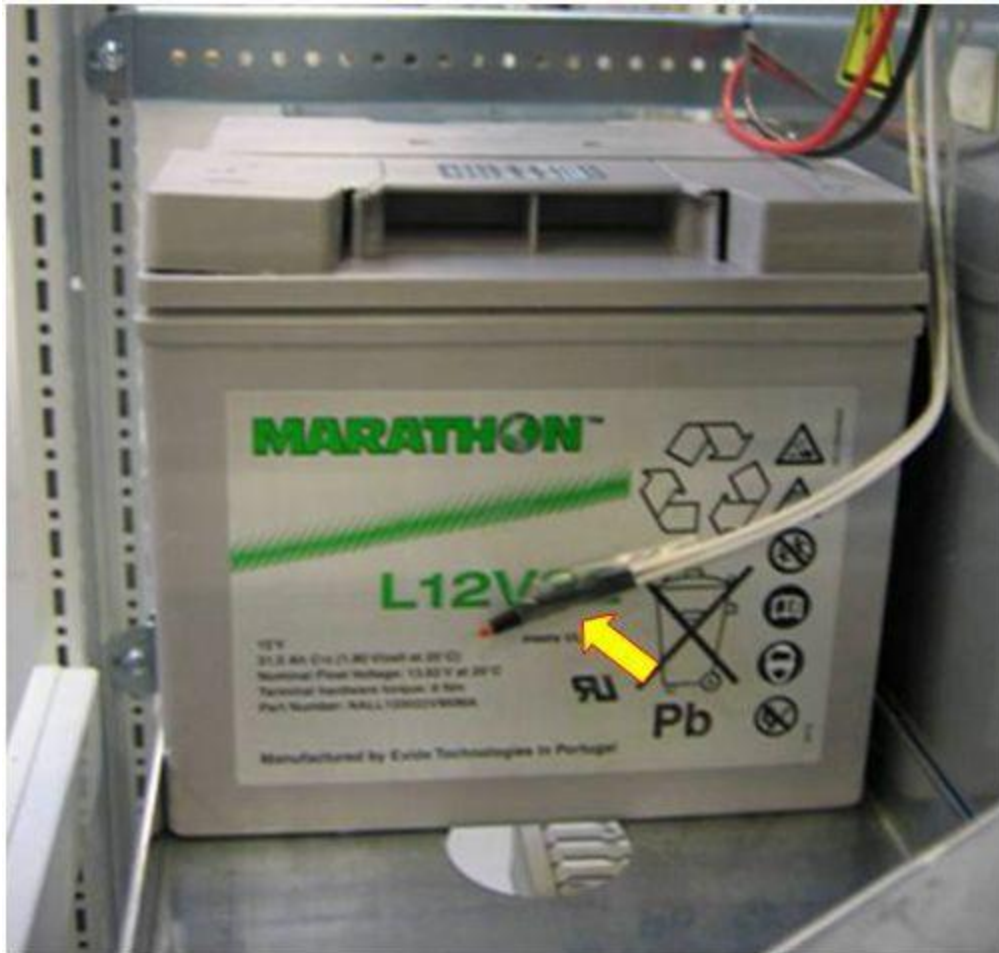
Check the temperature sensor (thermistor) (POS : R01) which is place in-between batteries. Replace the sensor if defective.

Replace the defect temperature sensor

60000720 - TEMP SEN BAT CHARGER ADC5483

JUMPER FOR TEMP. COMP.
SETTING = ON

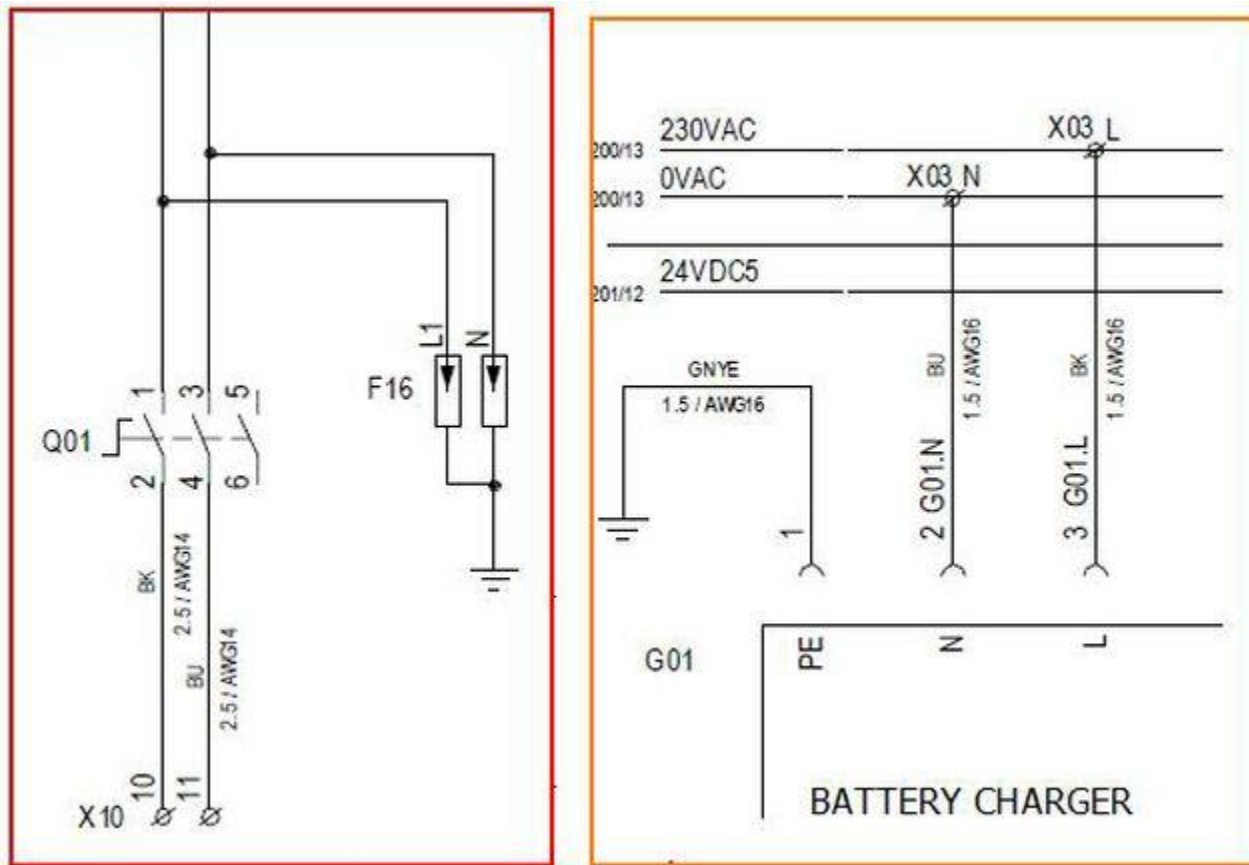
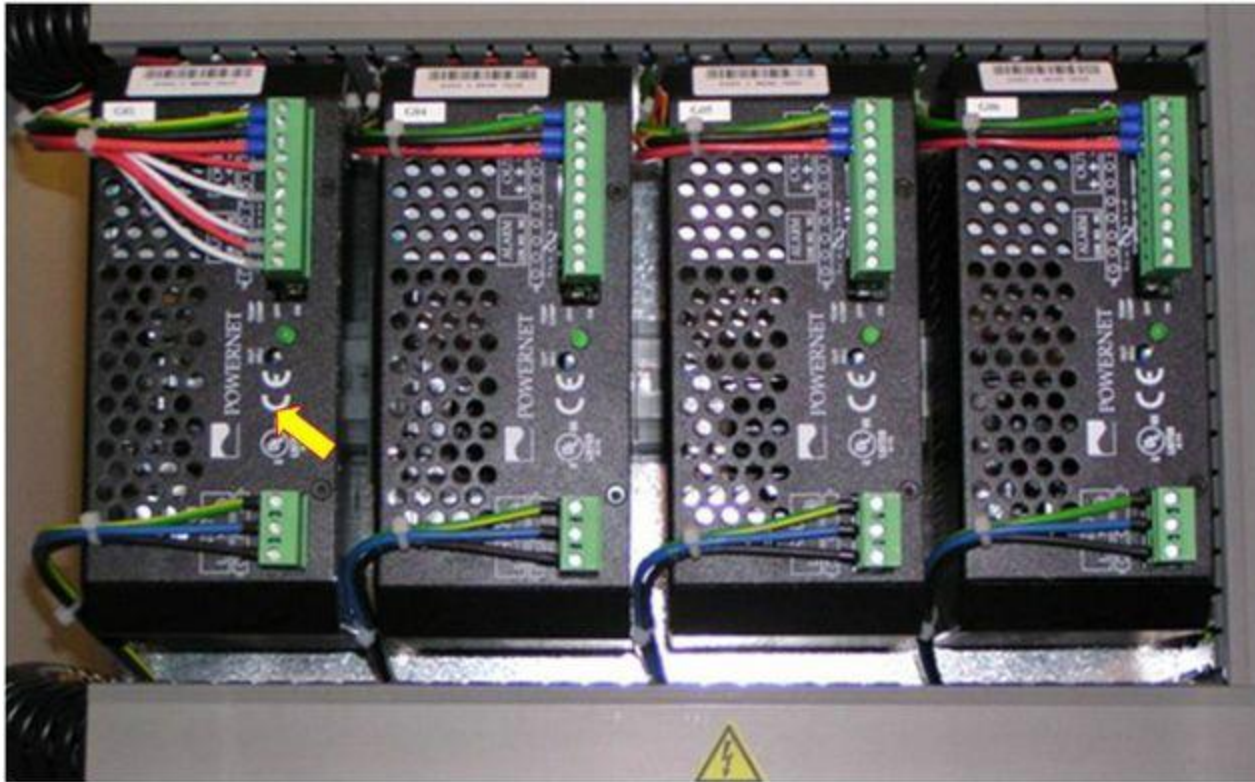
Check the power net for any loose or damaged electrical connections.

Check the INPUT /OUTPUT voltage; if the 230/115V supply is present, but the DC output is low or not present, it is likely a defective power net. If the output voltage is low, adjust the rheostat on the power net accordingly to increase the output.

If defect power net replace with new.

188453 - PS ADC 5483R-3 10A-27,4 NM PIN

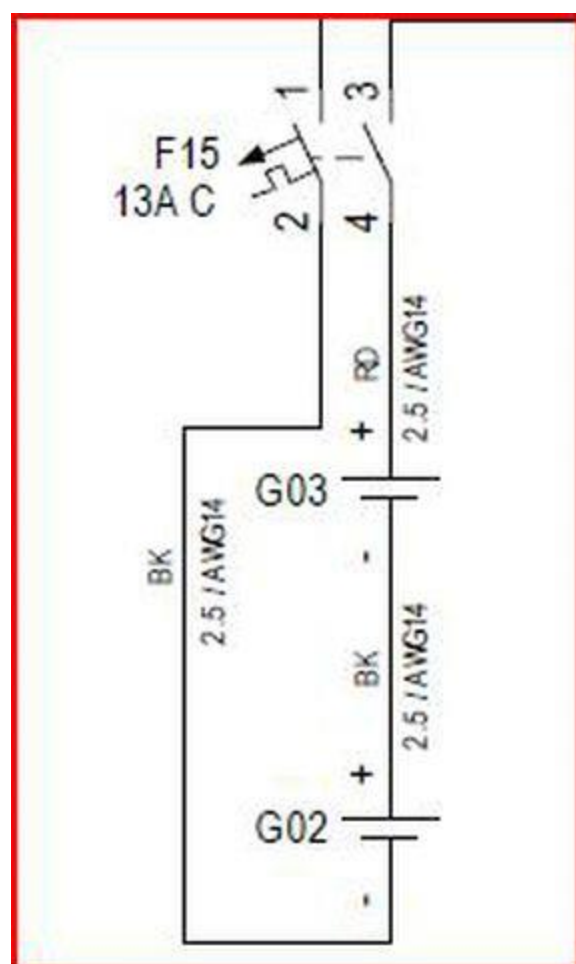
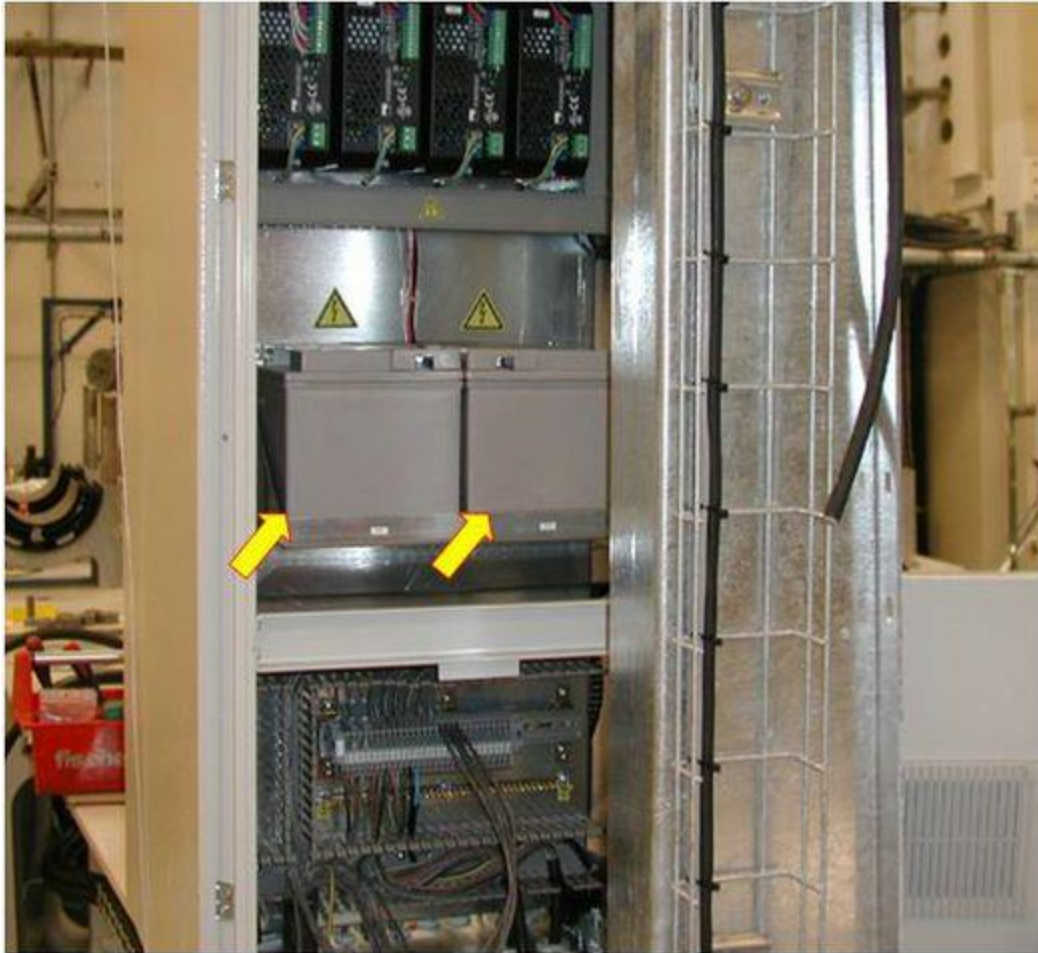
Visually inspect the batteries, look for bulging sides, leaking or corroded terminals. Check the voltage displayed on the charger. If the voltage is low, and the charging circuit has been verified, the batteries are likely failing and should be replaced. If the batteries are operational, yet have corrosion on the terminals, clean the terminals and apply dielectric grease to prevent further corrosion.

If defective, replace the batteries (G02, G03).

Check for any loose terminal connections. Repair as necessary.

60000711 - BAT H4 12V 32Ah

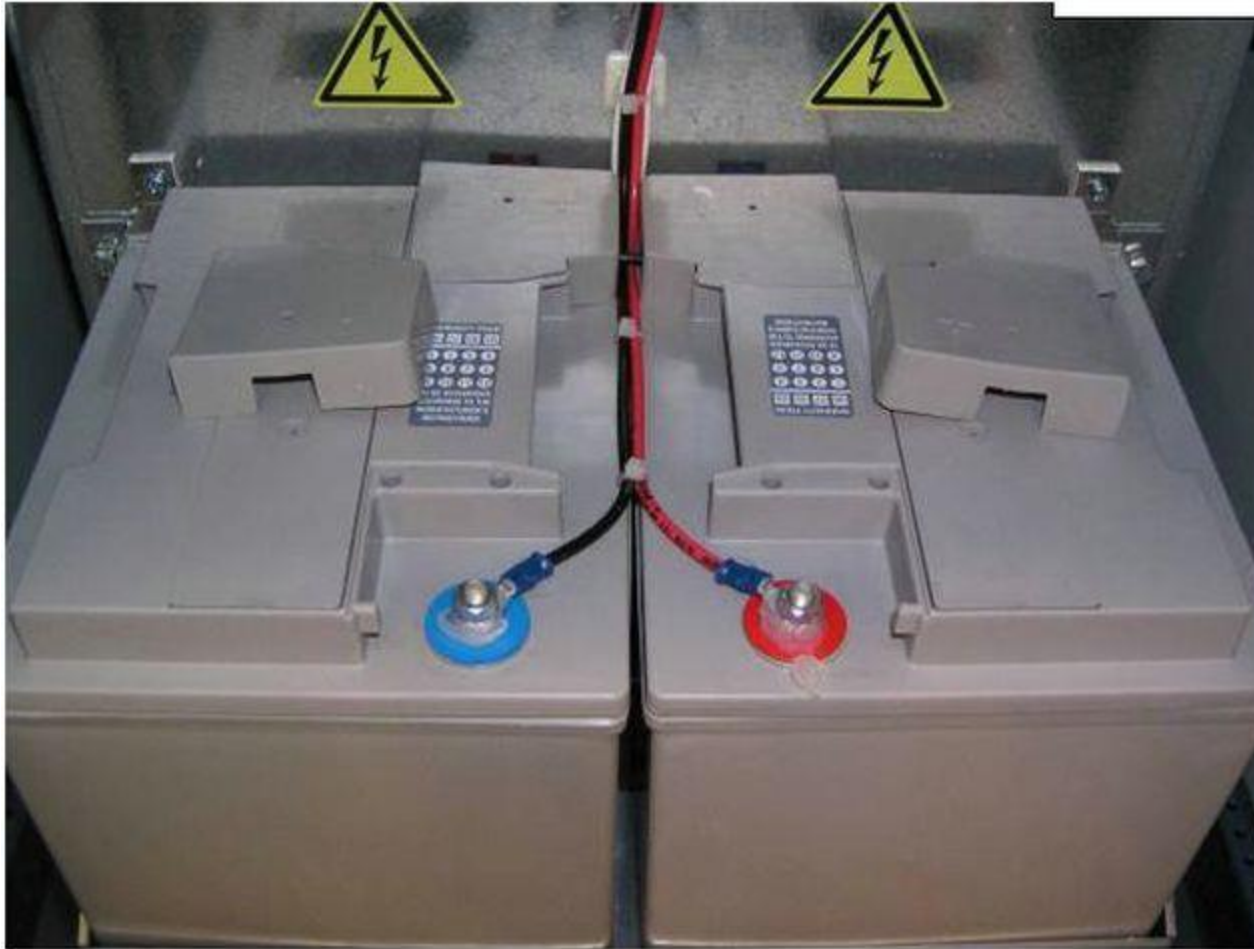
Cleaned terminals with dielectric grease applied:

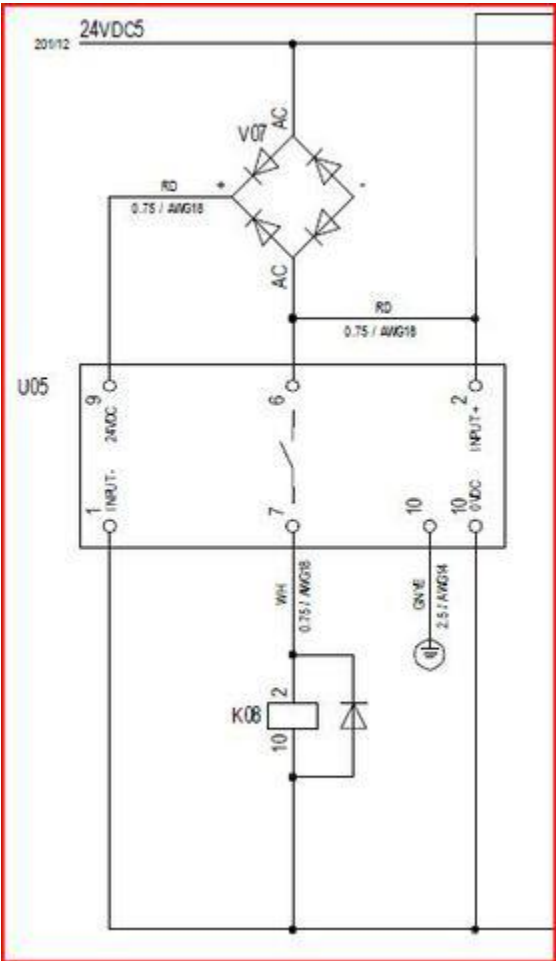
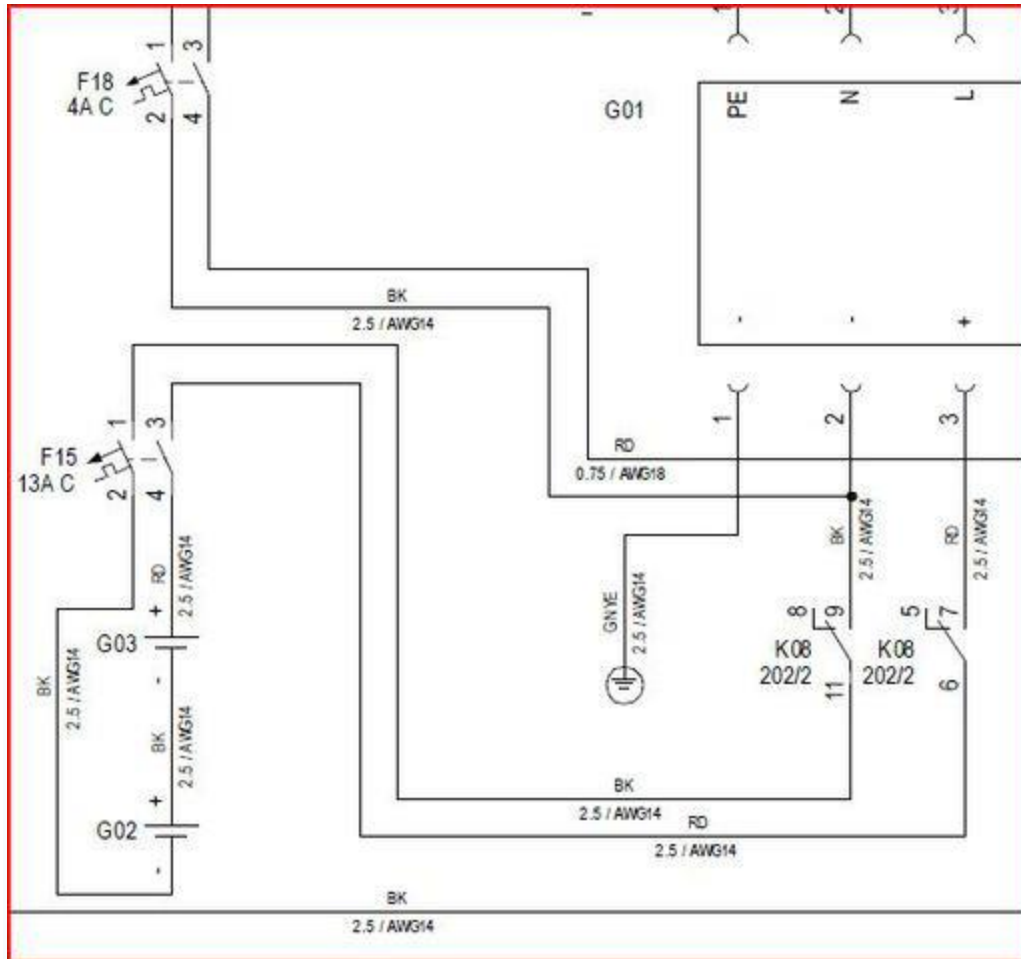
Check the K08 relay operation and INPUT/OUTPUT voltage.

Check the Trip amplifier and Bridge rectifier.

Check for any loose connections in the circuit.

Replace any defective components that are discovered.

Position- U05 → 60004924 - TRIP AMPLIFIER 2231D-1050

Position- V07 → 60000980 - DIODE BRID KBPC3506G 600V 35A

Position- K08 → 60004532 - RELAY MT3230C4 10A 24V 3P

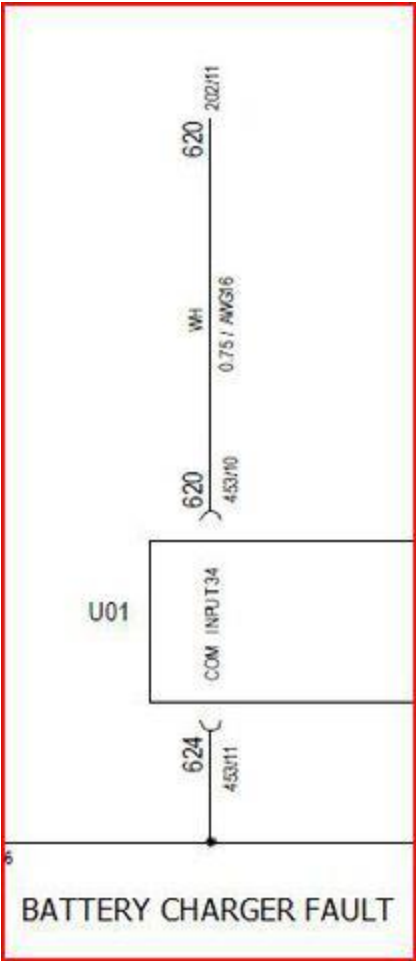
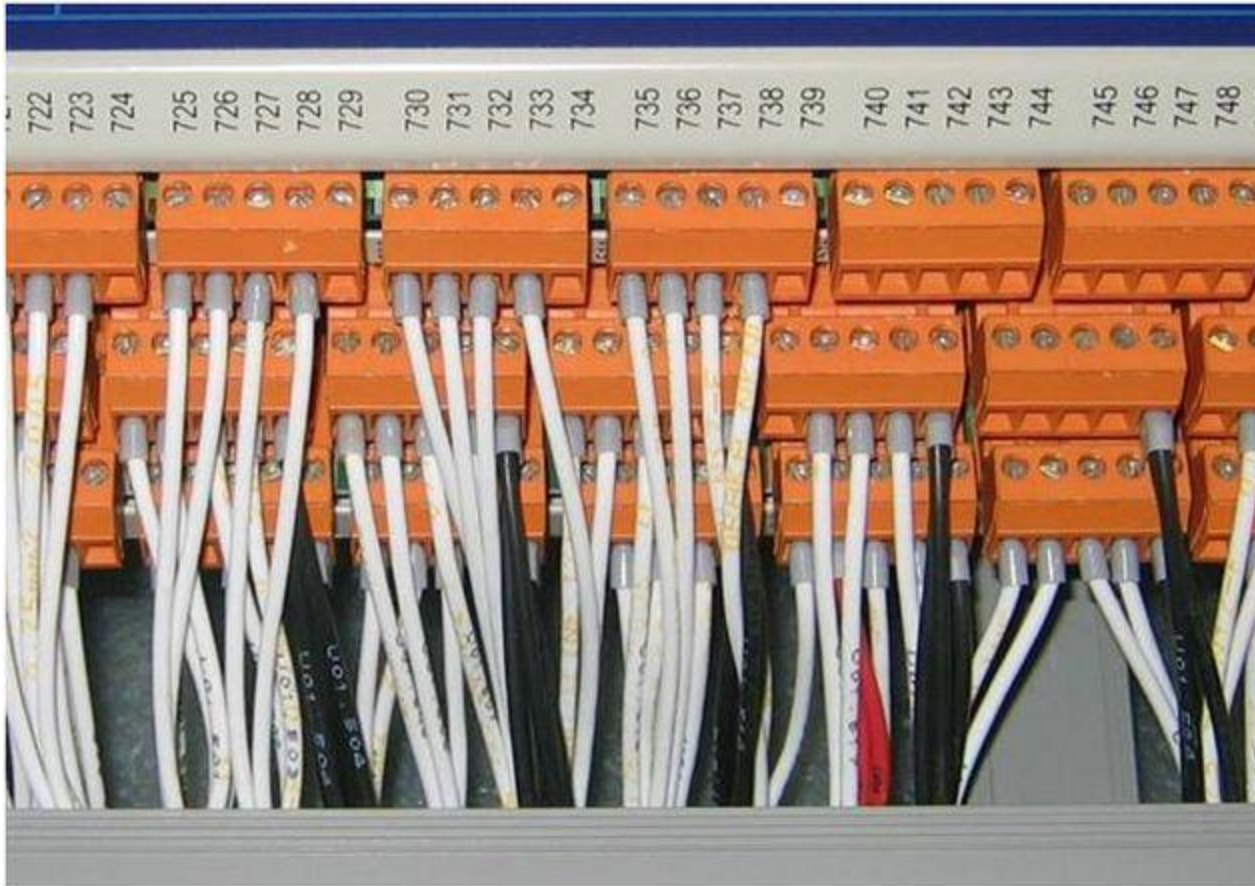
Check for the input signal for Battery Charger Fault.

If the signal is not present the cause is likely a defective TOI.

Check for any loose/damaged connections on the TOI.

Replace the defect TOI

51701601 - TOI-II INTERF EXT POC
