Check wires between TAC40 and the thyristors

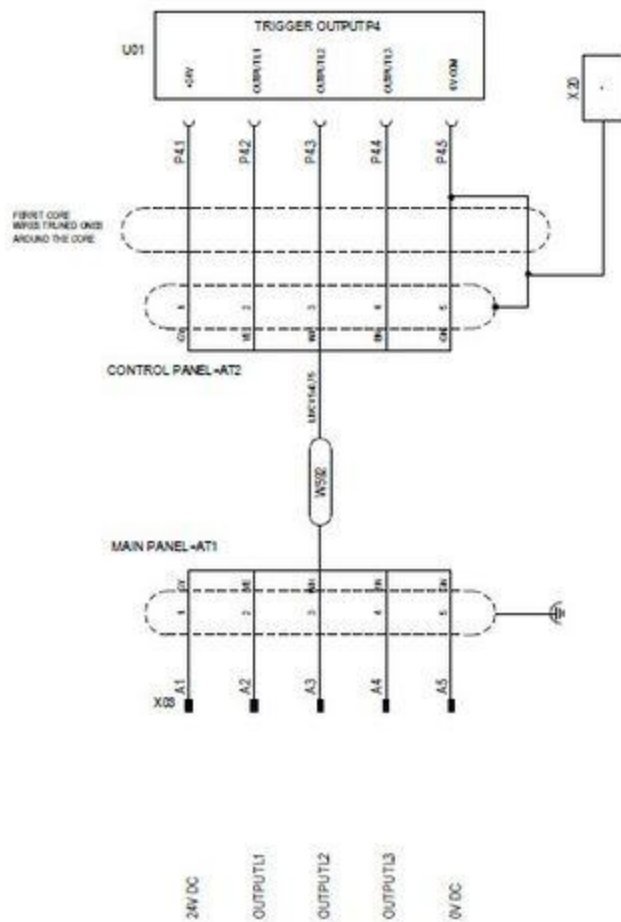
Check the X03 on the AT1. The trigger output from the TAC II may be lost in an open on the line.

Repair or replace the X03 Amphenol connector

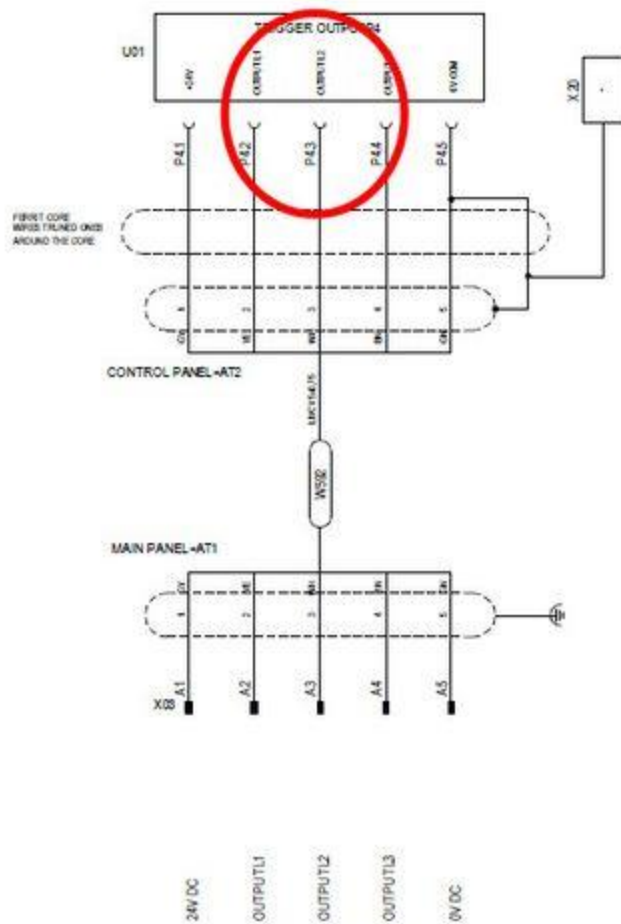
Test points circled

Check the TAC 40 for damage. Replace if it is bad.

You can test the TAC 40 while performing a motor start with the F01 open. Set the amperage on the motor start to 50 and jump the F01 out of the safety line.

Replace the TRIGGER BOARD TAC 40 690V

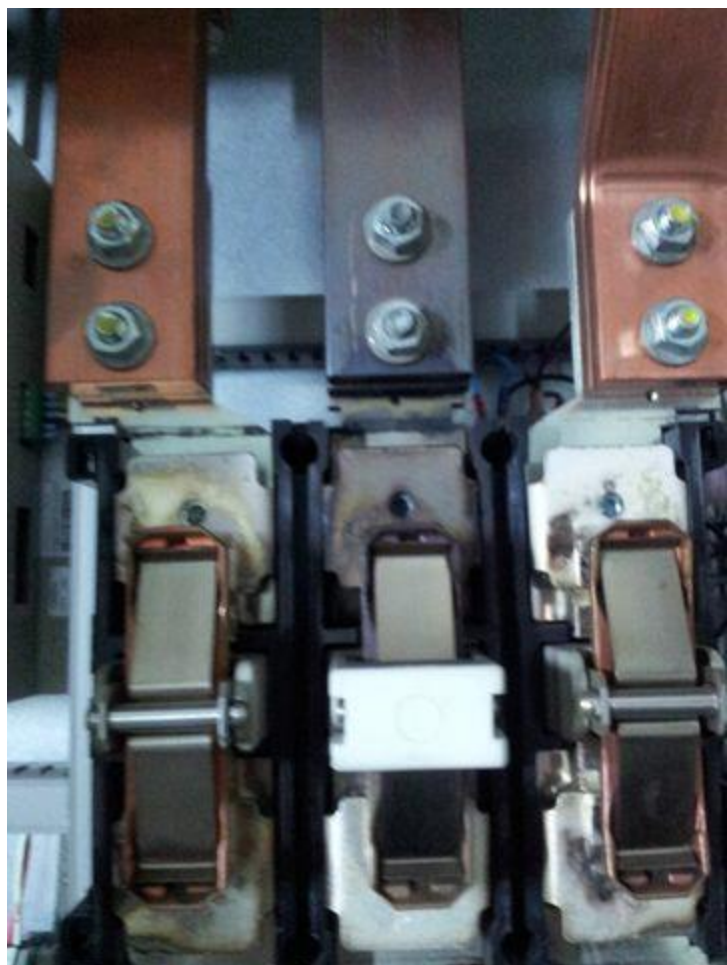
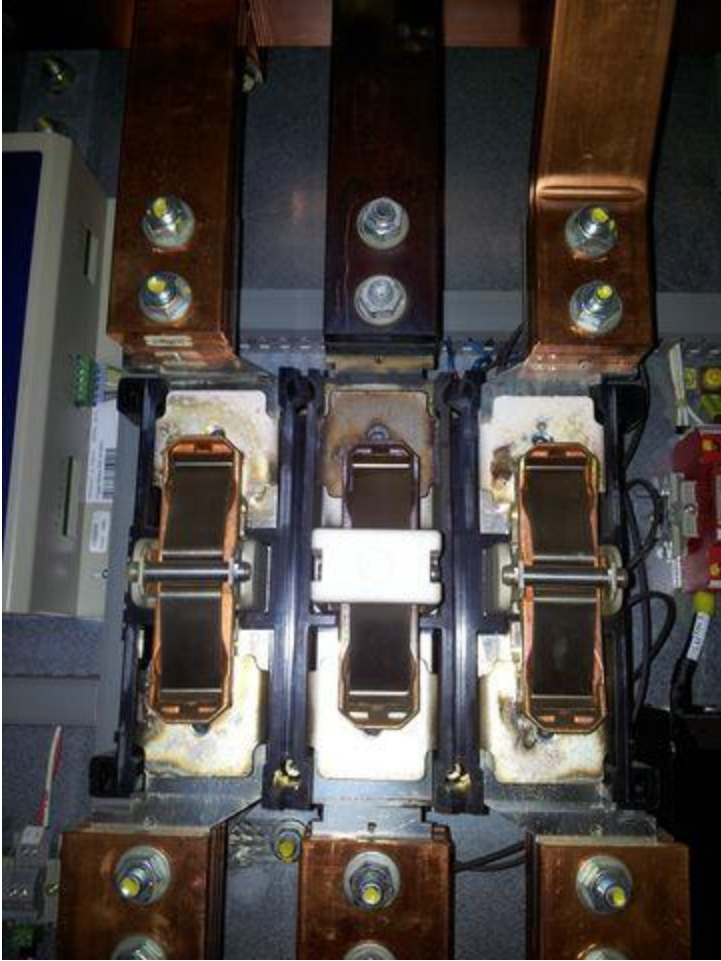
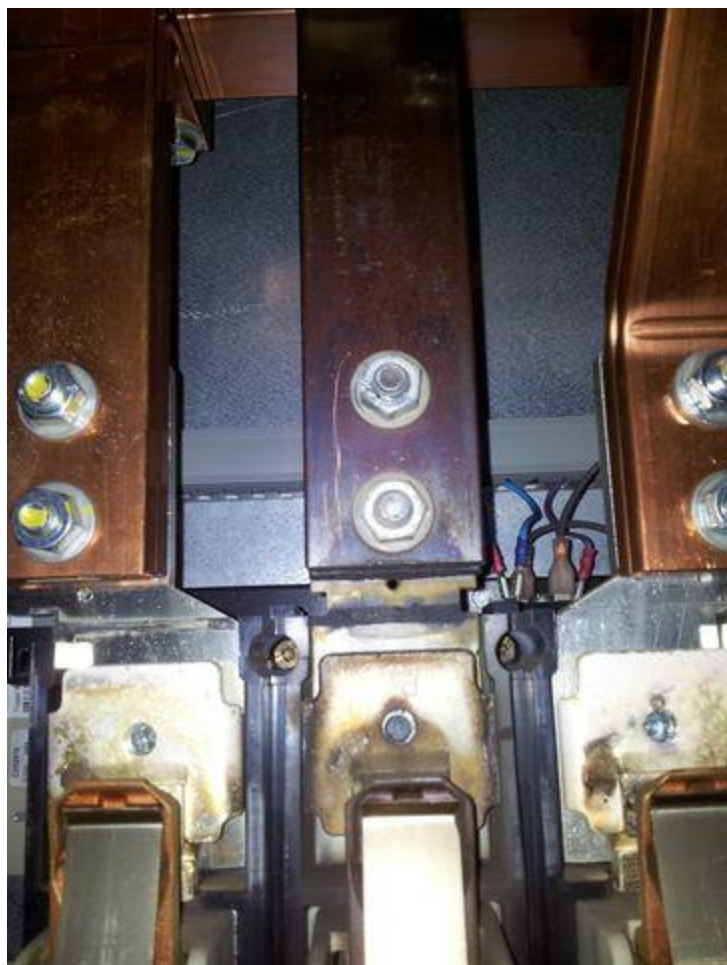
In the AT1 Main Panel, inspect the main contactors K02, K01, K03. Open the contactor front covers and check for any visible signs of damage and/or burn marks.

Also check the copper bus bars for any damage, signs of burns, overheating or arcing.

Sites have experienced contactor damage and heat transfer to bus bars as a result which have also been damaged. Replace any defective contactors and damaged bus bars as required.

Inspect and replace faulty contactors
