Replace the defective PT100 Sensor

Replace the PT100 sensor and repair the bearing housing

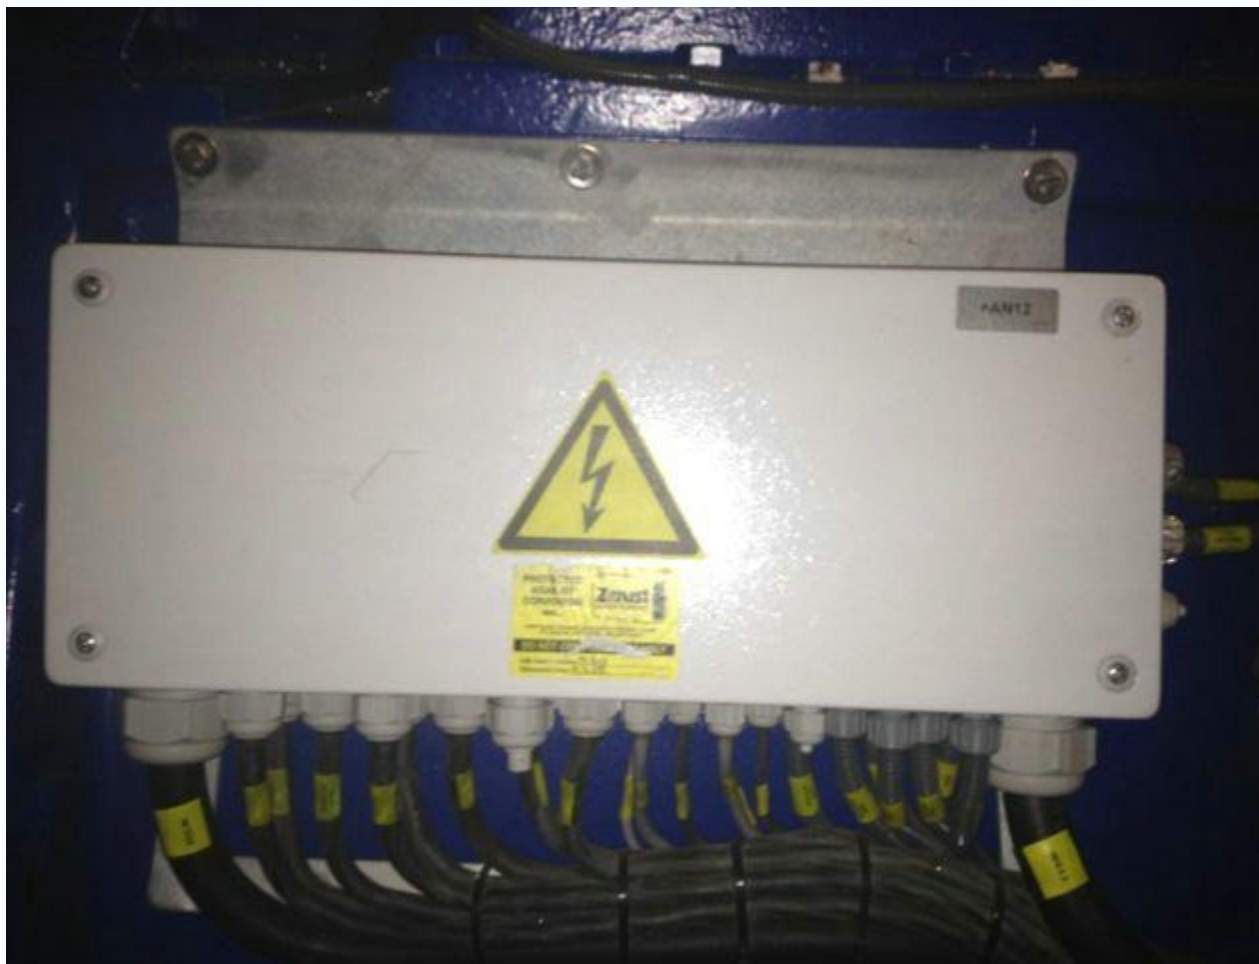
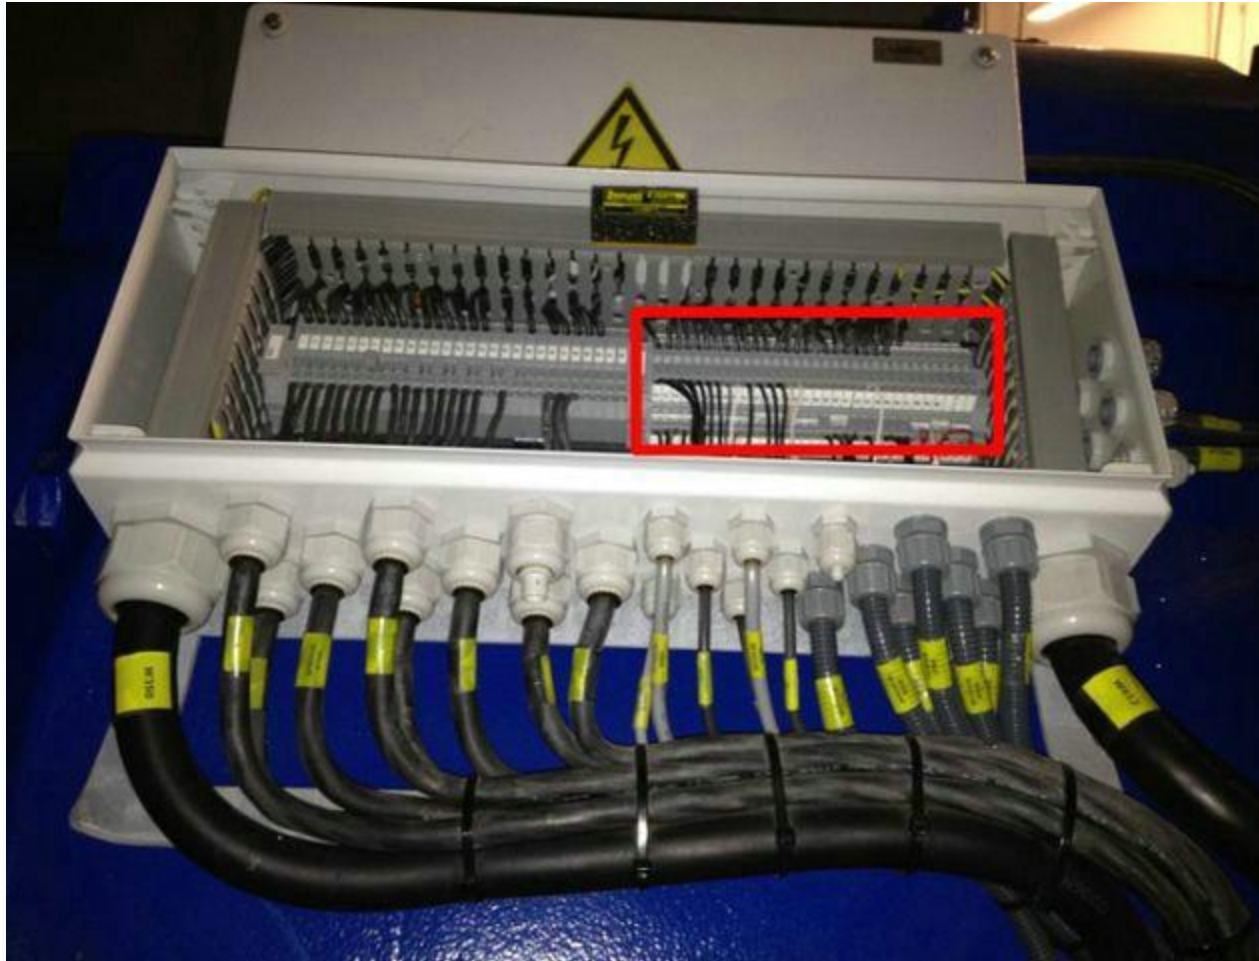
Check PT100 connections and tightness in +AN12 panel X02 connection 21 and 22.

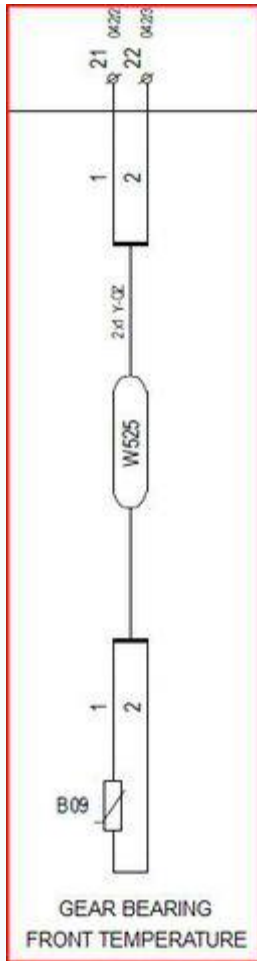
[60103090](#) - CABLE -W525 NM30T MODUL 2x1

Check the sensor cable for any cracks or damage.

If defective, replace the cable.

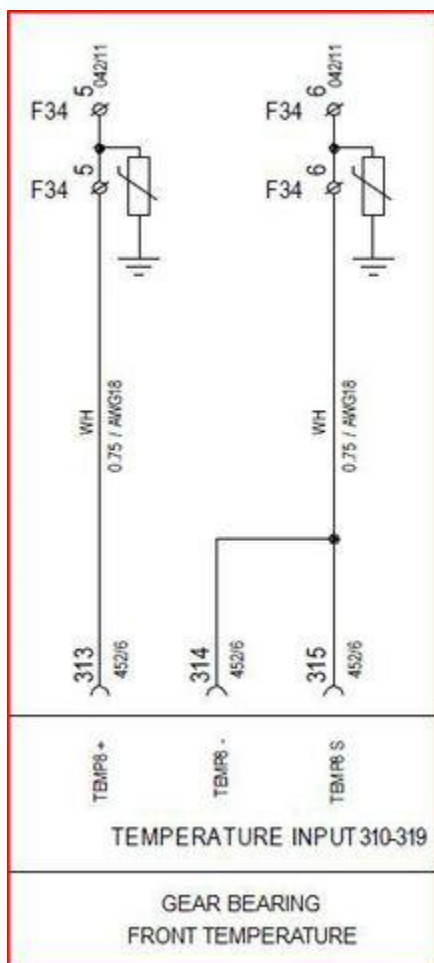
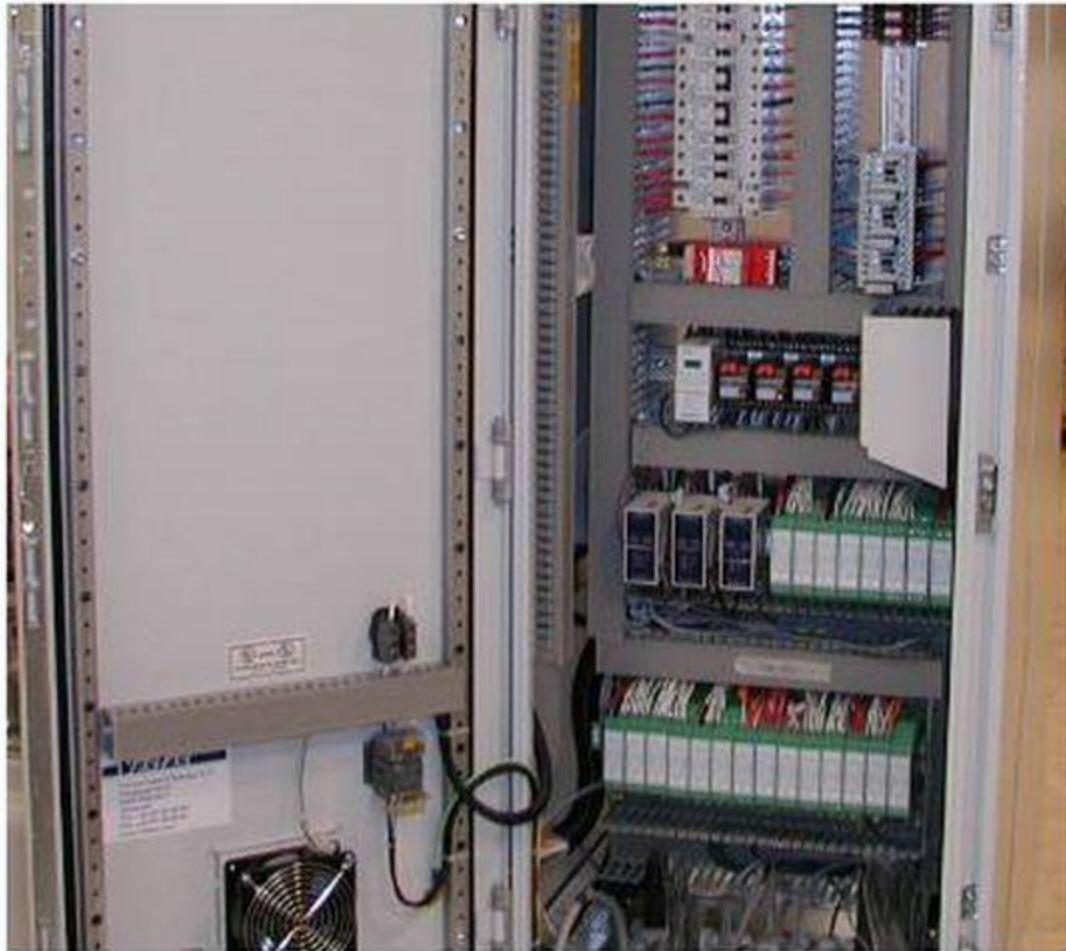
Varistors (F34) can be tested individually by placing a multimeter (set to measure Ω) lead on the common (earth) side of the varistors and the other on the individual varistor terminals. The resistance value over the varistor should be ∞ or in the high M Ω range. If the resistance is lower, the varistor has been damaged by an over voltage in the circuit and must be replaced.

Replace the defective varistor

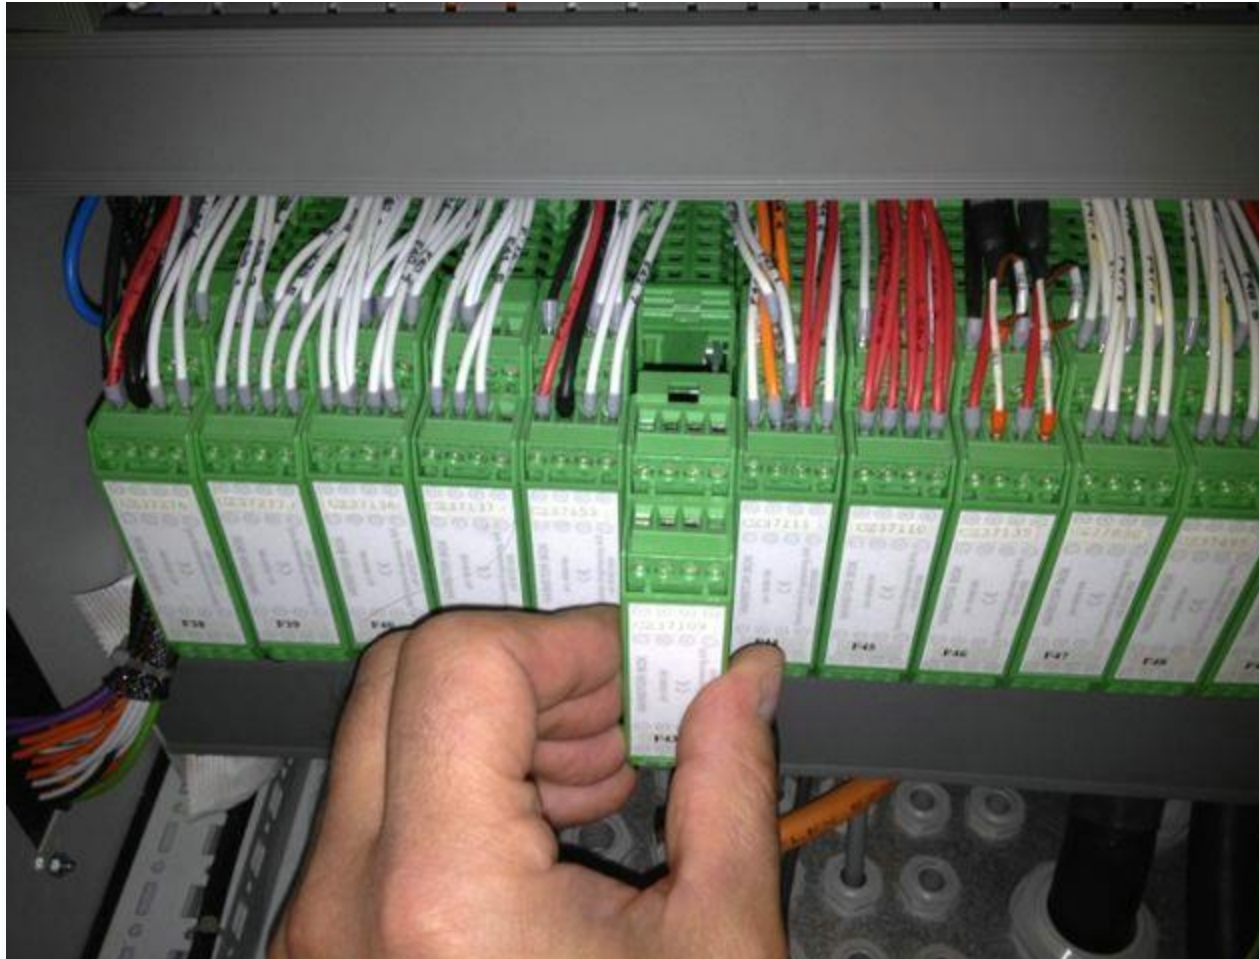
The varistor box is made up of eight varistors and has provisions for 16 wire connections (protection for 8 signals)

Press clip on top and bottom of varistor box and remove varistor assembly from housing:

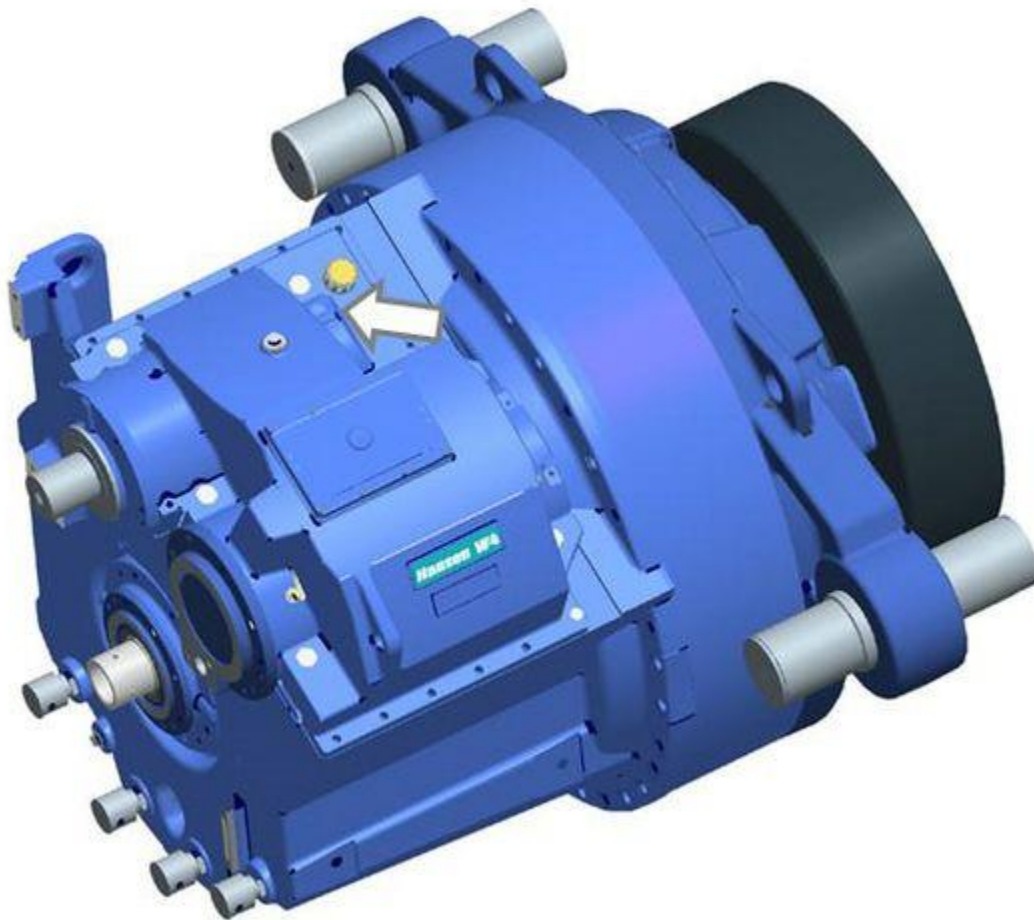
Position of the Sensor:

If the alarm "114 –Gear bear Front temp high", is active or recent in the alarm log, and the turbine has equipped with HANSEN gearbox- it is most likely a spinning bearing race causing the fault.

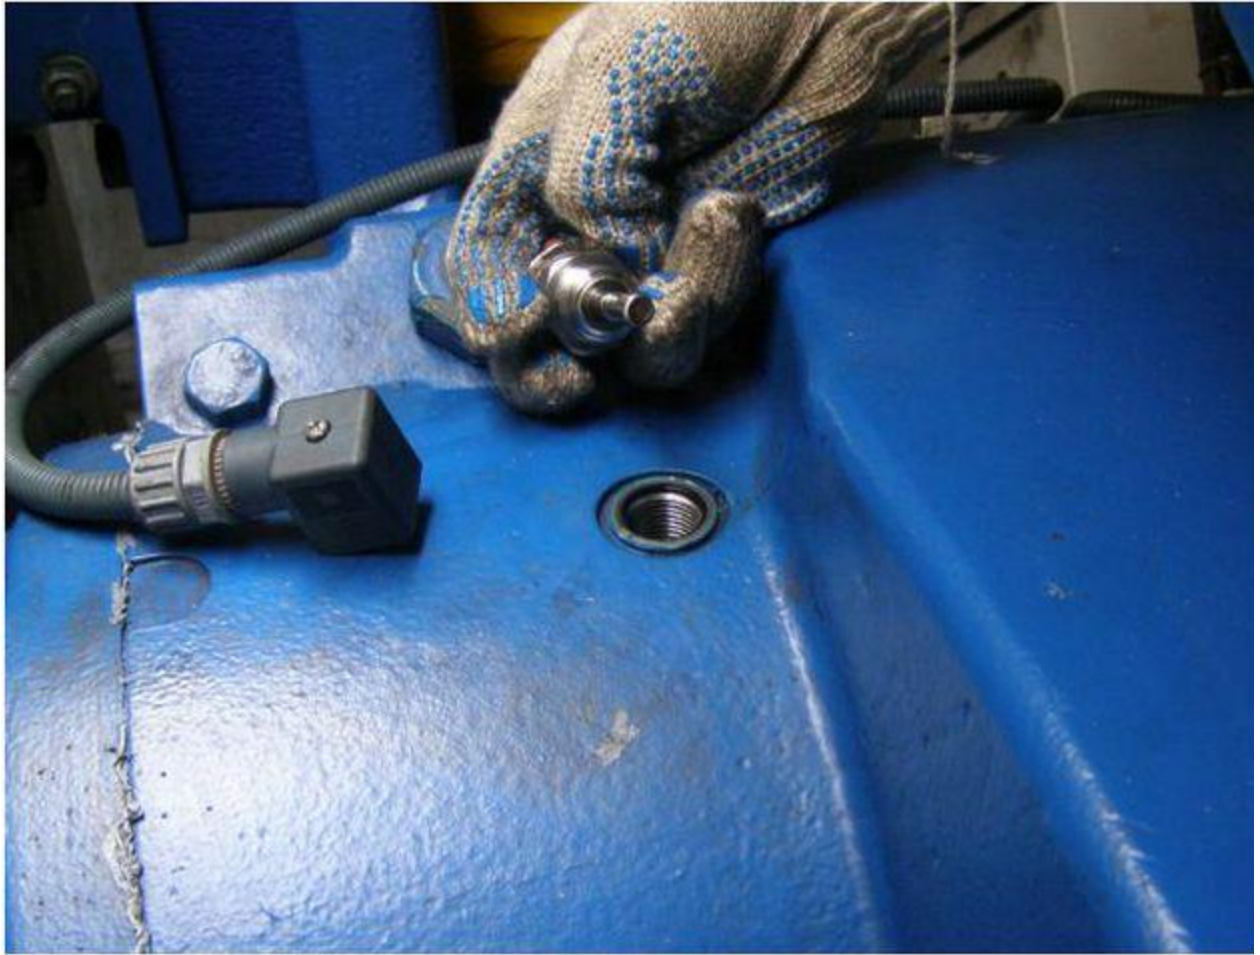
Inspect gearbox rear PT100 sensor tip for signs of wear.

Remove the PT100 sensor check the sensor tip surface

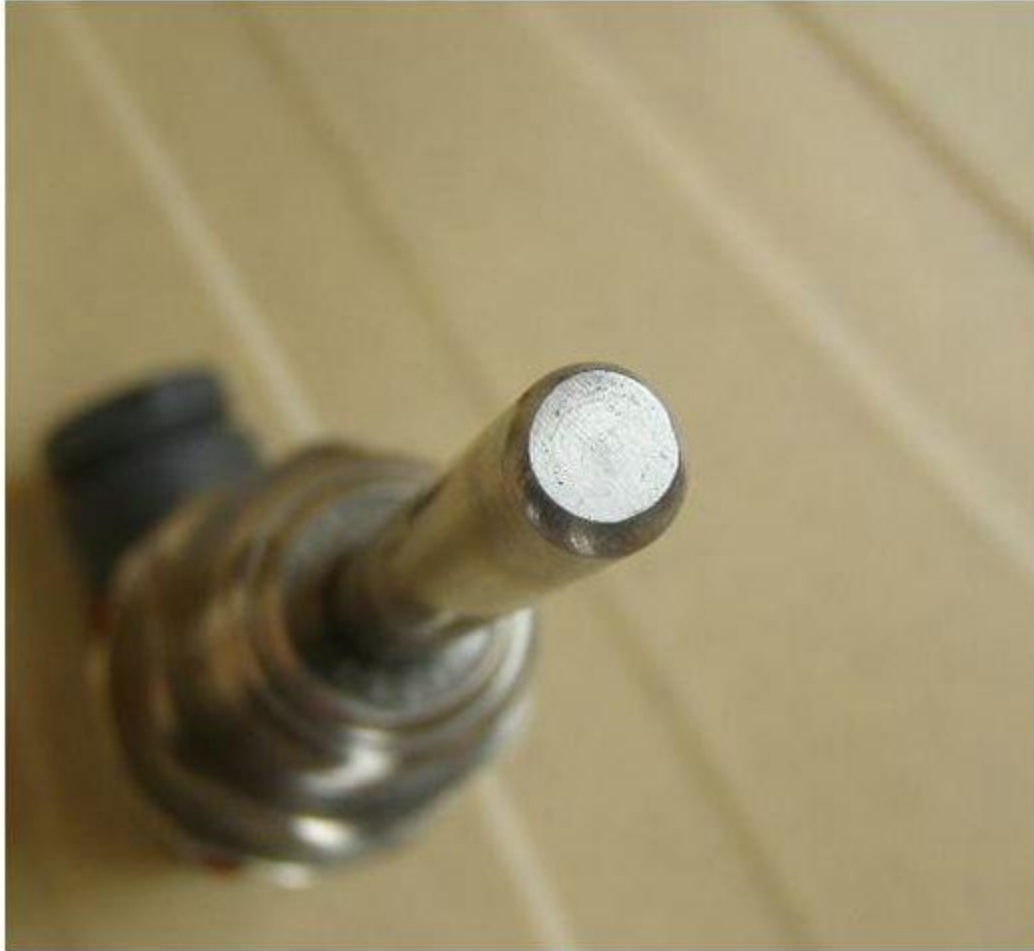
Wear PT100 Sensor 1:

If there is wear on the tip, probably the outer race of the bearing has been spinning in the bearing. Then proceed with repair solution with refer to CIM 1312/2217.

If during repairing the gap between the outer race and housing are >0.23mm, Mechanical lock solution will be required to prevent the outer race from spinning.
