Reset after grid recovery

Troubleshoot generator speed sensor

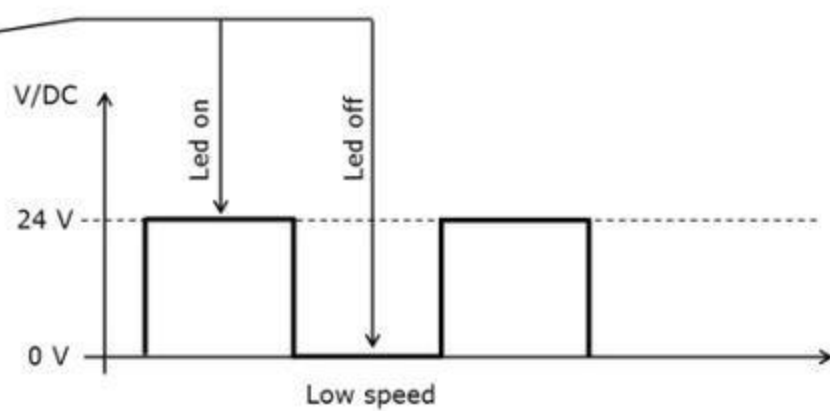
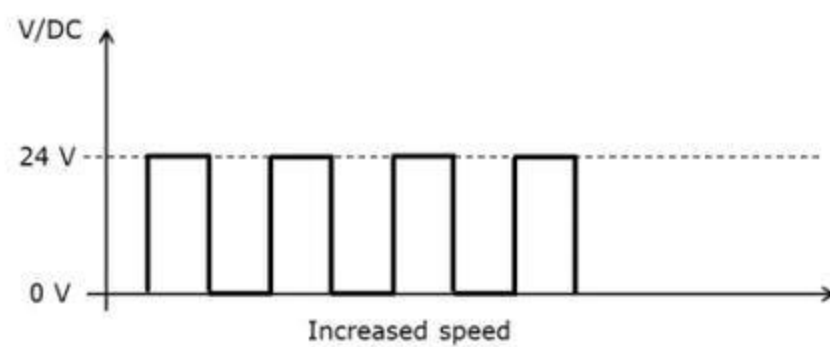
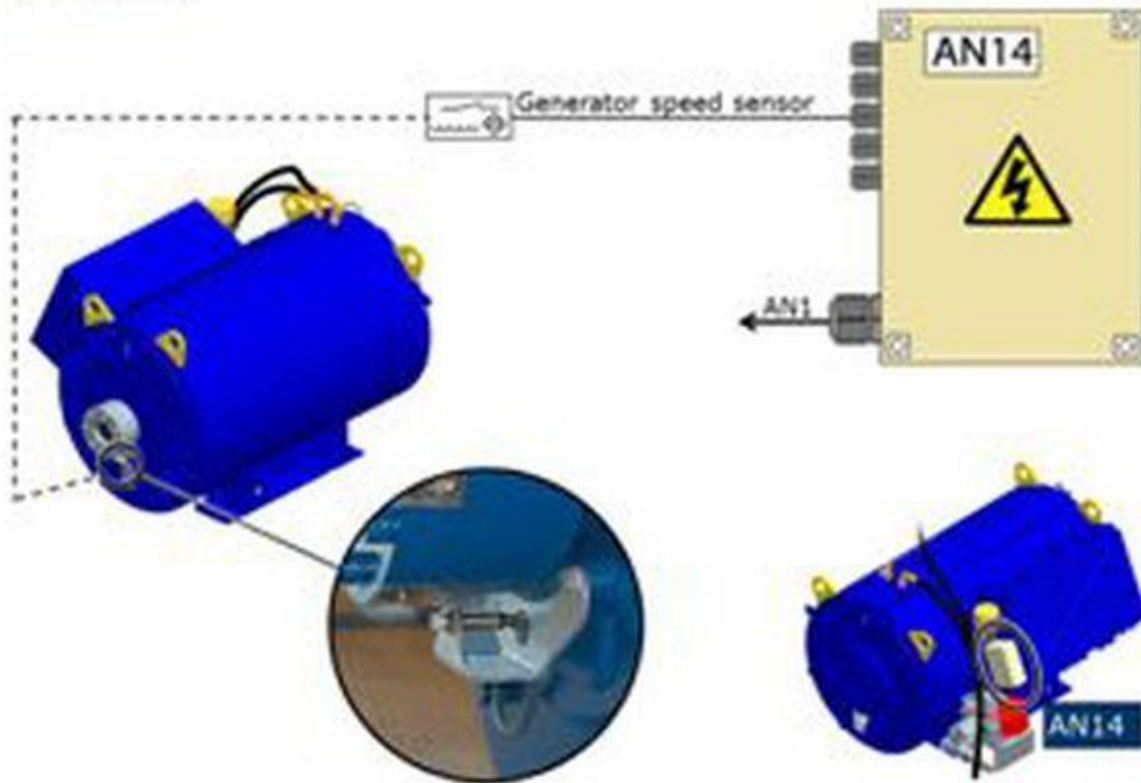
Generator speed sensor

The generator speed is measured by an inductive proximity sensor which creates a pulse signal as a pickup point passes over it.

In the case of the generator, there are seven pickup points for every rotation of the shaft therefore the speed is calculated as $\# \text{ of pulses} / 7 = \text{generator RPM}$. If the sensor is loose or failing it can "flicker" which will simulate a higher RPM than actual. The sensor can be tested by passing a screwdriver or other ferrous object past the sensor. If it consistently emits a light the sensor is likely operational. The sensor can also be tested by rotating the generator shaft and ensuring that the sensor emits a light when each of the (7) link element bolts passes over the sensor.

If the sensor does not emit a light each time a link element bolt passes over it, lock the shaft and check for correct sensor adjustment. Check the bolts on the speed sensor bracket and ensure that they are properly tightened. The end of the sensor should be within 1,5-5 mm from the pickup point. Adjust the sensor by loosening the nuts that clamp it to the mounting bracket and move it forward or back to achieve the required distance from the pickup point.

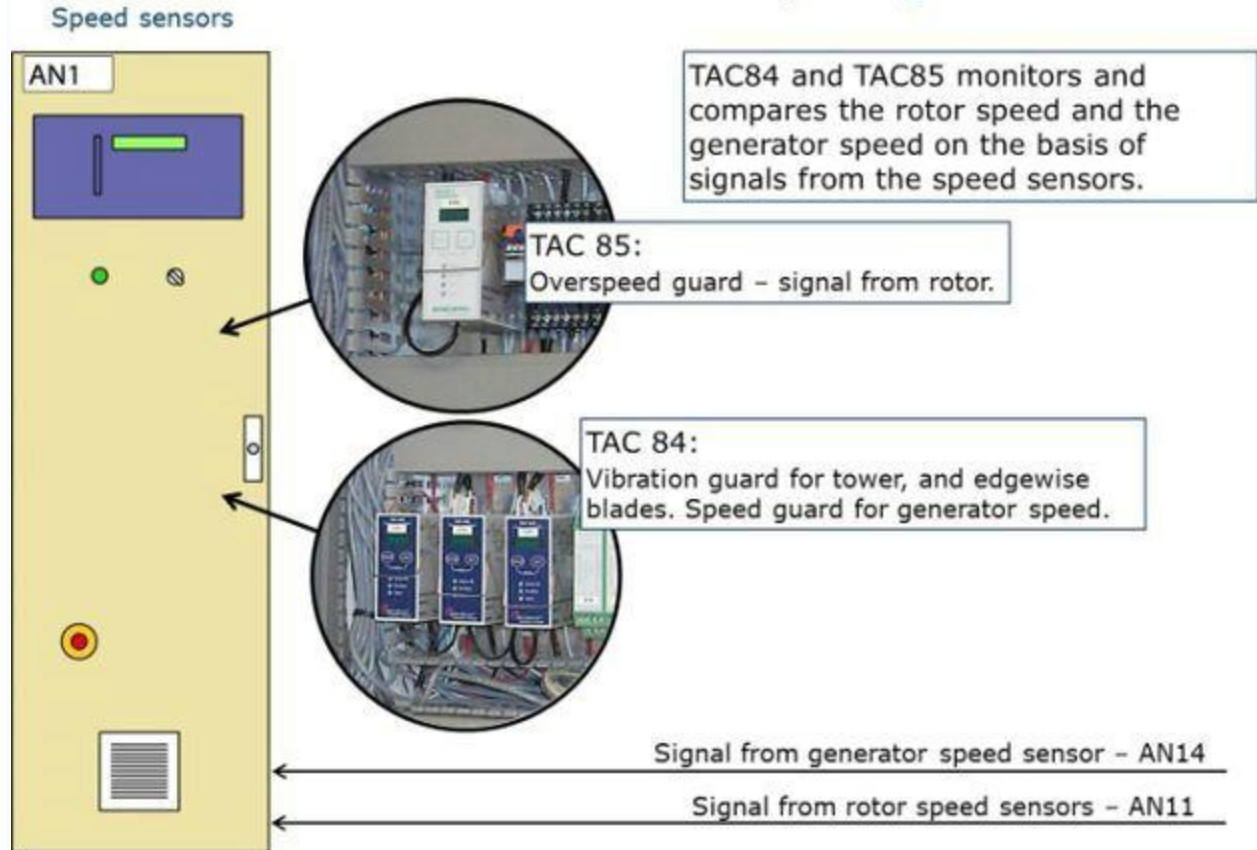
TAC84 & TAC85 overspeed guards

The signal is transmitted to the TACII controller and the three Vibration/overspeed guard modules.

Before replacing the sensor or components, check the circuit for loose connections.

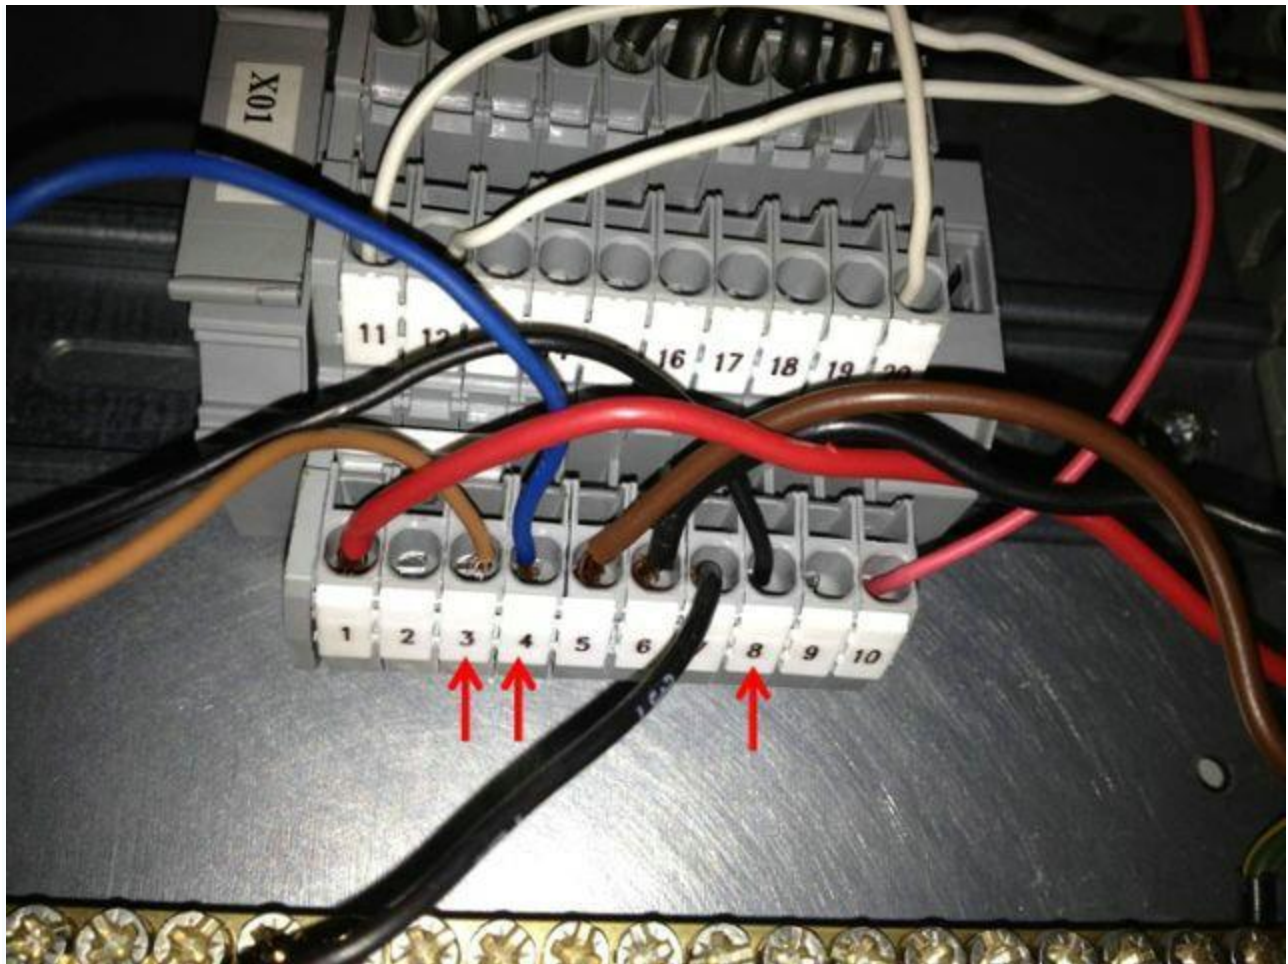
Terminal block –X01 terminals 3, 4 & 8:

Check for loose sensor terminations in the AN14 panel. (The AN14 terminal panel exists only in V82 1.65 Mw. NM72/82 1650Kw generator speed sensor cables terminate directly at the AN1 Top Box).

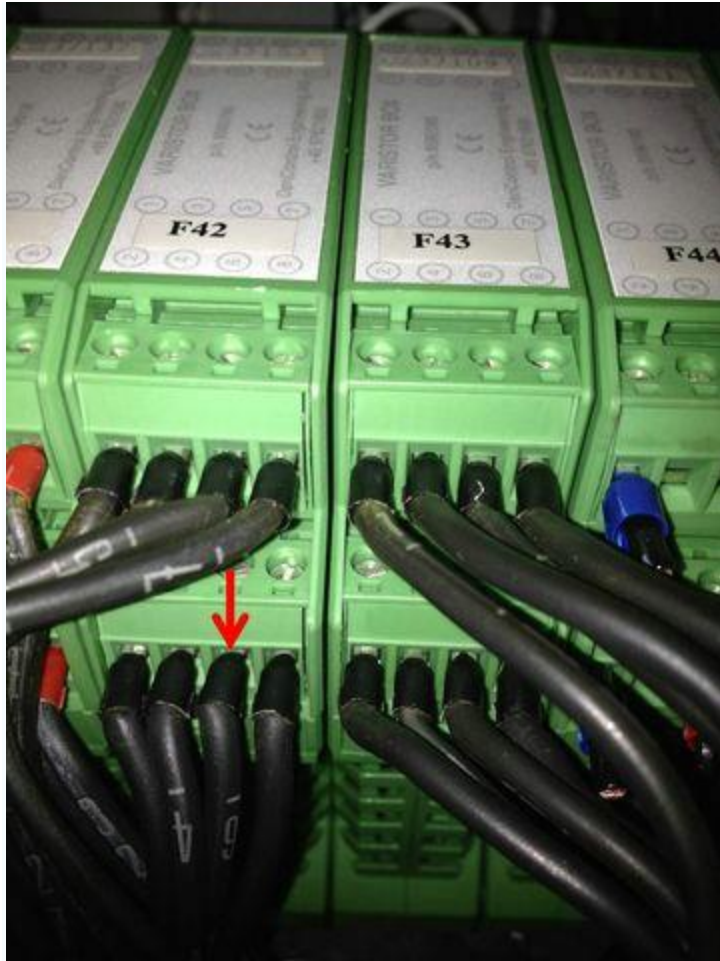
Check for loose wire terminations in the AN1 Top Box (sensor wire from the AN14 terminates into F42 Varistor Box terminal 6:

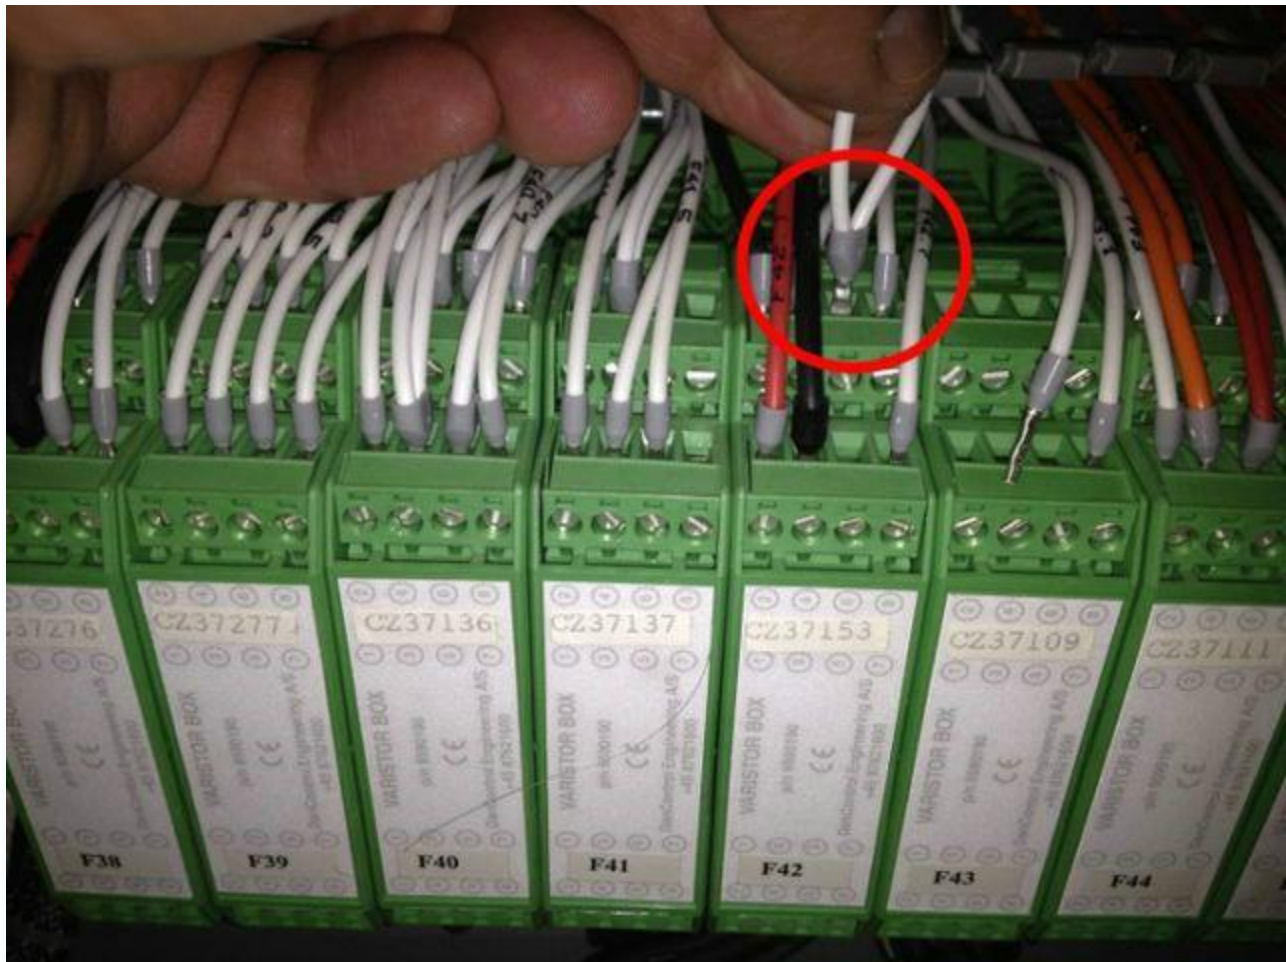
The signal wires from the F42 varistor box are double stacked, pay close attention to this crimped connection as the wires may be loose:

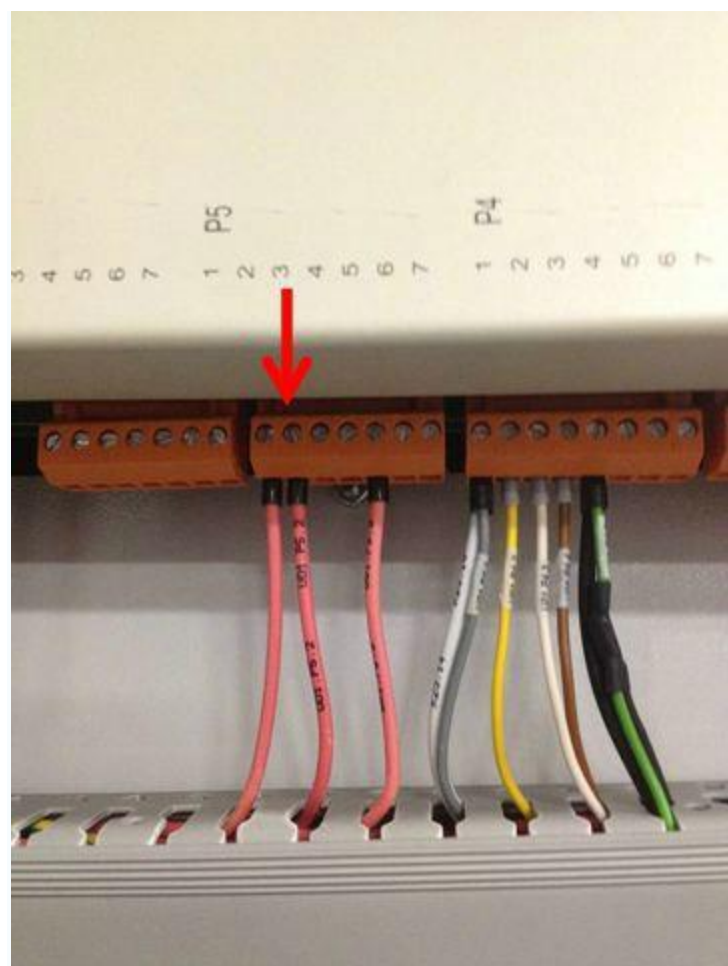
Finally check the signal termination at the TAC controller (P5 terminal 2):
