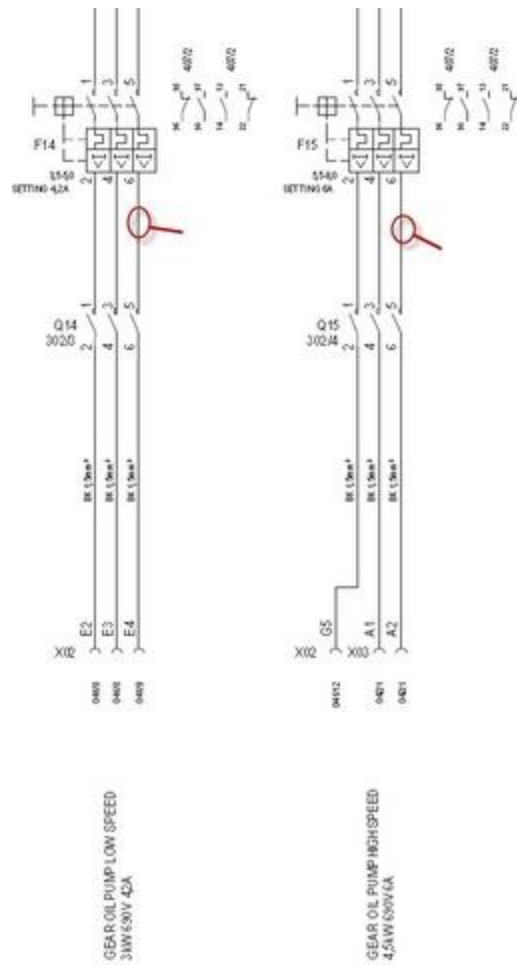
Using an amp clamp, measure the current consumed by the motor at both low and high speeds. At low speed the current consumed should be about 6.8 Amps. At high speed it should be about 9 Amps. Use one wire at a time from the +AT2 F14 breaker for low speed, and one wire from the +AT2 F15 breaker for high speed. Measure all three cables for each motor.

- If current is more than 10% higher than 6.8/9 Amps investigate the cause.

Check the three phase circuit from the F14/15 all the way to the motor for loose connections or poorly terminated wires. Pay special attention to the pins in the Amphenol connections, as these can back out and cause poor contact.

Using a Megohmmeter test each phase of the motor from phase to phase and phase to ground. If any of the measurements show connection from one point to another then the motor has failed.

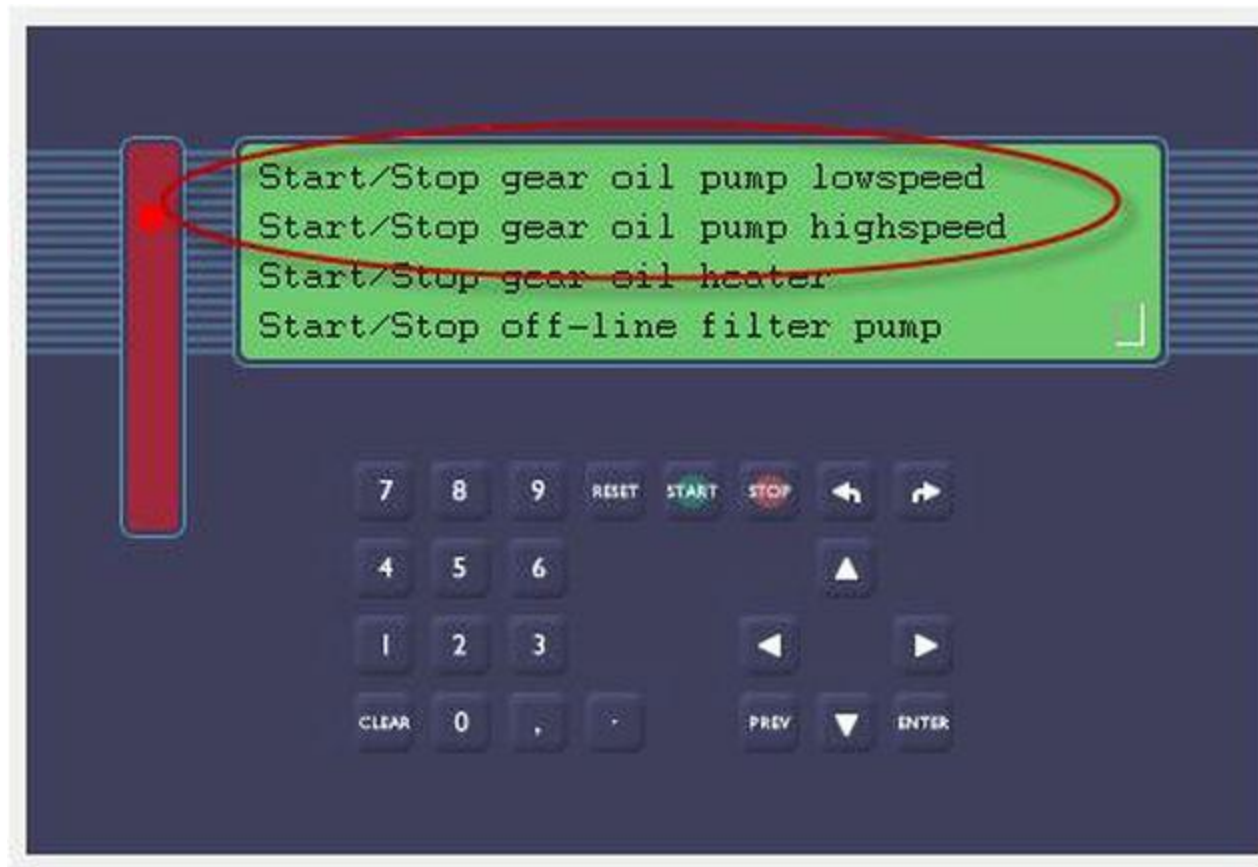
The pump can be stopped and started in the following menu: Service-Manual Test-Start/Stop Gear Oil Pump Low/High speed.

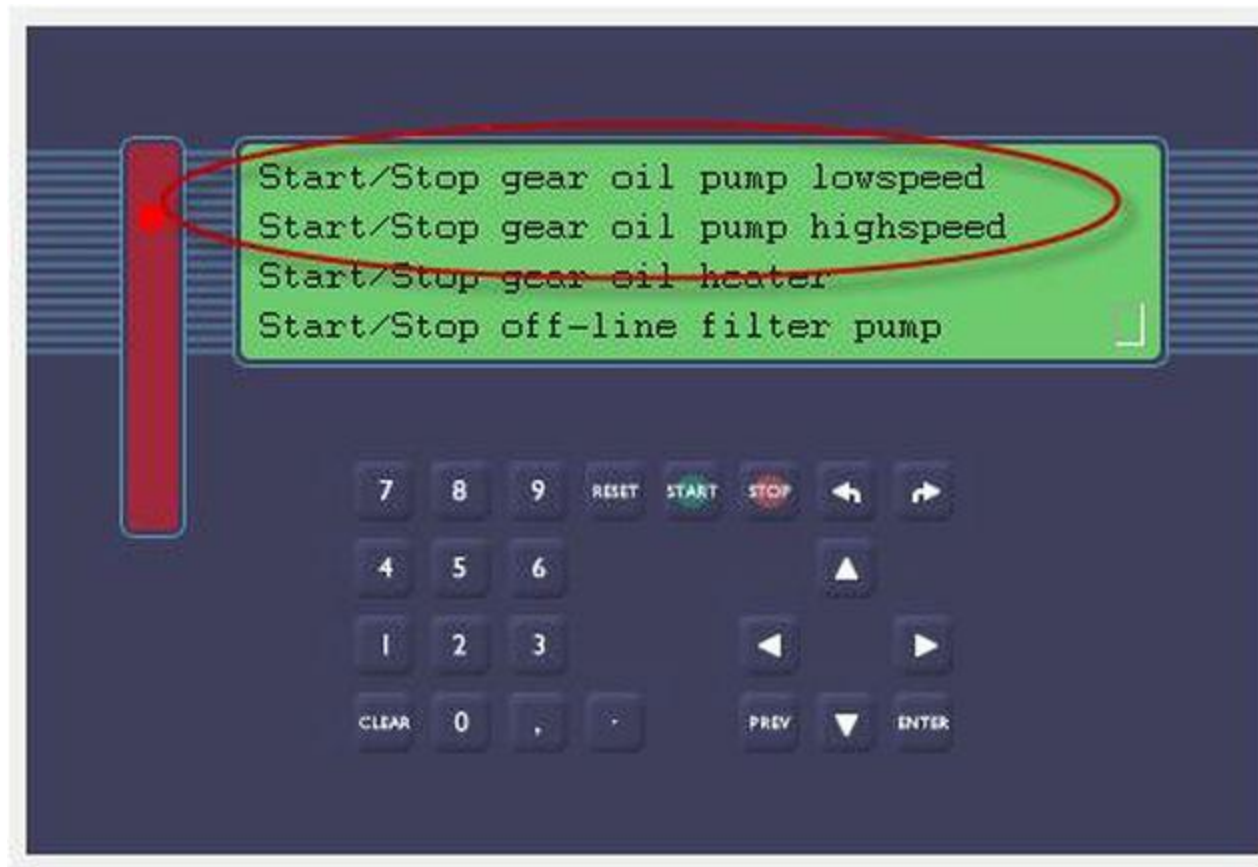
The pump can be stopped and started in the following menu: Service-Manual Test-Start/Stop Gear Oil Pump Low/High speed.

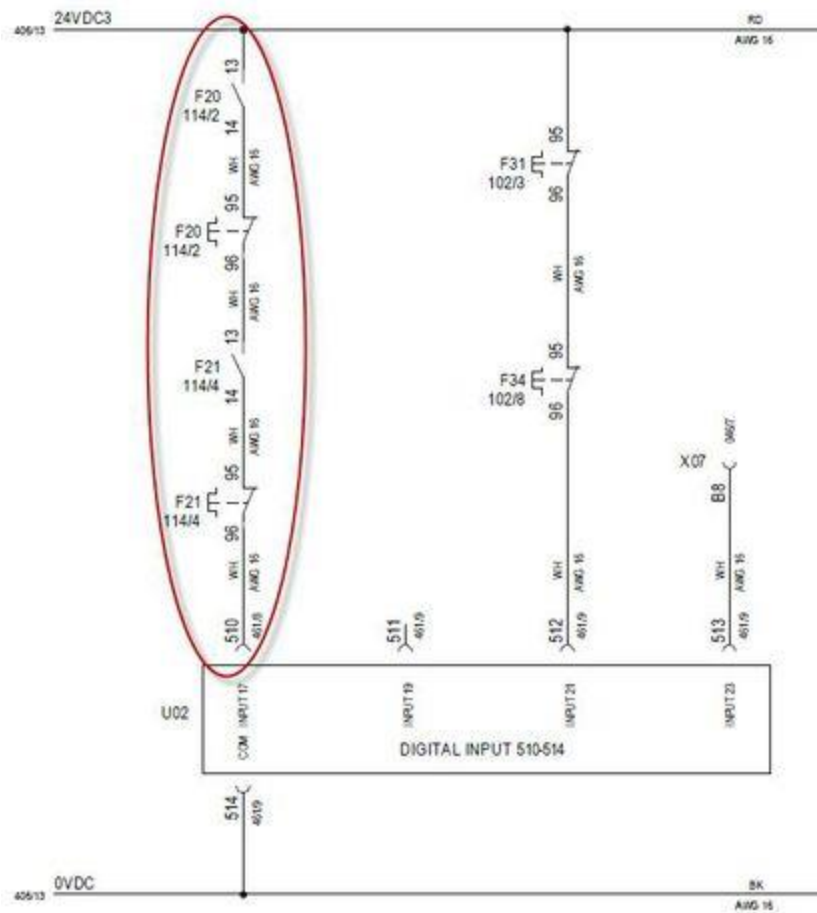
It is possible that overload feedback is missing, even if the motor is not defective.

With the breaker energised and the pump shut off check the 24VDC circuit below. There should be 24VDC at every point from top to bottom.

If there is not then replace the defective component.

If there is 24VDC all the way through the circuit but the AT2 TOI input 510 light is not on replace the AT2 TOI.
