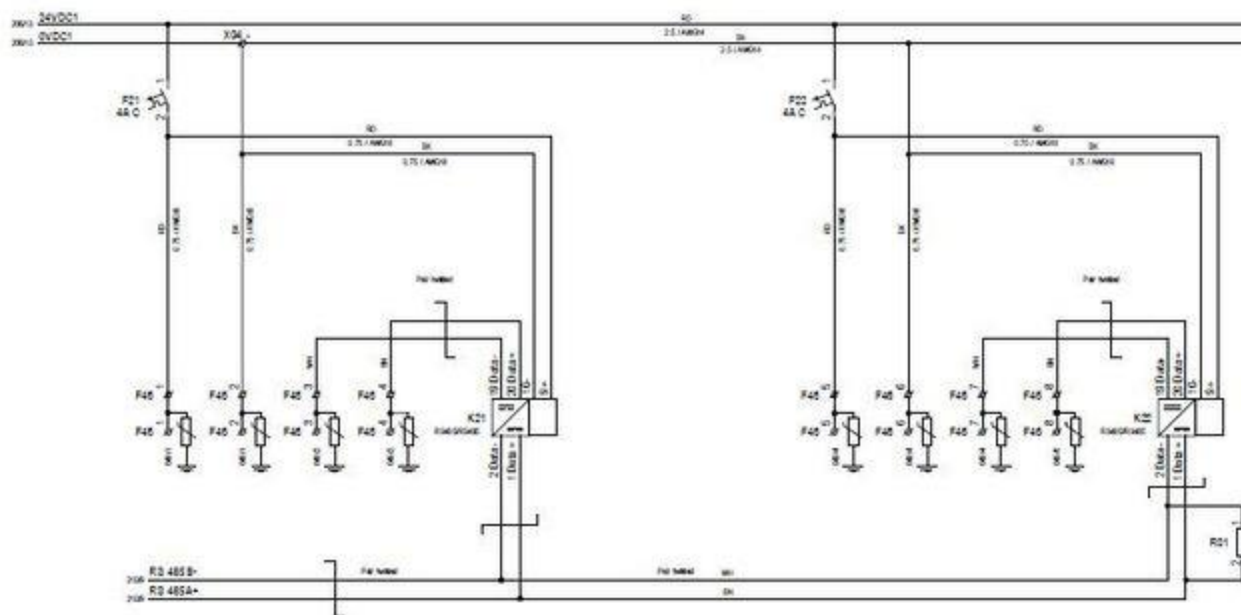
+AN 1 Panel

Check the connection at RS485(K21) repeater & check LED status, One LED for power "ON" glow continuously other LED for signal transmission blinks, if the LED not glow change the RS485 repeater

Replace the defective RS485 Repeater

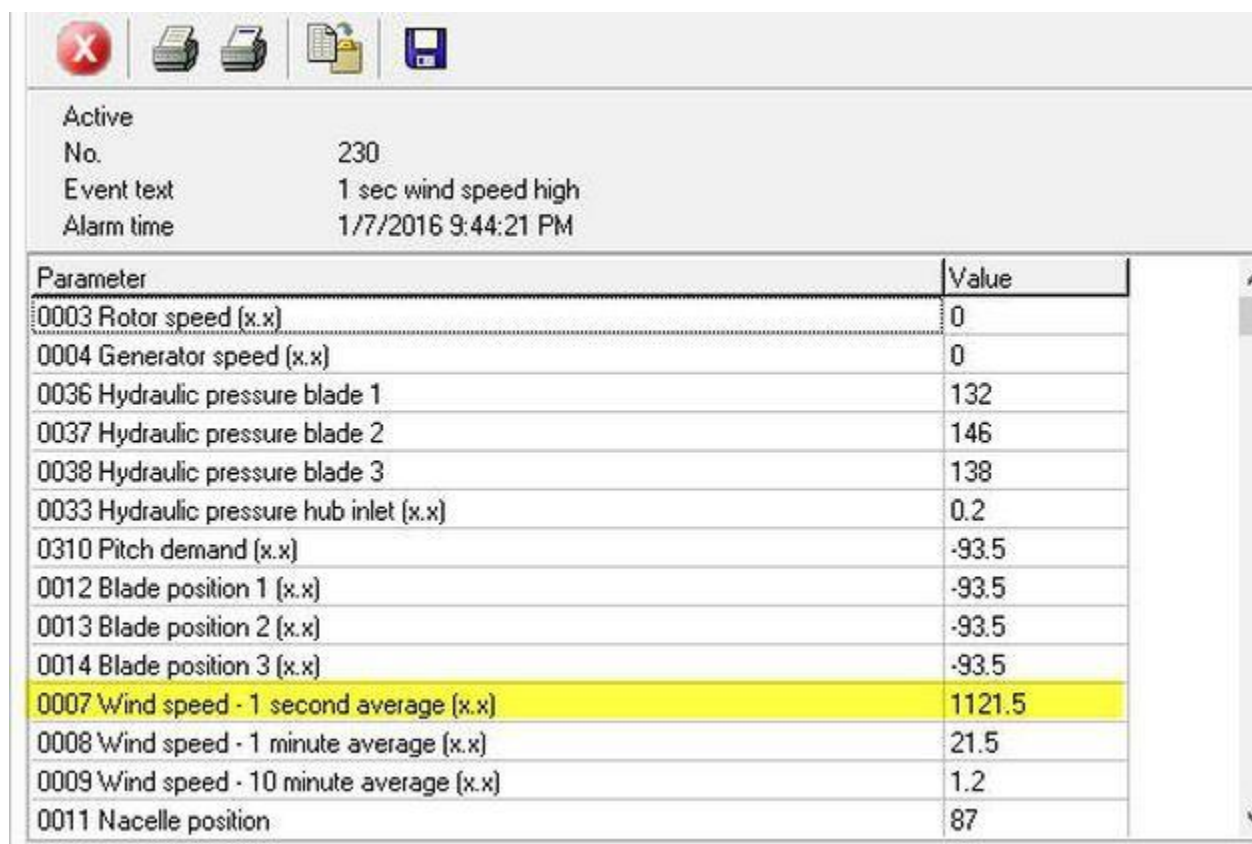
Check the instantaneous wind speed measurement recorded in the TAC-II controller. If the value shows abnormally, then FT sensor might failure and need a replacement.

Below screenshot shows an incorrect measurement in the controller:

Check the Sensor alignment and replace the defective sensor

Relevant spare parts	
Description	Item No.
WIND SENSOR US FT702LT	106510
