Replace the defective TAC84 module

- **Explanation**
IN THE +AN1 CABINET:

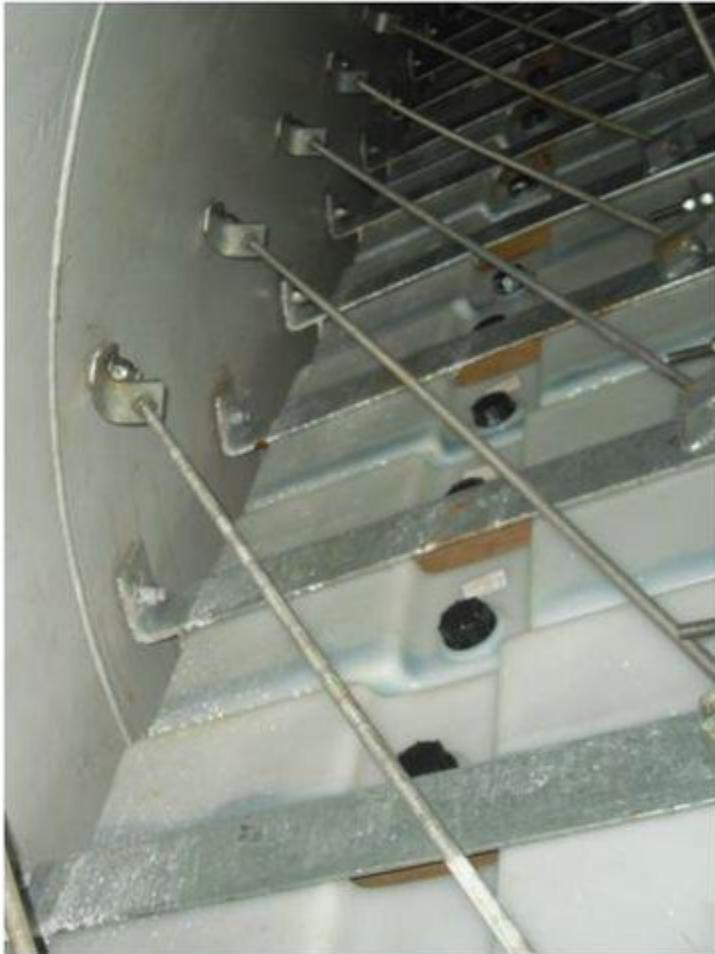
Check the containers for any sign of leakage in the tank and the closing cap.

If any caps are found to be leaking or damaged - replace both the cap and seal.

Ensure the seal is properly seated.

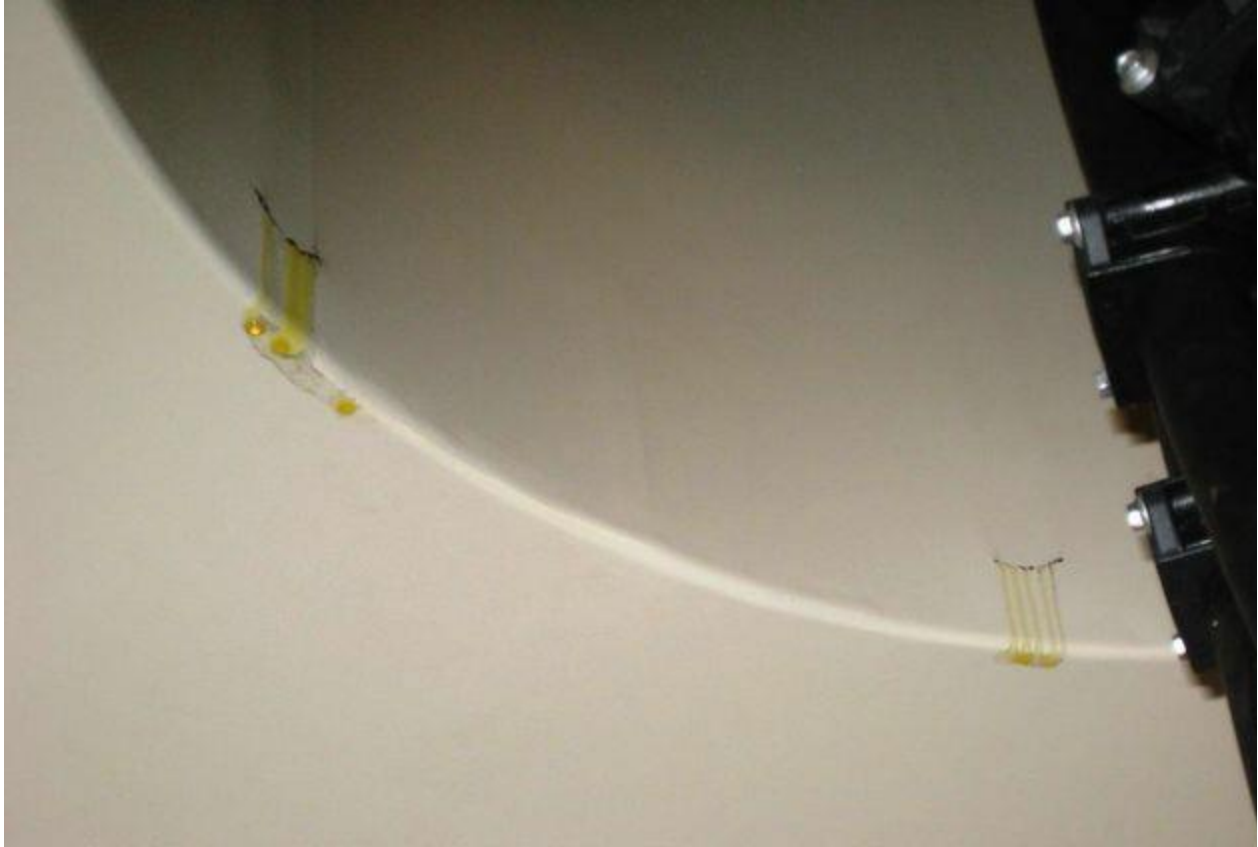
Damage to damper tanks:

Inspect the damper wall internal to the tower for cracks or leaks. If the pendulum is making contact with the tank wall, install larger fenders- **“80-mm Fender**

Part # 78600140” and contact the local engineering department for instructions to patch the tank. Top off the oil in the tank per the I&S Data.

Refer CIM1838 (RCA Phase) for instructions on fender instillation (also reference the Commissioning Manual) and recommendations for tank repair solution.

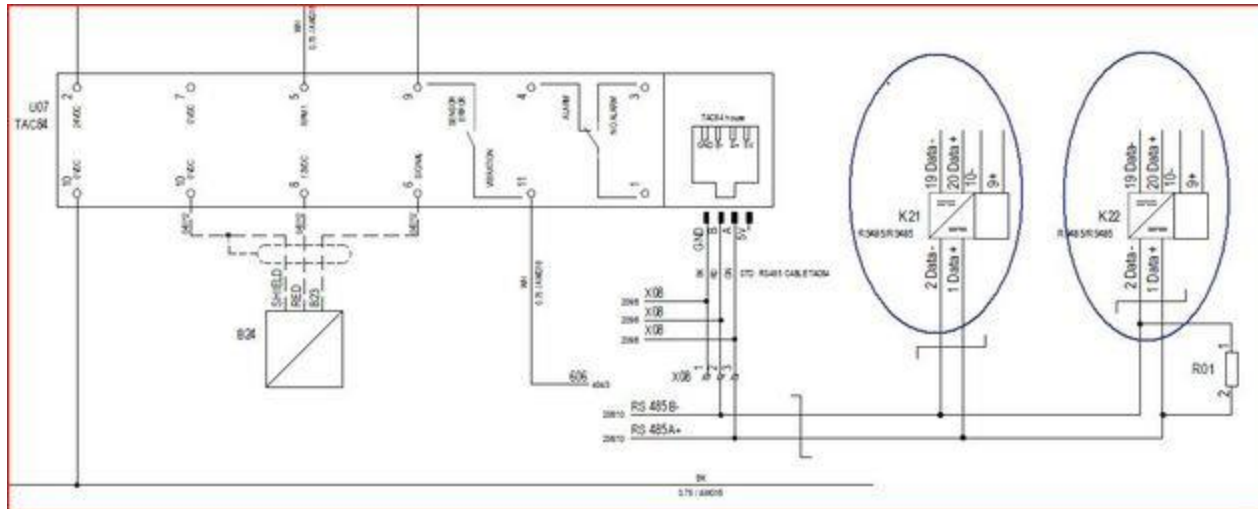
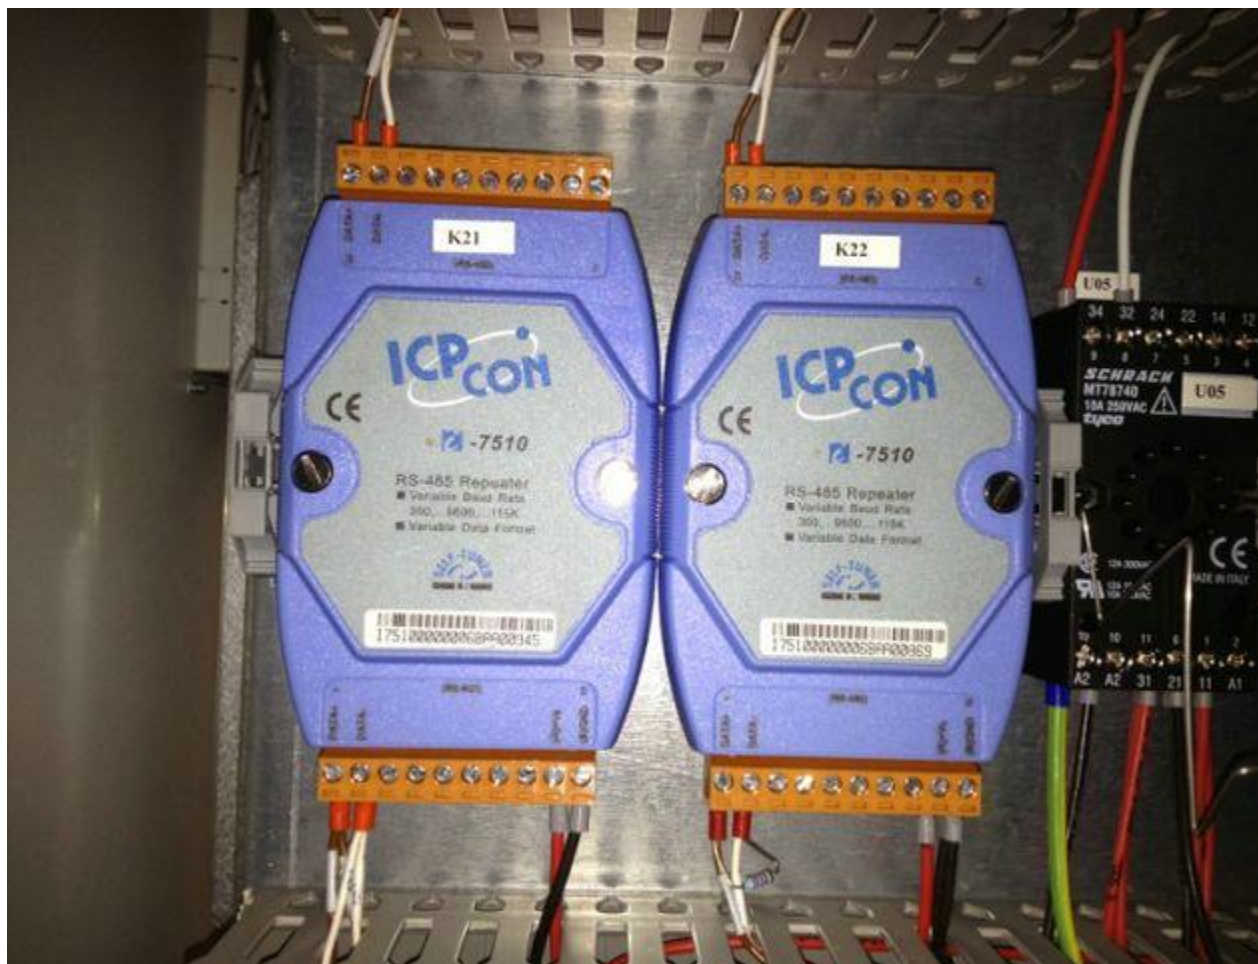
Check the connections at the ICP RS485 repeaters (K21 & K22) in the AN1. Check for loose wires and plugs or corrosion at the repeater.

If there is no communication on one sensor, switch the ICP RS485 repeaters to see if the communication returns. If communication returns when the repeaters are switched, replace the faulty repeater.

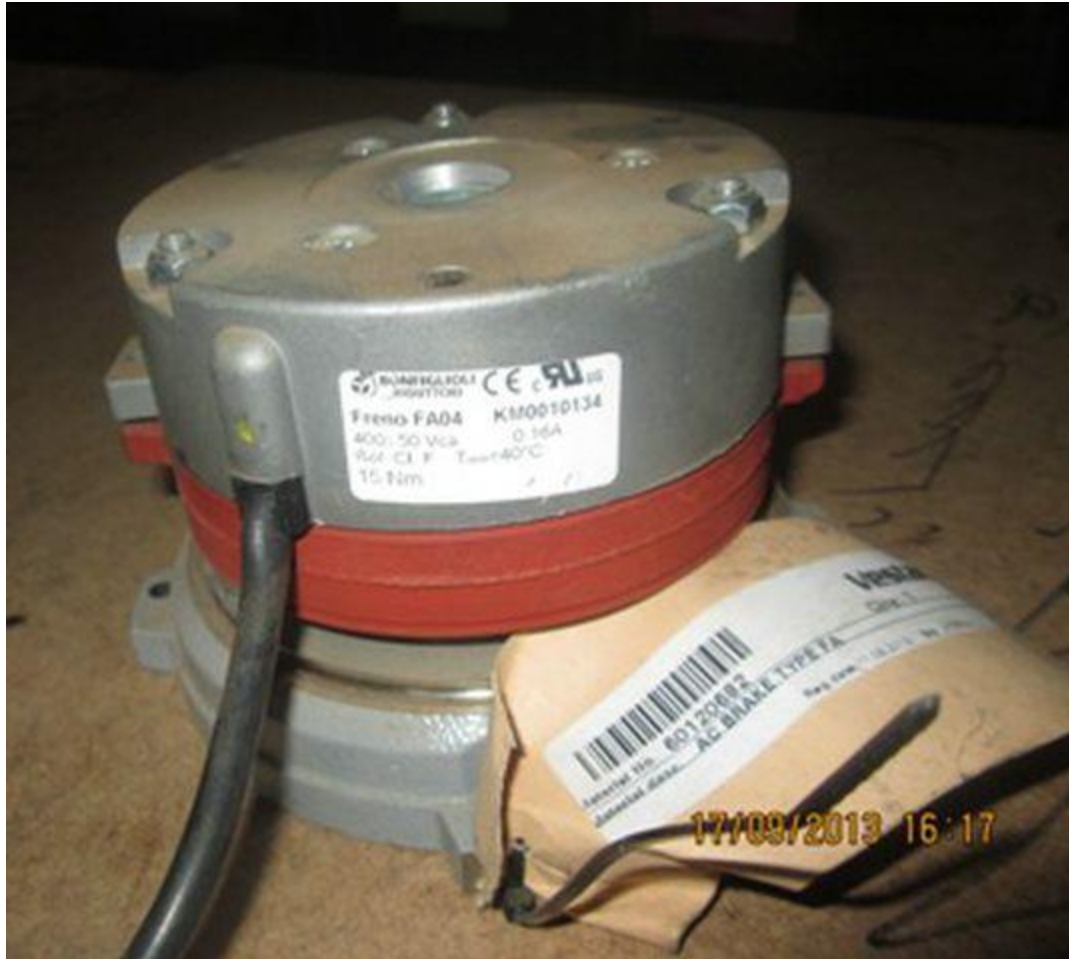
Yaw magnetic brake failure is one of cause of lateral vibrations.

Check all of the yaw motors for any bearing failure or brake failure.

If the Magnetic coil is found to be defective replace the magnetic coil.

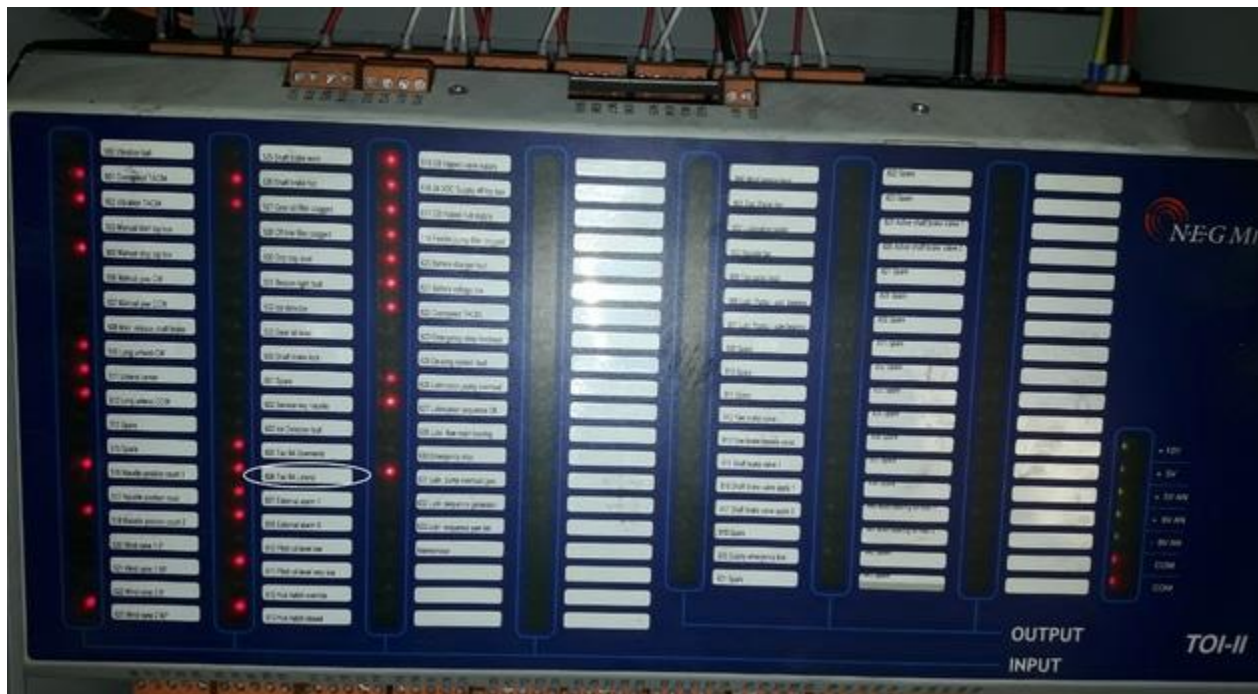
Check the input signal to TOI-II (606) and replace the TOI, if error not clear with signal feedback available in 606

Check the input signal at 606, TOI-II unit and replace the TOI-II if you receive the signal at 606 and error not reset
