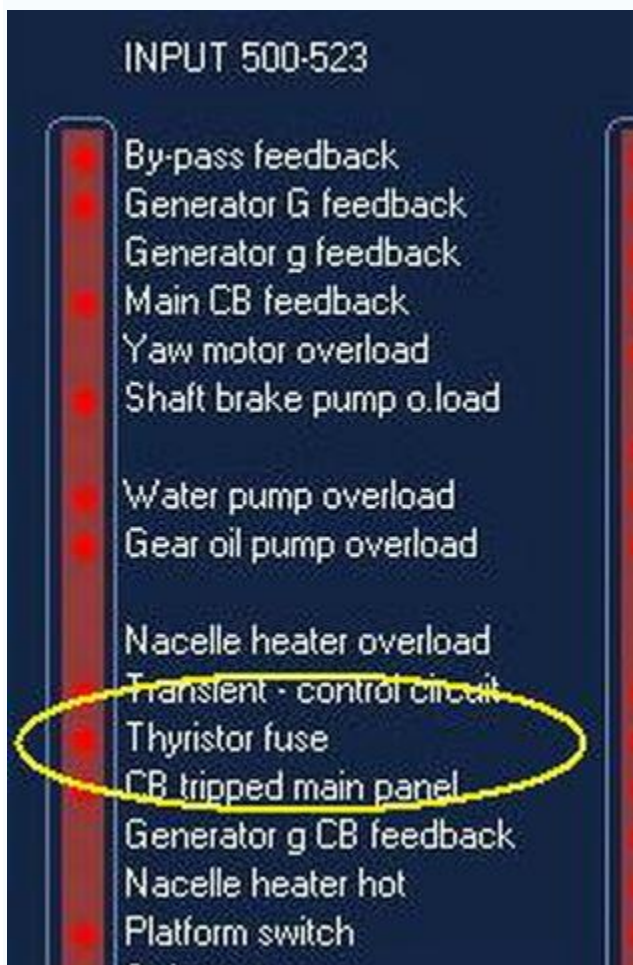
Check "Thyristor fuse" led in Tower T01:

If it is OFF, the alarm is real and nothing can be done in remote. The thyristor fuse will need to be replaced: Notify the site of the problem and dispatch a service team.

If it is ON, try to reset and restart the turbine. If the alarm reoccurs, notify the site and dispatch a service team.

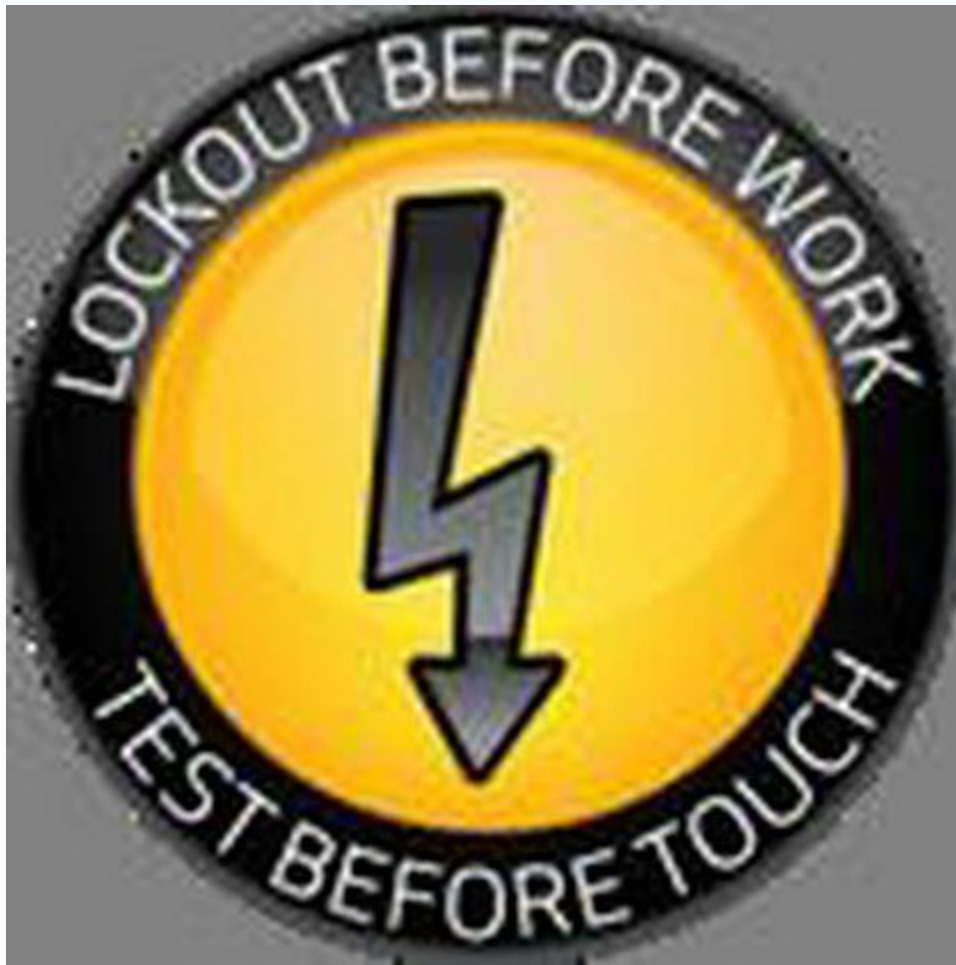
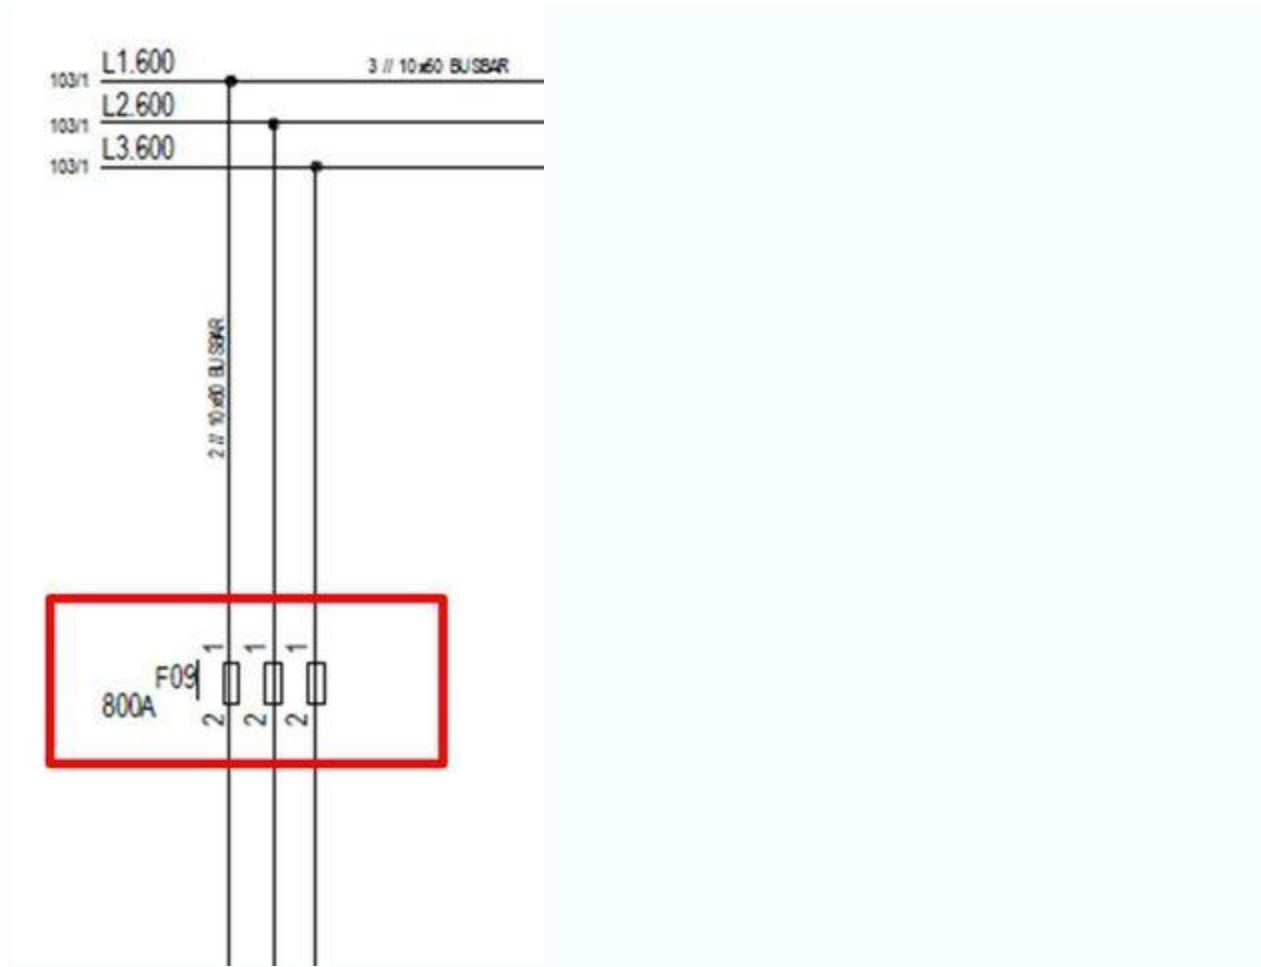
Using a multimeter set to read Ohms, check the continuity of the fuse.

Replace the failed fuse: (F09)

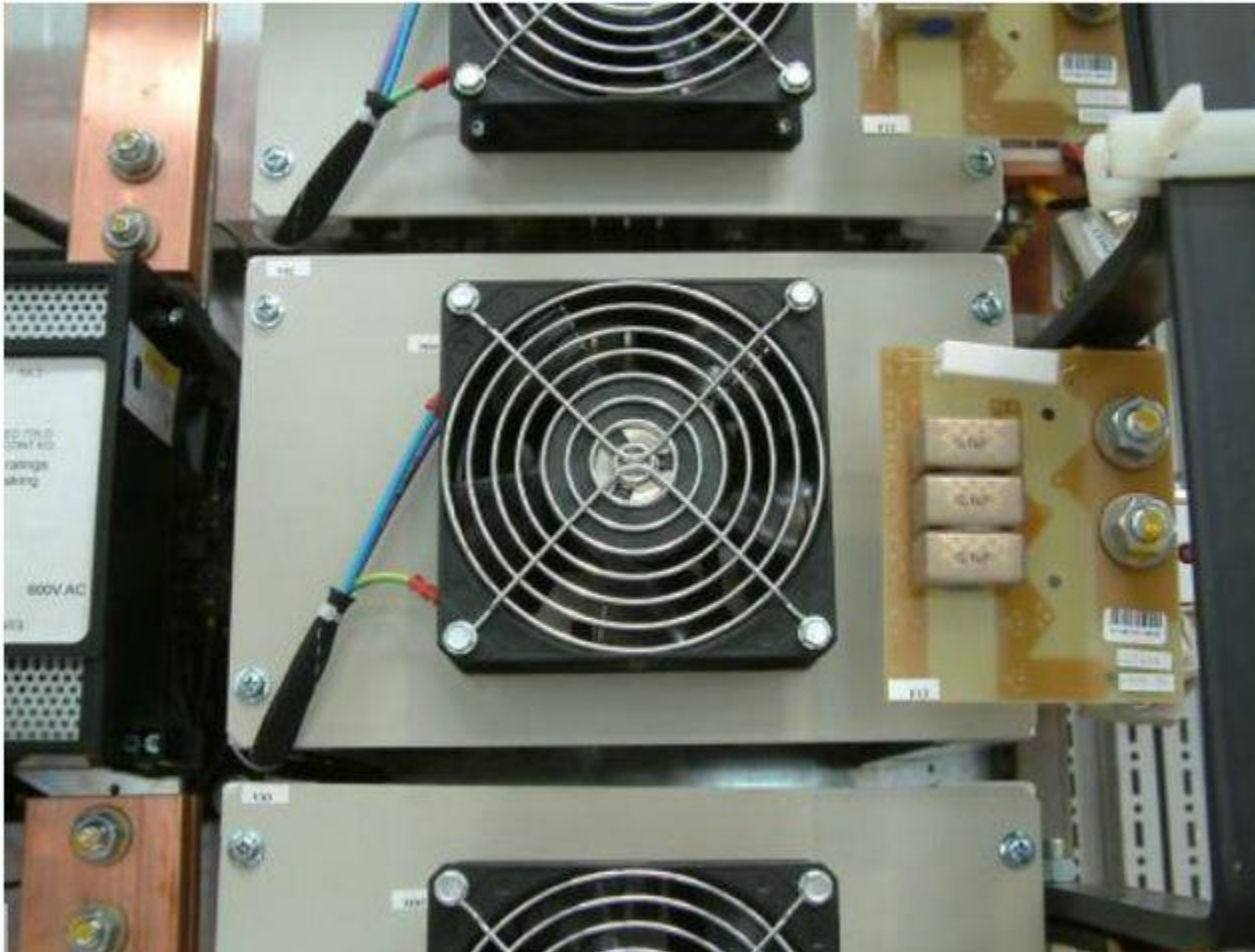
Check the operation of the M3, M4, and M5 cooling fans. If they do not operate, verify that power is making it to the fan and replace the fan if needed. Failure fans will leads to thyristor to get overheated which may lead to thyristor/ fuse failure.

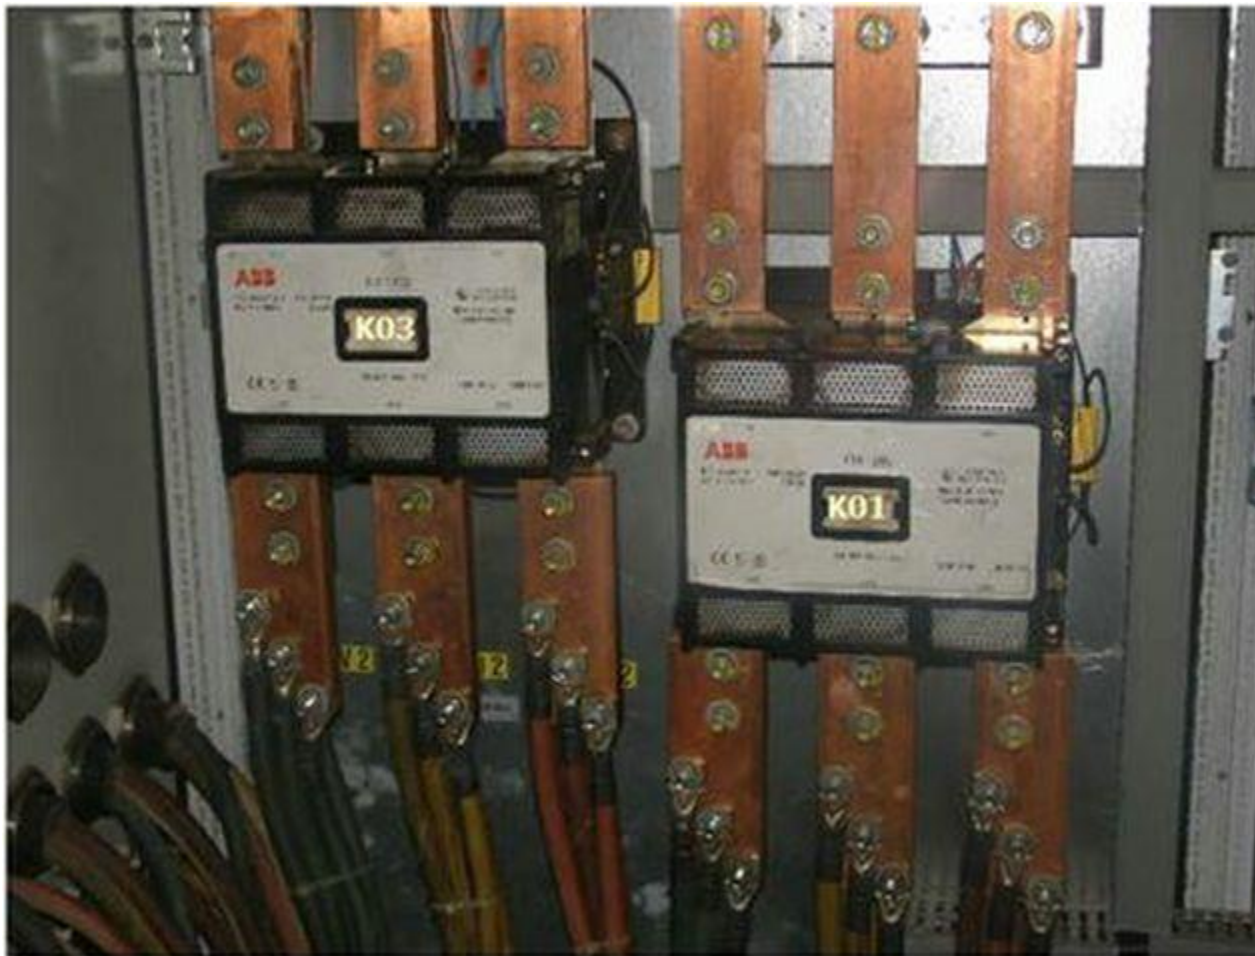
Check all the contactor function K01, K02 & K03.

If defective replace the contactor:

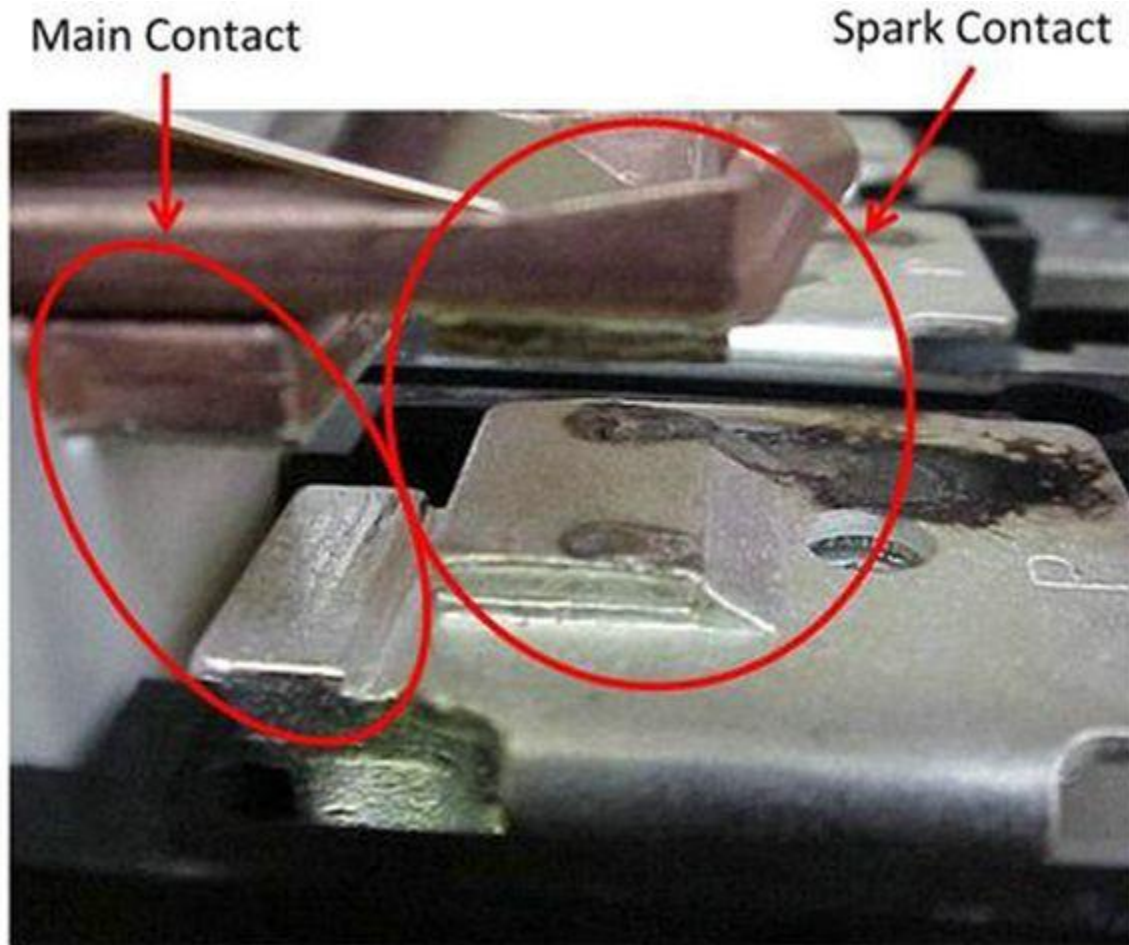
Picture 1.

There is 2 contact set for each phase.

A Main contact and a spark contact (See picture 1 below)

The main contact set must be in a good looking condition. This is where the full load is to be transferred through the contactor.

The Spark contact is designed to handle the unavoidable sparks and arcs that will be developed when opening and closing this amount of energy. (Up to 2-3MW). So burn marks on the spark contact set is not only allowed, it is expected.

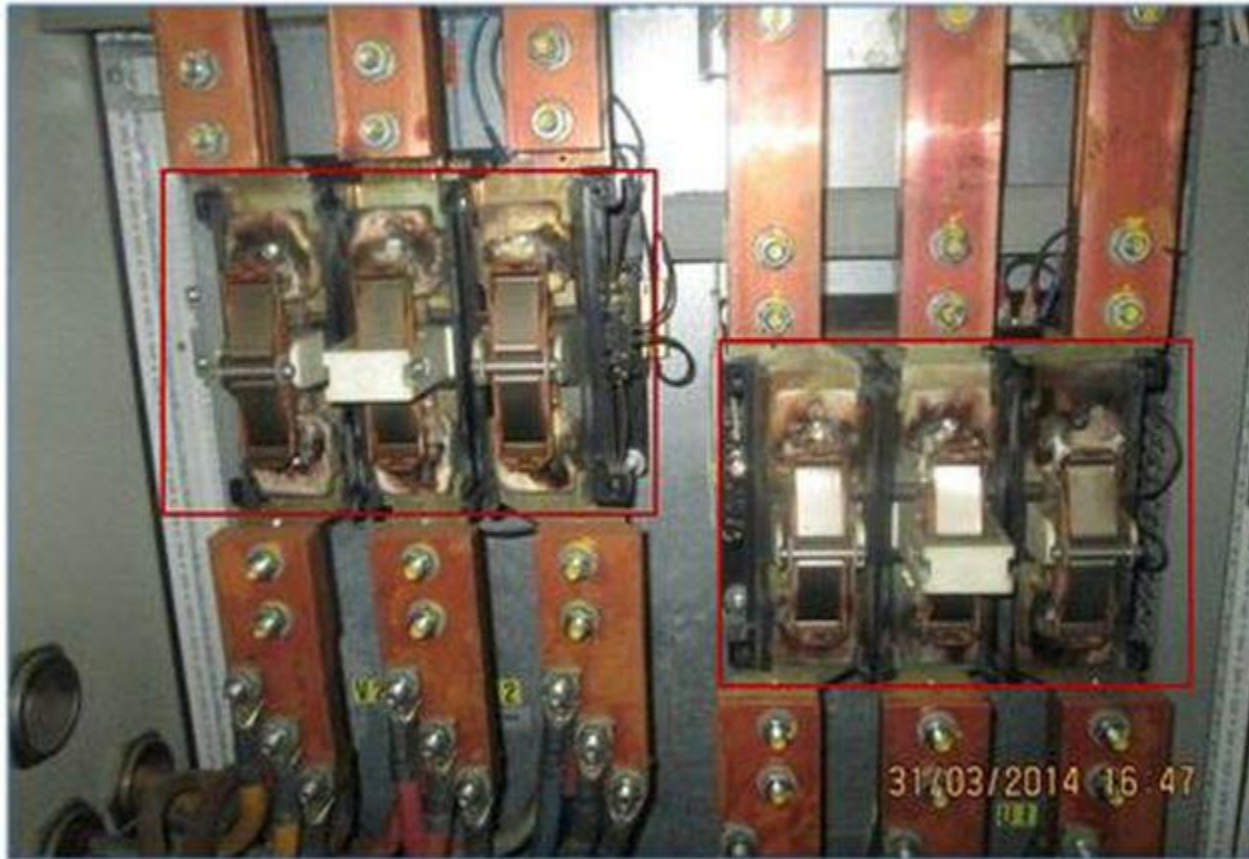
The contactors below show clearly burn marks, but all burn marks that can be seen from this view are placed on the **Spark contact set** where it is supposed to be like this.

Only a closer look from the side of the contactor will show if the **Main contact set** is damaged.

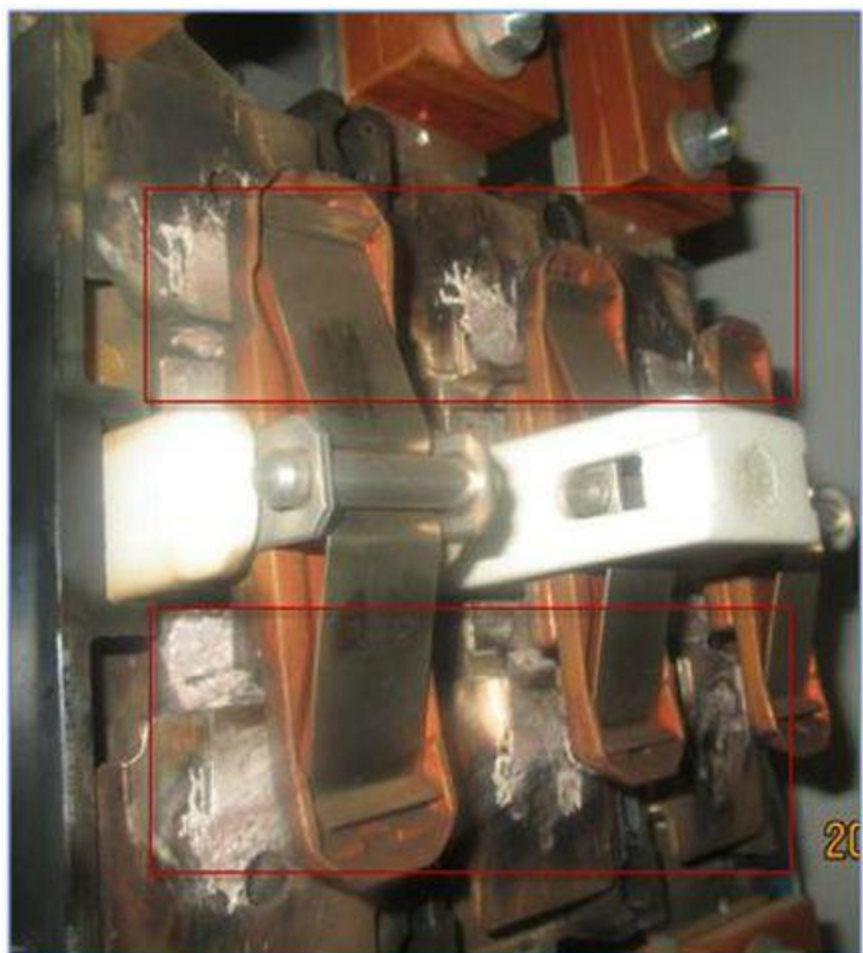
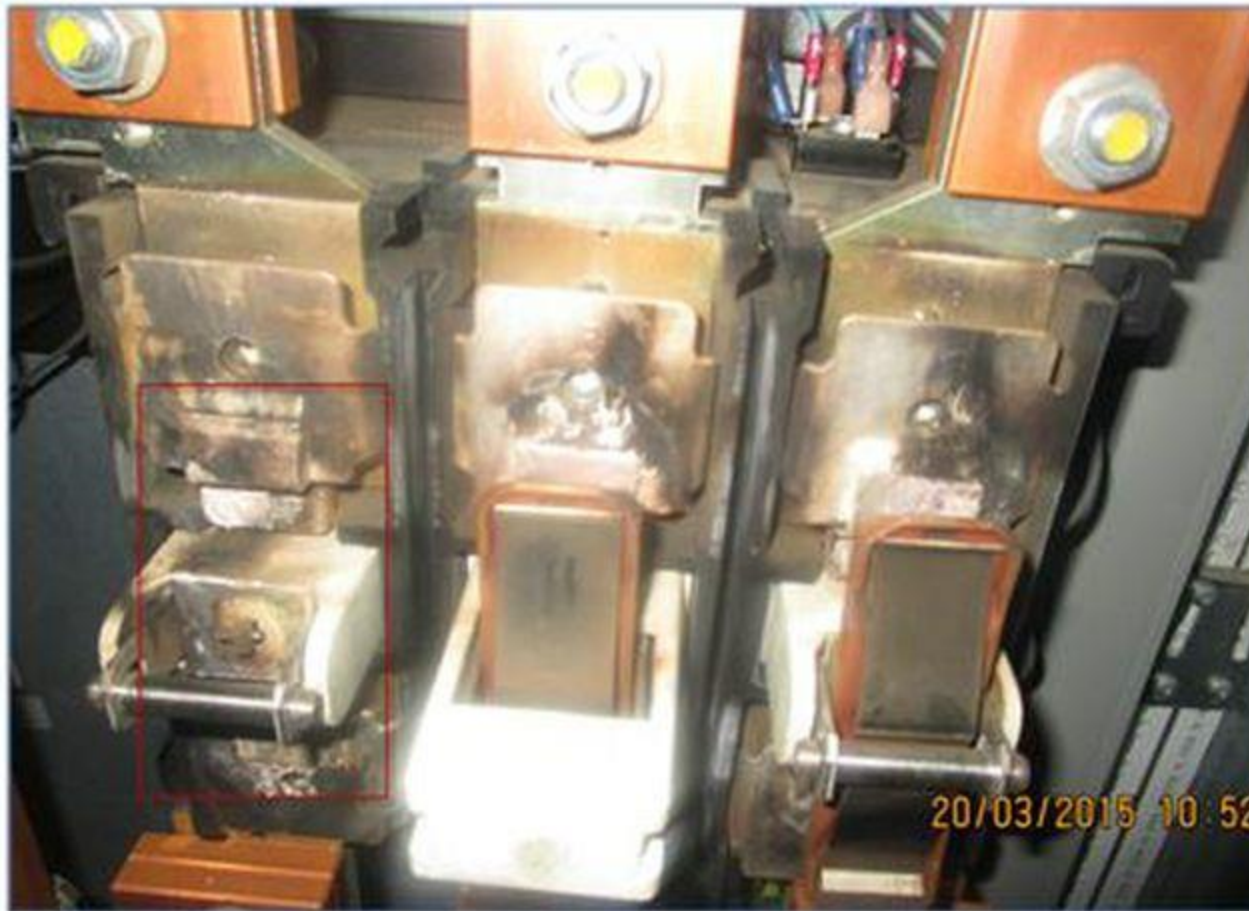
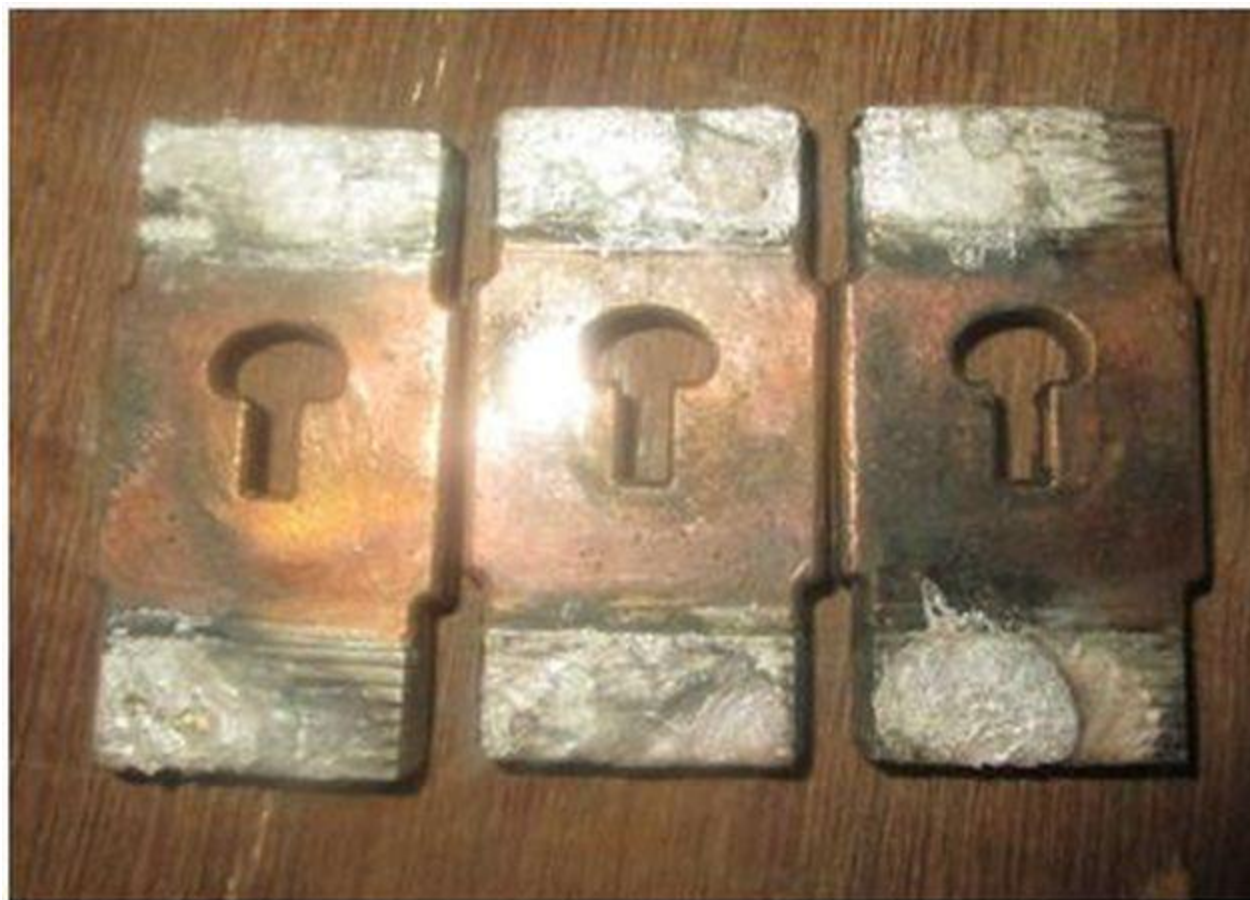
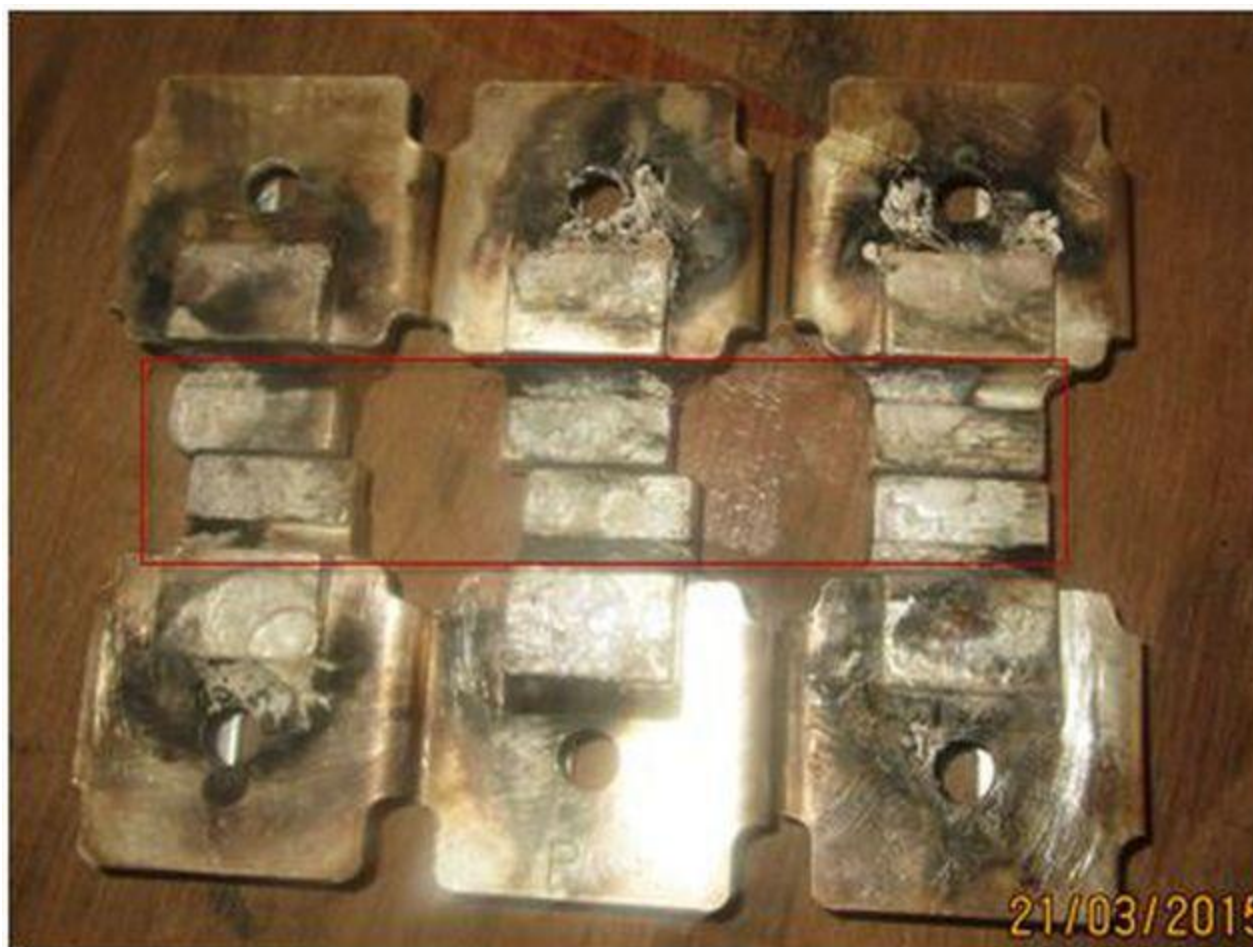
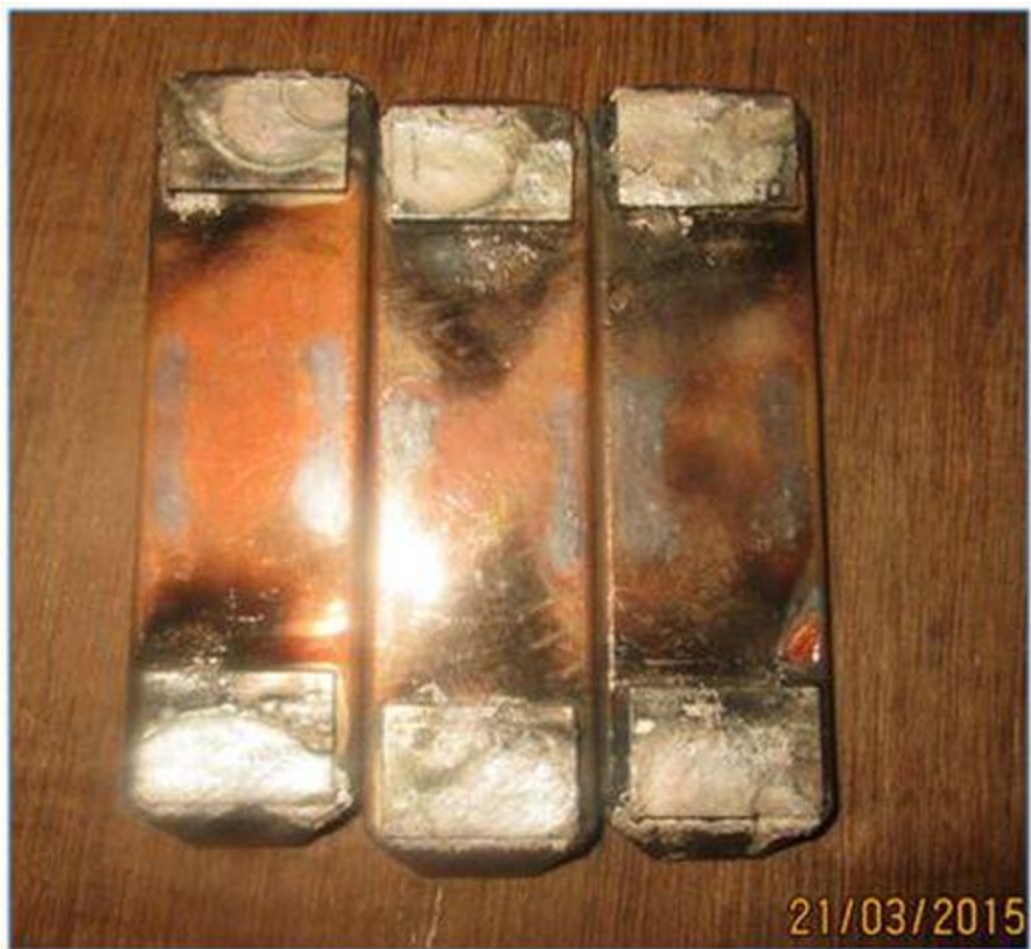
Refer the below pictures for burn damaged spark contact and main contacts:

If the **spark contact set** has suffered a complete melt down or have extreme burn damage making the spark contact fall apart, then a replacement is required.

If the **main contact set** has burn marks making the surface un-even, then a replacement is required.

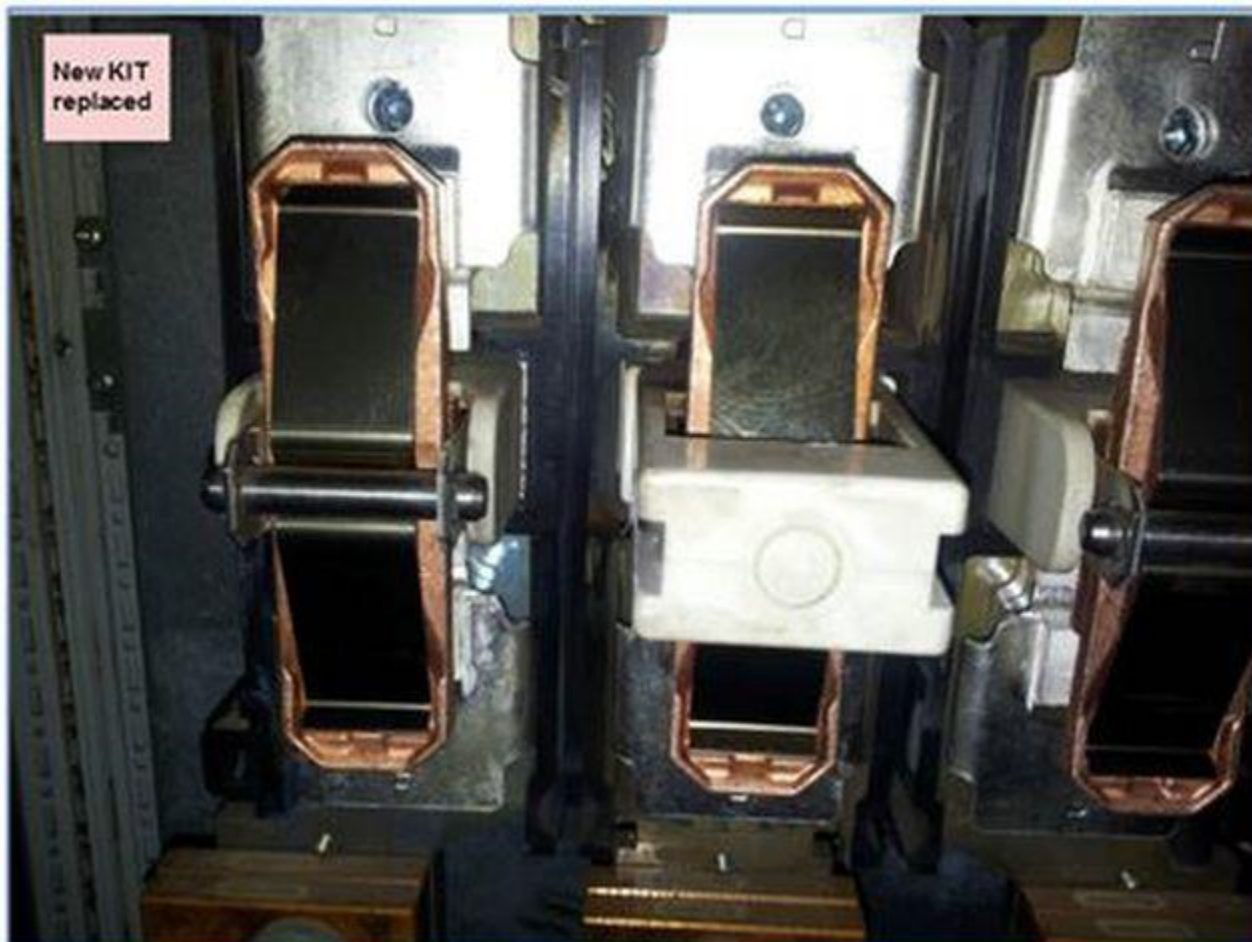
The picture below shows an EK/EH1200 contactor, where a new contact set (repair kit) have been mounted.
