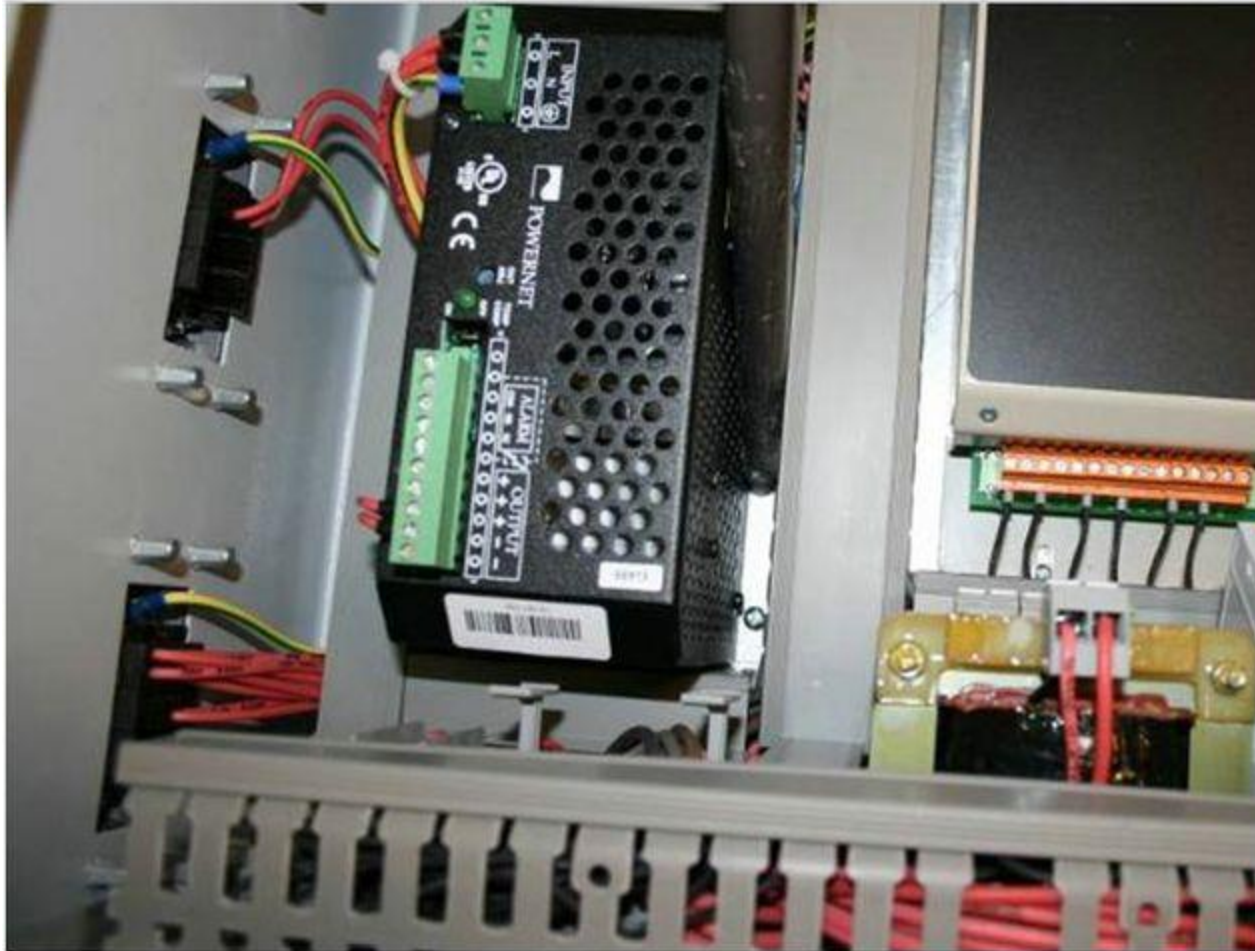
Check for any loose connections at the power net (Pos: G401).

Check input and output voltage 230/115VAC /24VDC

If defective replace the power net.

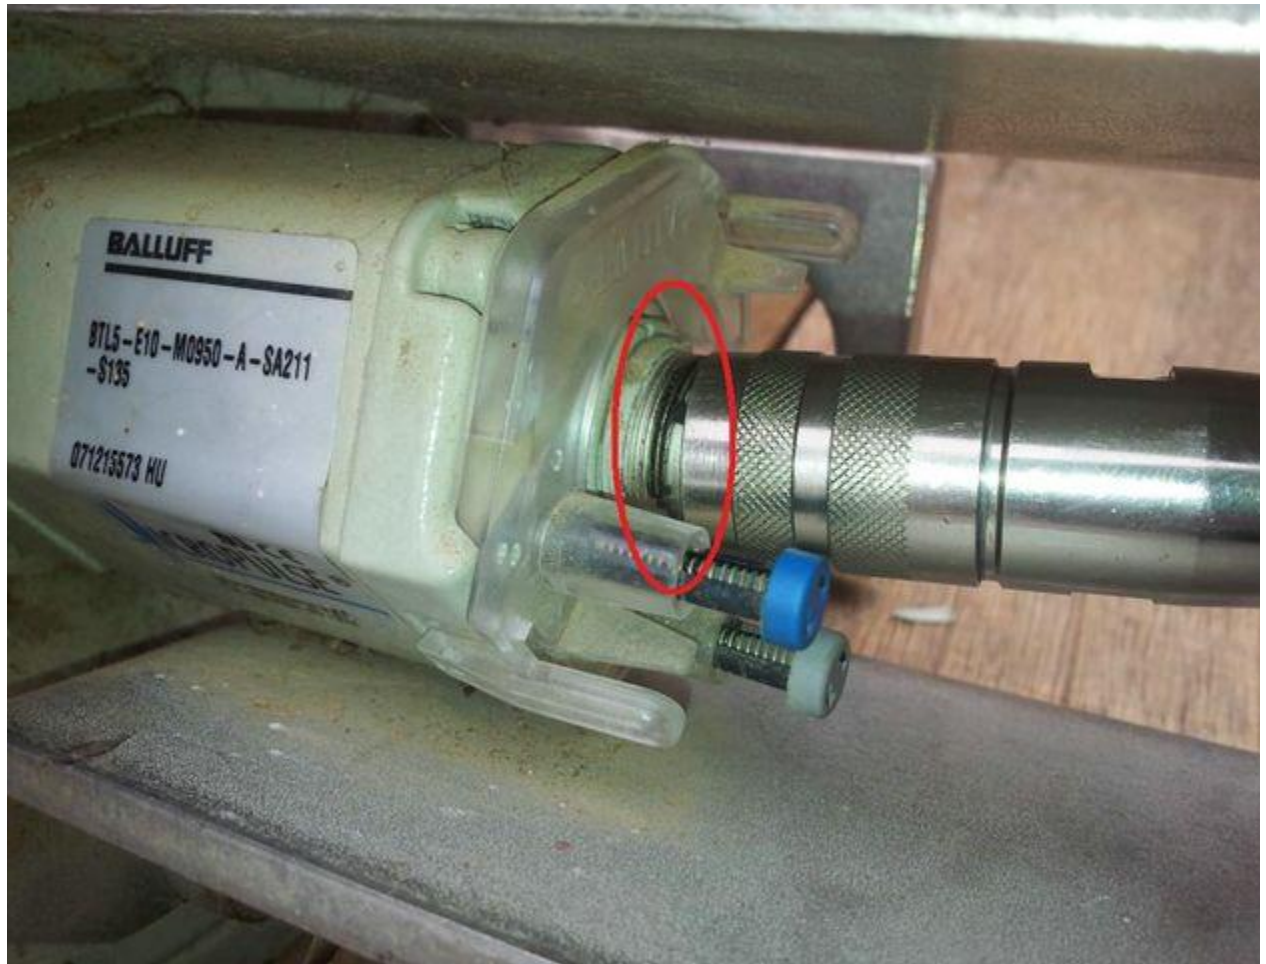
Check for any loose connections in the hub computer terminal X19.

Check for any loose connections on the Blade position sensor.

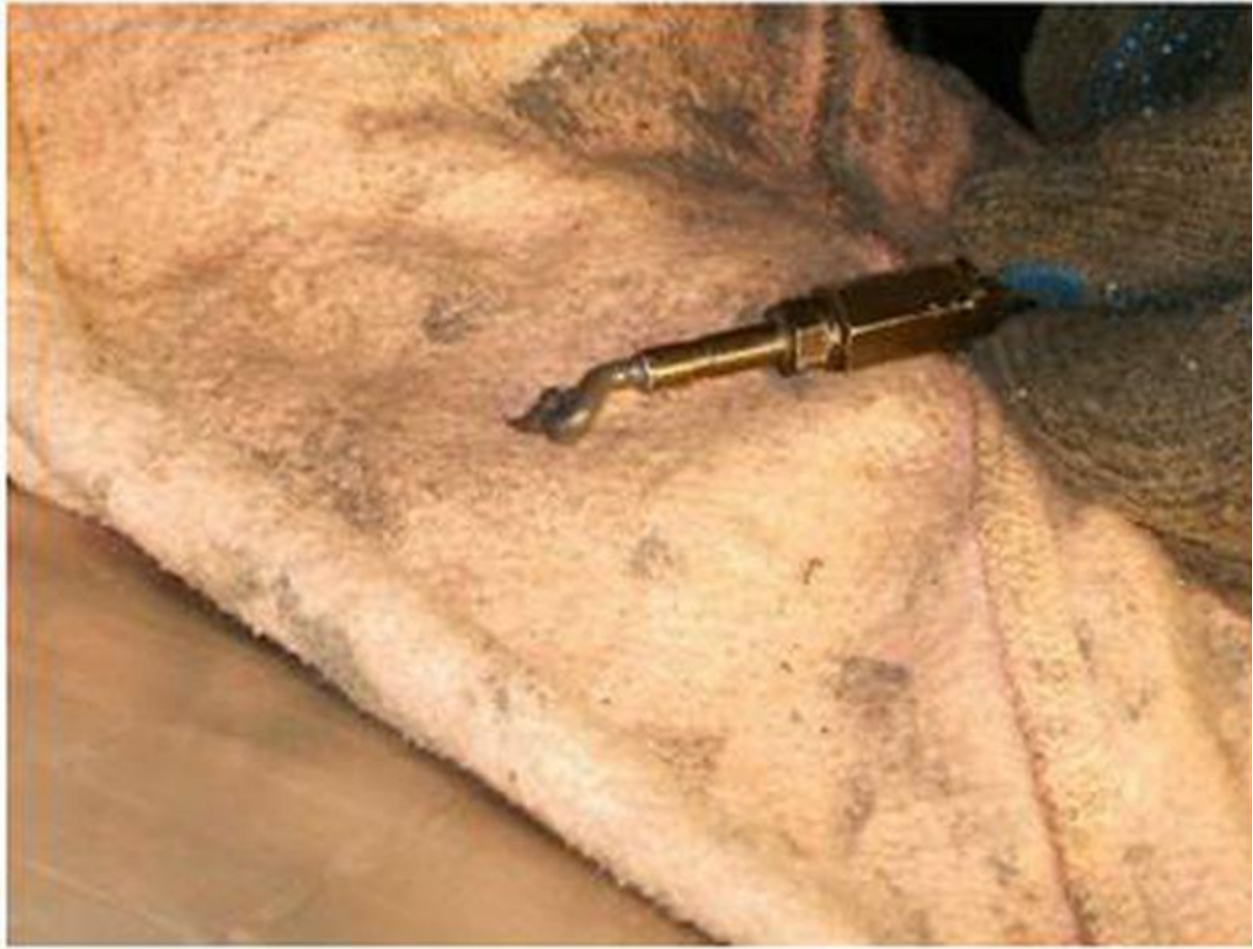
Check that the grease flows from all of the ports:

Inspect for any damaged hose fittings, manifold grease blockage or hose damage.

If necessary replace the manifolds and hoses.

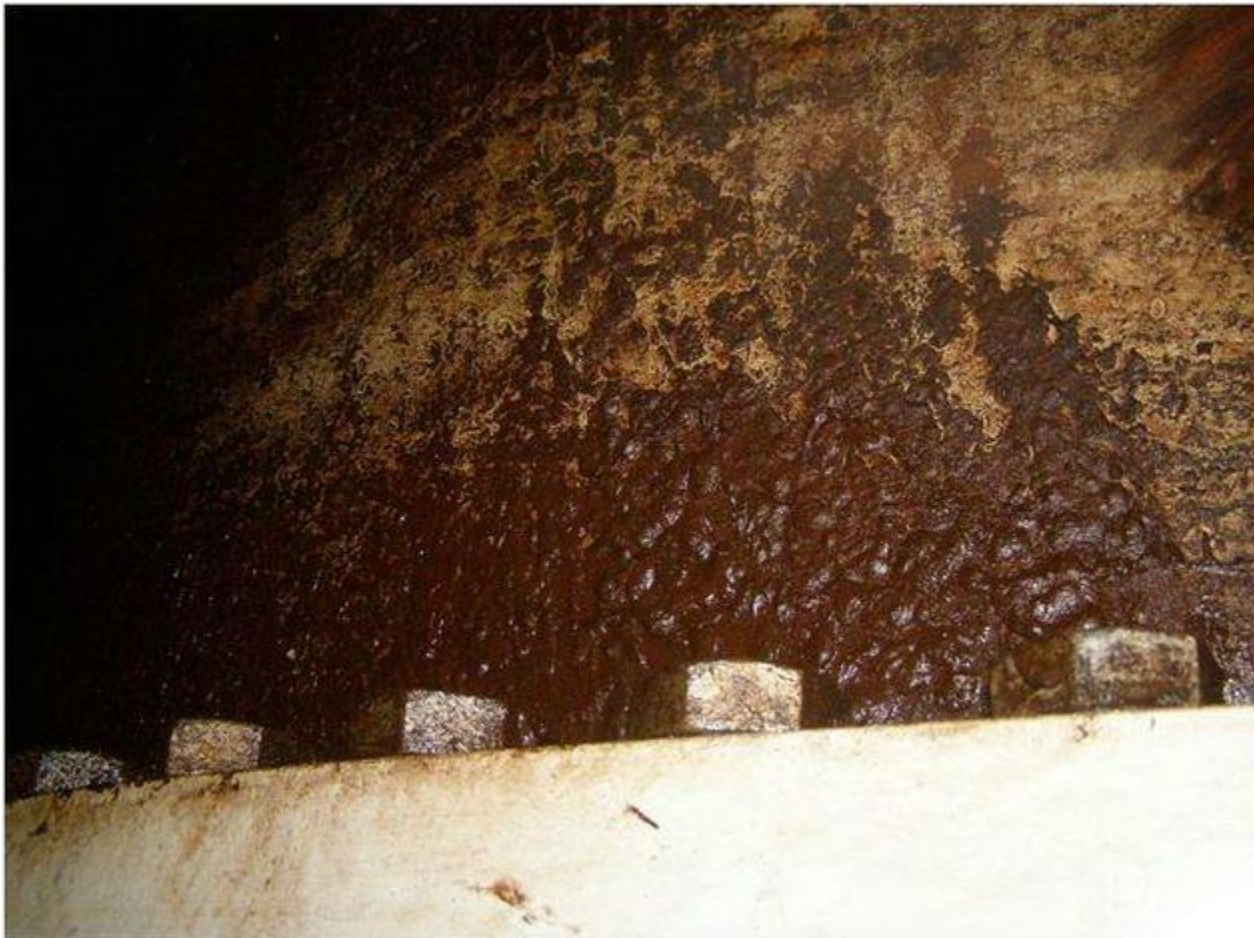
Check blade bearings for any grease leak.

Check the hydraulic system for any leaks, isolate and repair any leaks that are found.

Check for grease or oil stains on the blades and spinner.

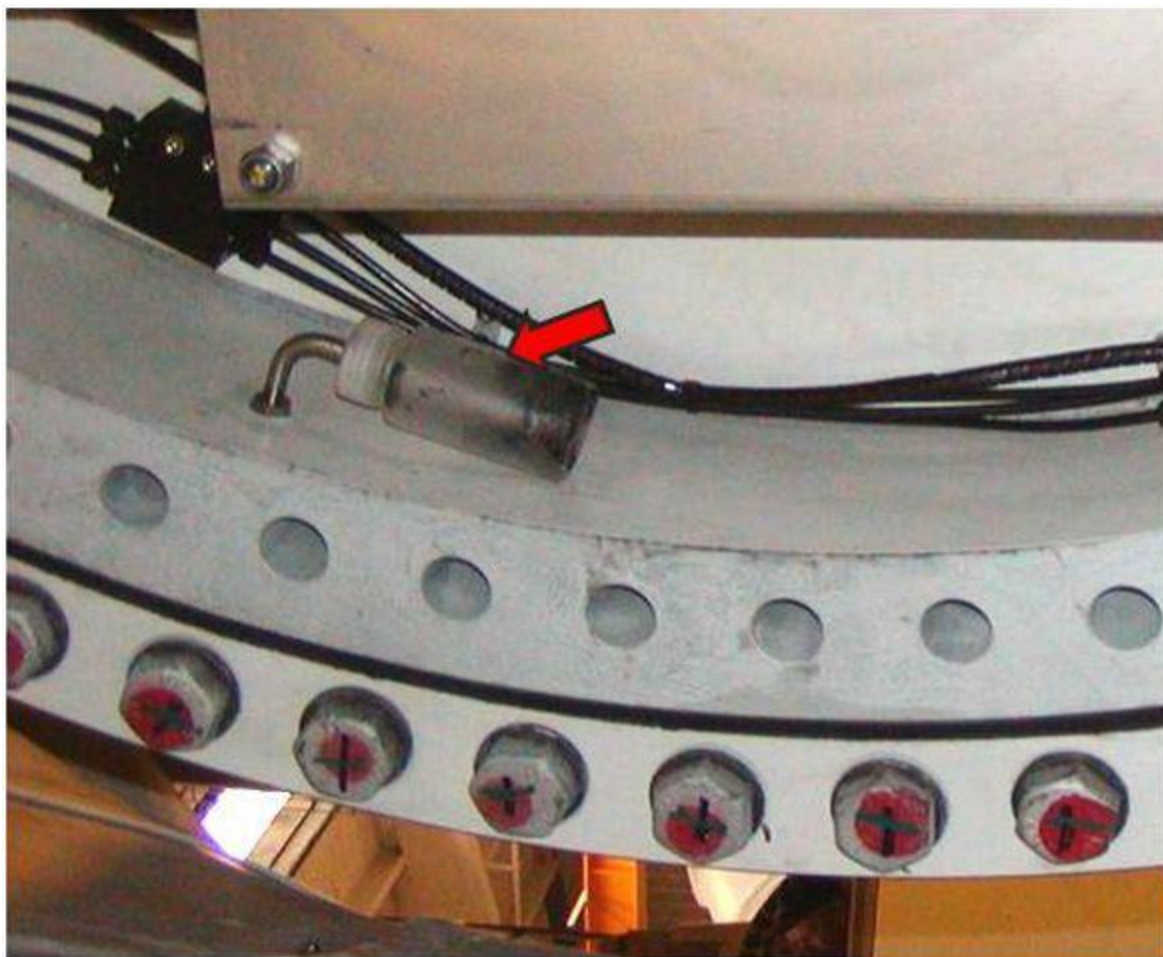
Check the grease collector bottles in all blade roots. If there is a large volume of oil in the hub or evidence that oil has penetrated into the bearing, perform a manual greasing operation on all of the blades.

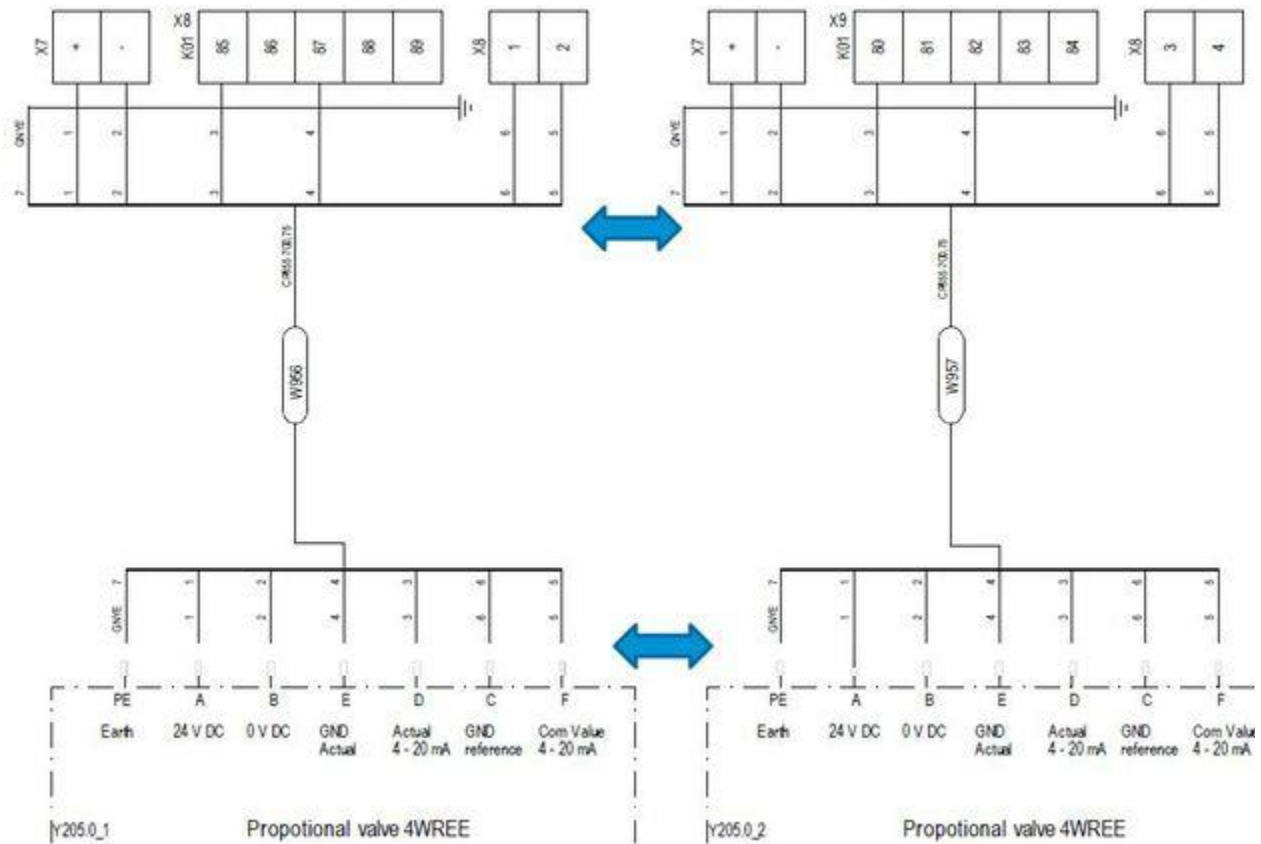
In the example below, we are swapping the plugs between blades A and B.

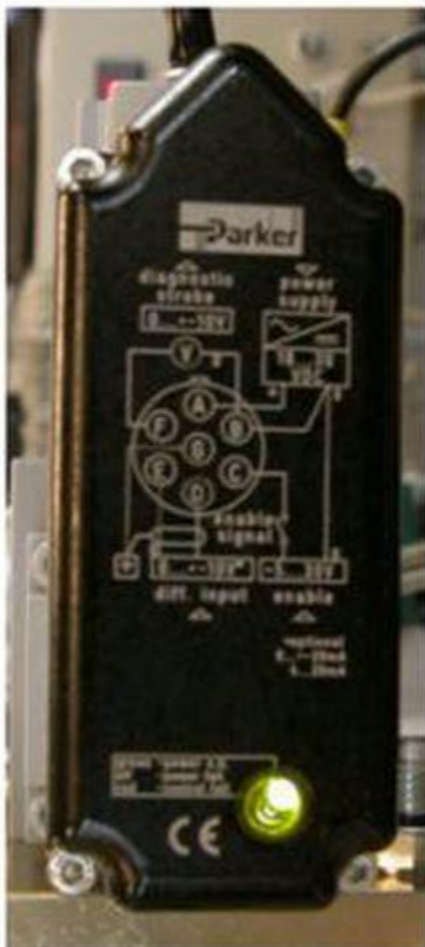
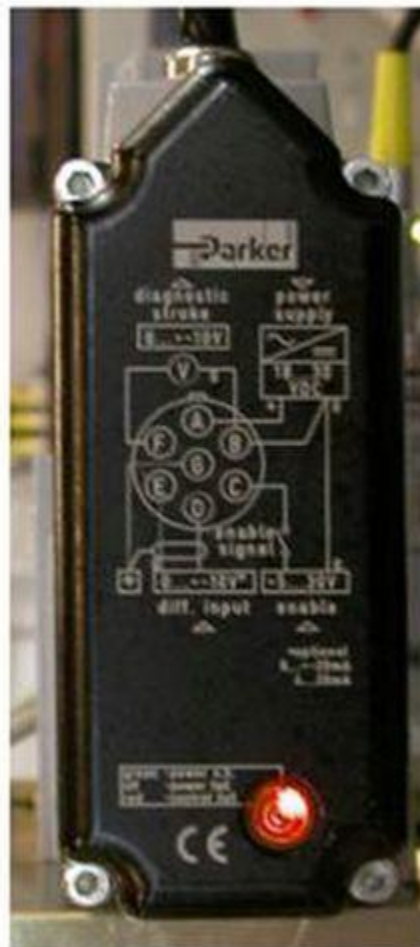
The LED should be green with the pitch system pressurized.

If it is red and there is pressure verified on test port MP, then the valve may also be defective.

Replace proportional valve using **SWI 0016-1690**
