## Replace the defect direction Guard

- **Explanation**  
**IN THE +AN1 CABINET:**

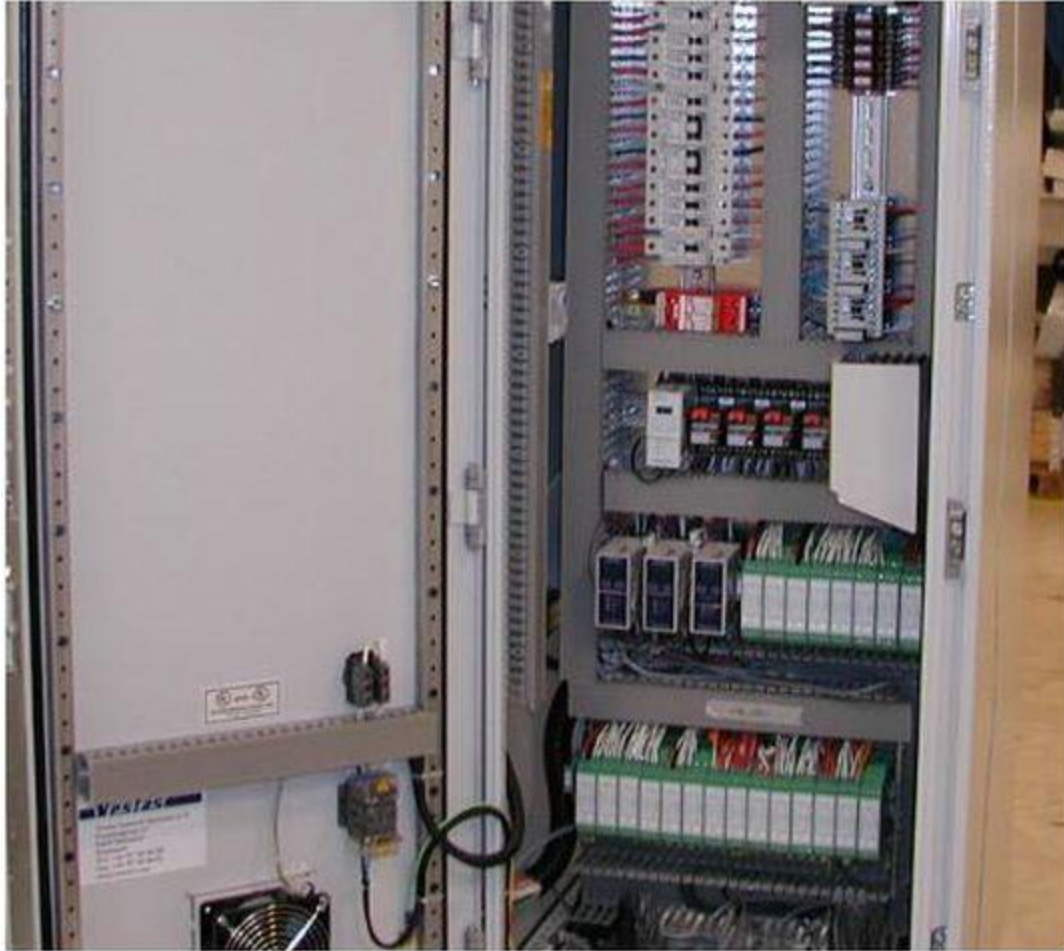
**Part Number for TAC85 :**

51700402 -TAC 85-1 DIRECTION GUARD VWS

Ensure the Settings for TAC 85 Over speed guard

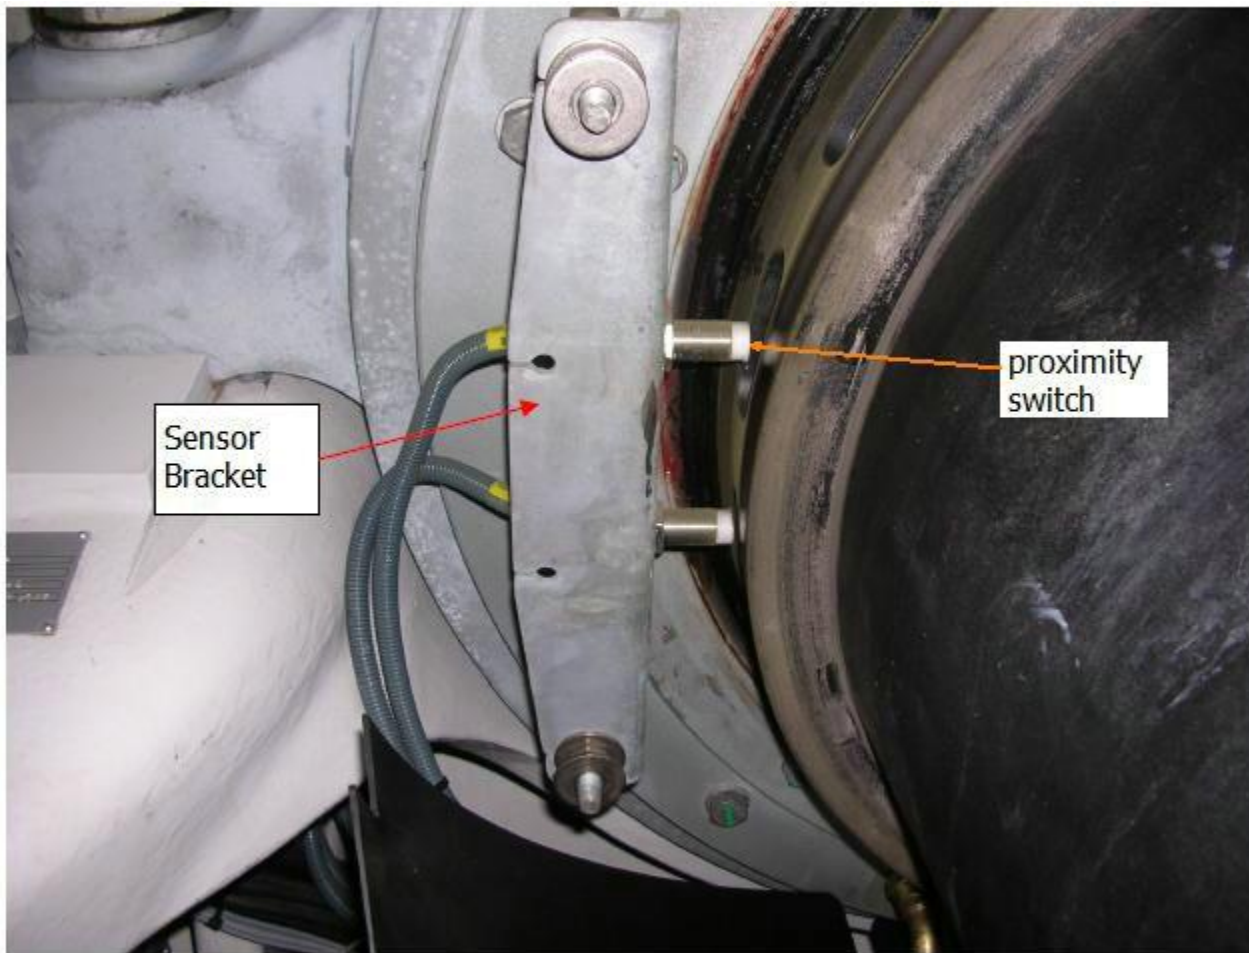
Remove the outer FRP cover from the main bearing housing.

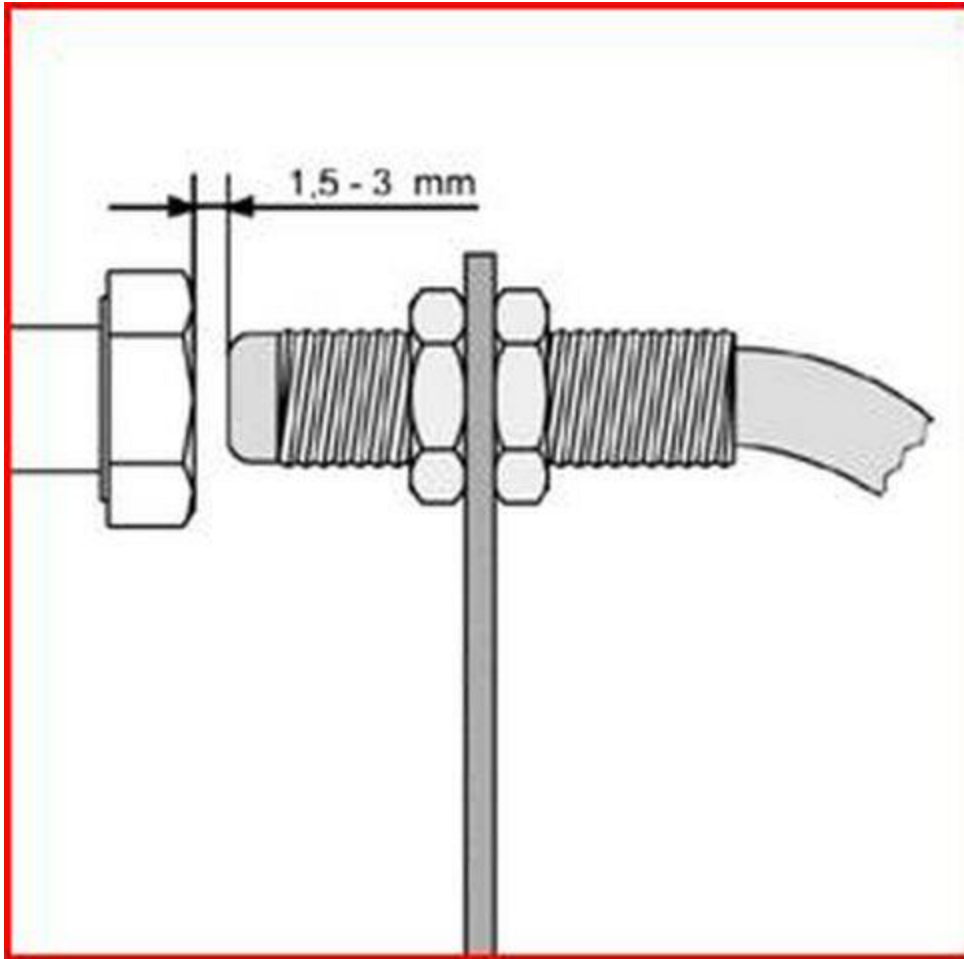
Check that the sensors are secure in the mounting bracket and are adjusted correctly,

Using a screwdriver, pass the metal portion past the inductive sensors. The sensors should light up at the moment the screwdriver is passed over them.

If they do not, ensure that the sensors are free of dirt and oil/grease. Retry passing the screwdriver over the sensors at varying distances.

If only one of the sensors emits a light, the other is likely faulty or has a faulty cable.

Adjust the distance between the Inductive sensor and the scanning points as per Instalation & Service Data DMS : [5003033](#)

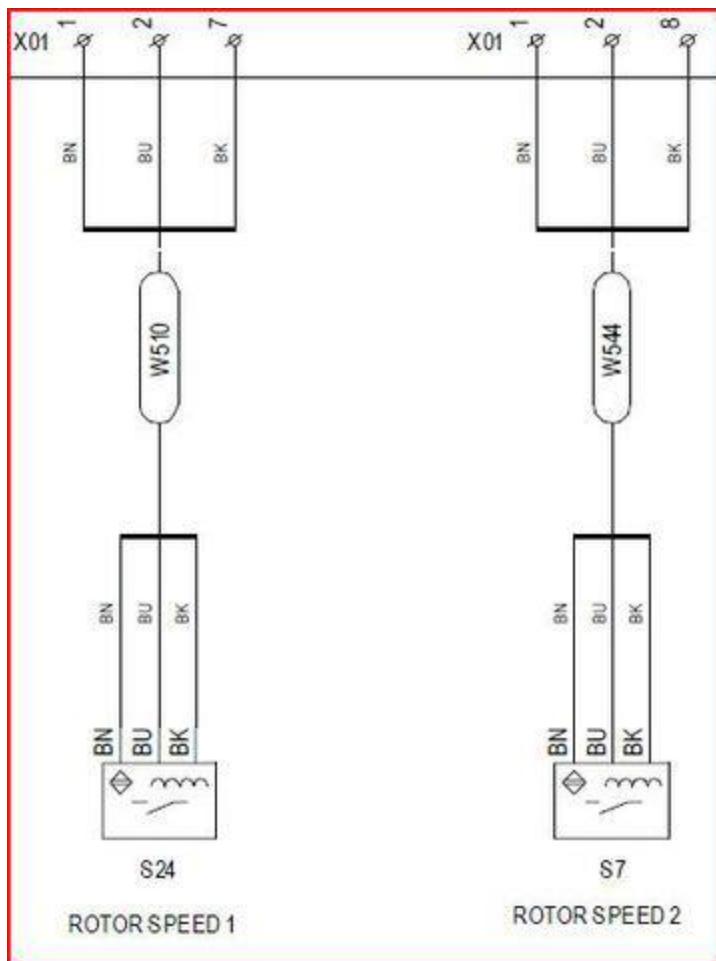
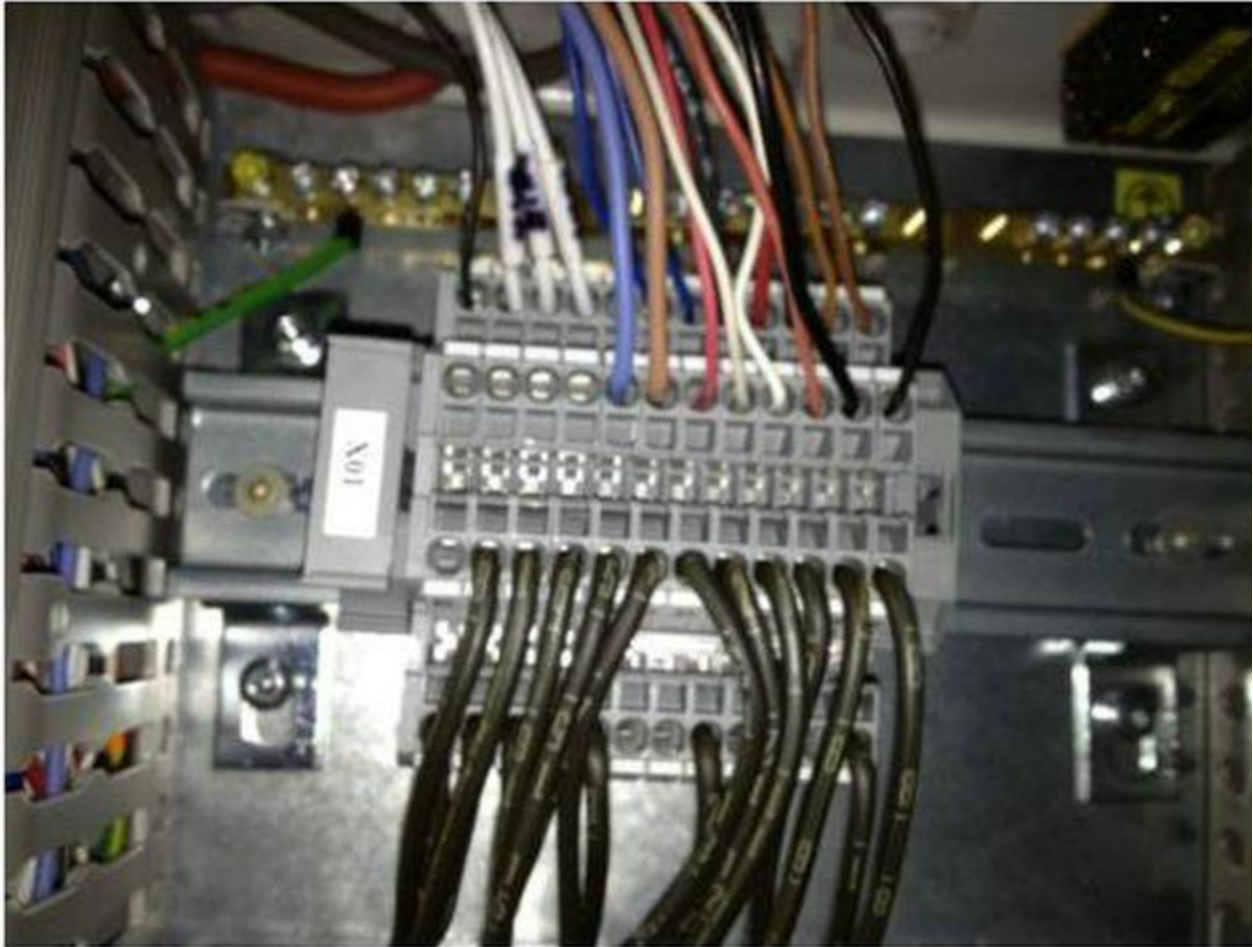
**IN THE +AN11 CABINET:**

Check the sensor wiring connections
