### Troubleshoot/replace cable

### **Repair spinning race IAW 1312 repair 1**

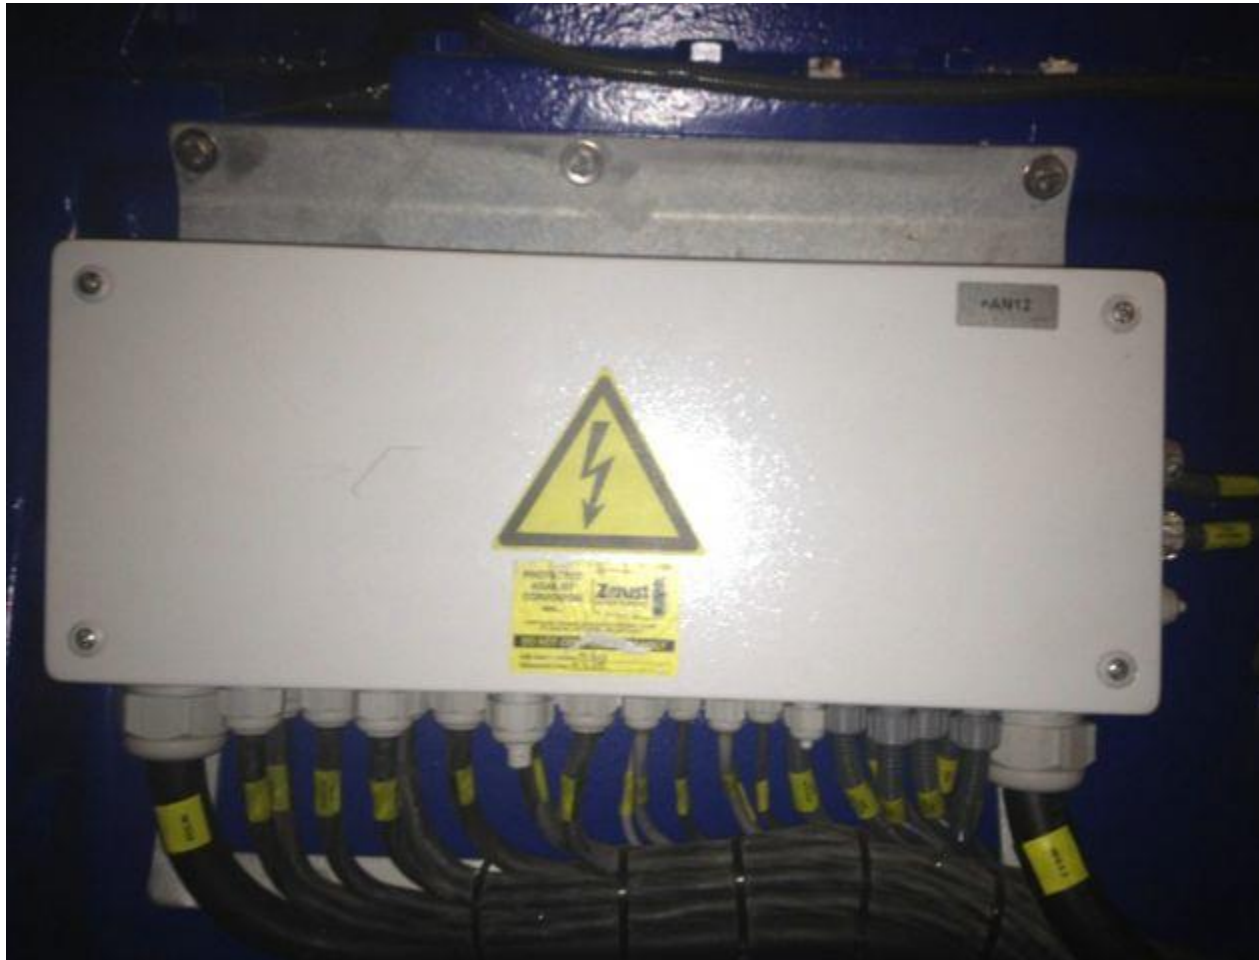
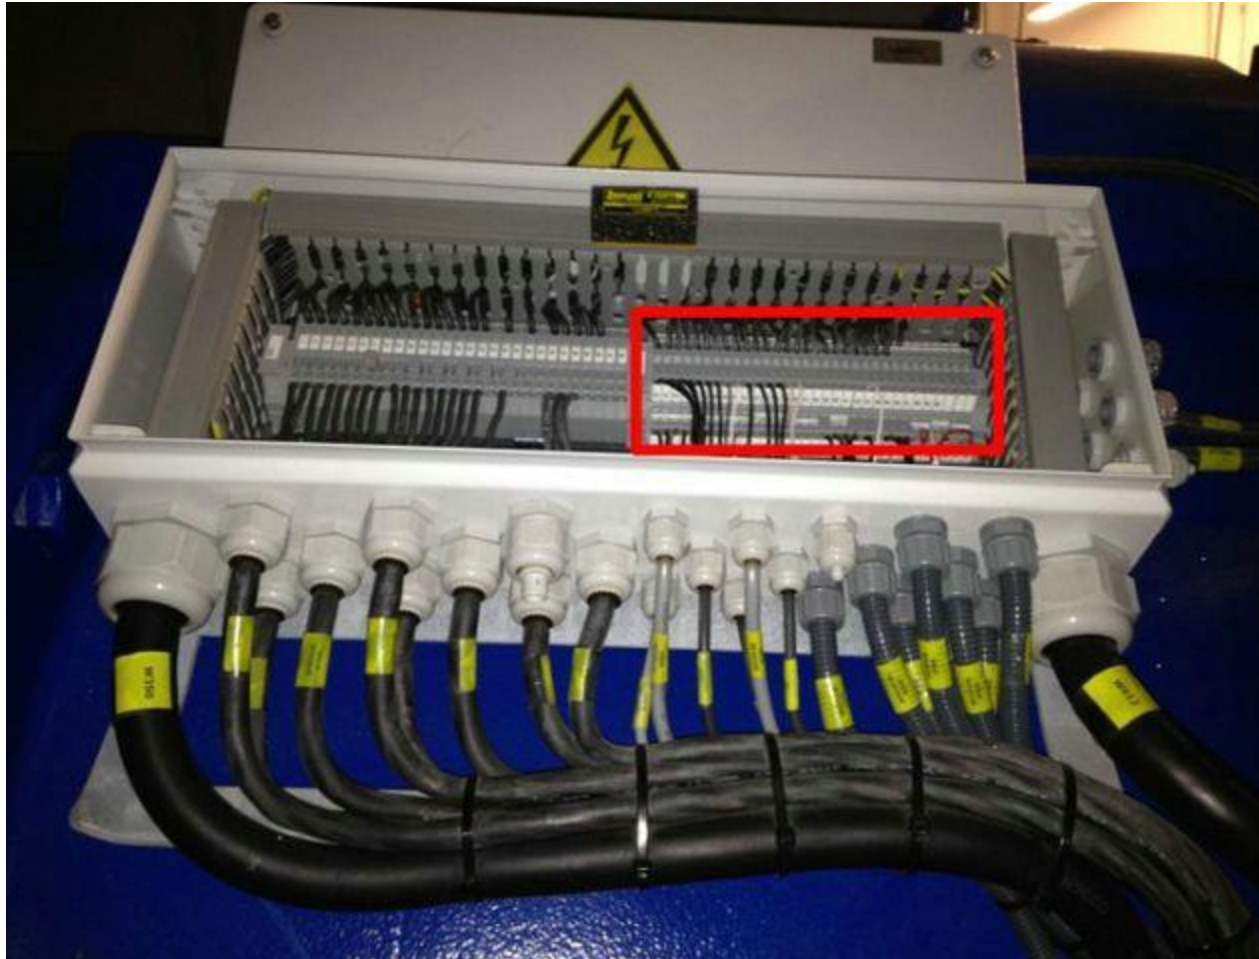
AN12:

Remove the cover from the PT100 housing. Check for loose wire connections or corrosion in the PT100 and in the AN12 (X02 terminals 23 & 24), remove any corrosion and note any loose connections in the PT100 and/or AN12.

Disconnect the wires from the PT100 and from the AN12 junction box on the side of the gear. Connect one end of the wires together and connect the other ends to a multimeter set to measure Ohms. The value should be very low in the milliohm range. If the value is in the ohm, meg ohm range or infinite, there is an open conductor in the cable. If the value is zero or very low in the milliohm range, flex the cable in several places to ensure that the value does not show an open conductor. Replace the cable if found to be defective. **Item no. 60103088- Cable -W521 NM30t. Module 2x1**

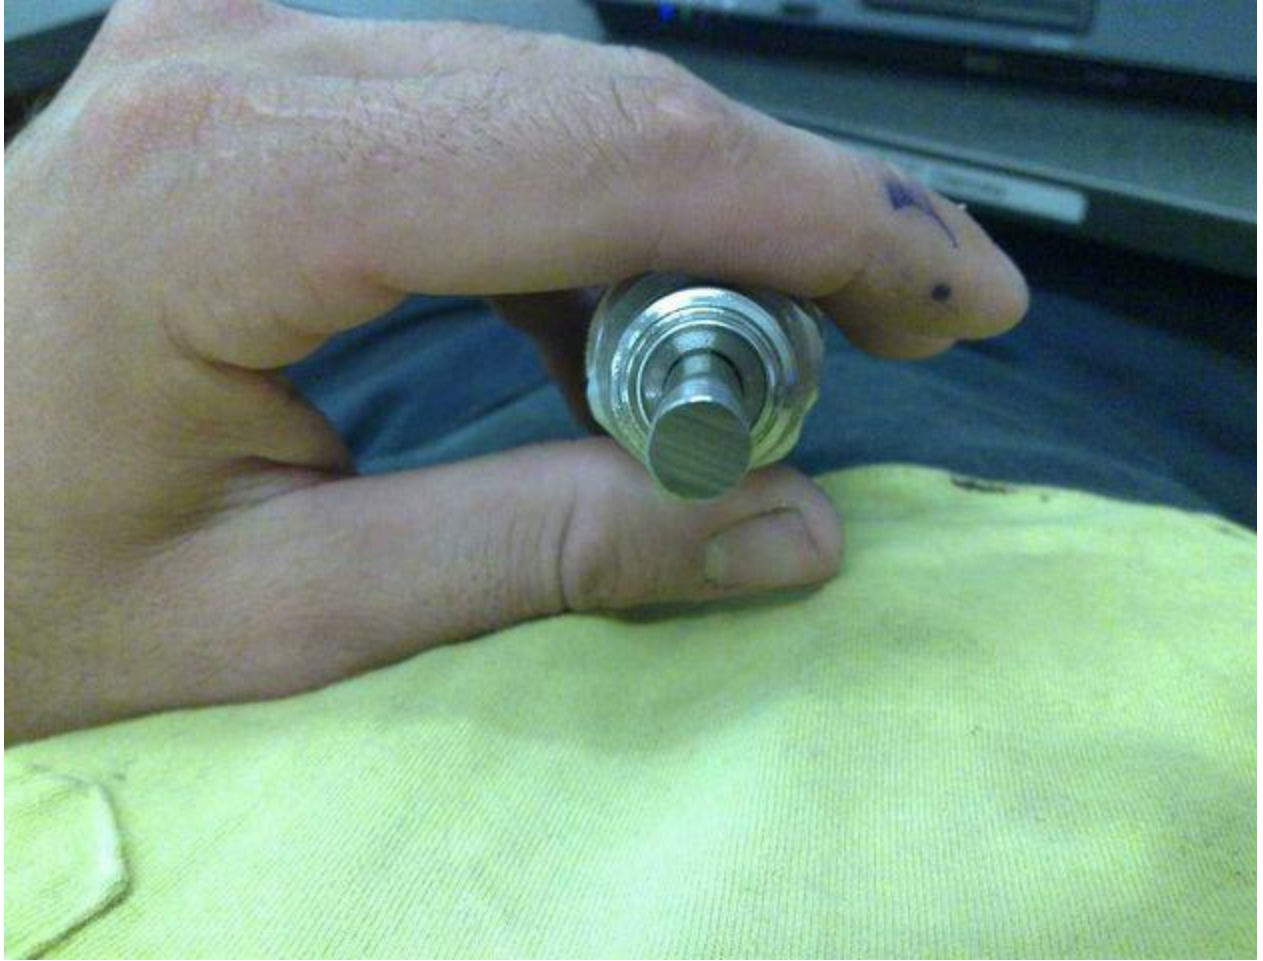
If alarm 870 – Pt100 fault gear bear. Rear is active or recent in the alarm log, and the turbine has a Hansen gearbox- it is most likely a spinning bearing race causing the fault.

Inspect the tip of the PT100 temperature probe for signs of wear. If there is wear on the tip of the probe the outer race of the bearing has or is spinning in the bearing bore of the housing.

Wear on PT100:

If the PT100 was replaced at the time of the repair, and it is showing signs of wear, the race has begun spinning again and the repair must be completed a second time.

Follow the detailed instructions in document - [DMS 0001-4318](#) **Securing Hansen 803-A and 803-C HSS Bearing Outer Races, NM72-1650, NM82-1500, NM82-1650, V82-1.65 MW** to proceed with repair solution 1. HTI trained Vestas Technicians will be required to complete the repair.

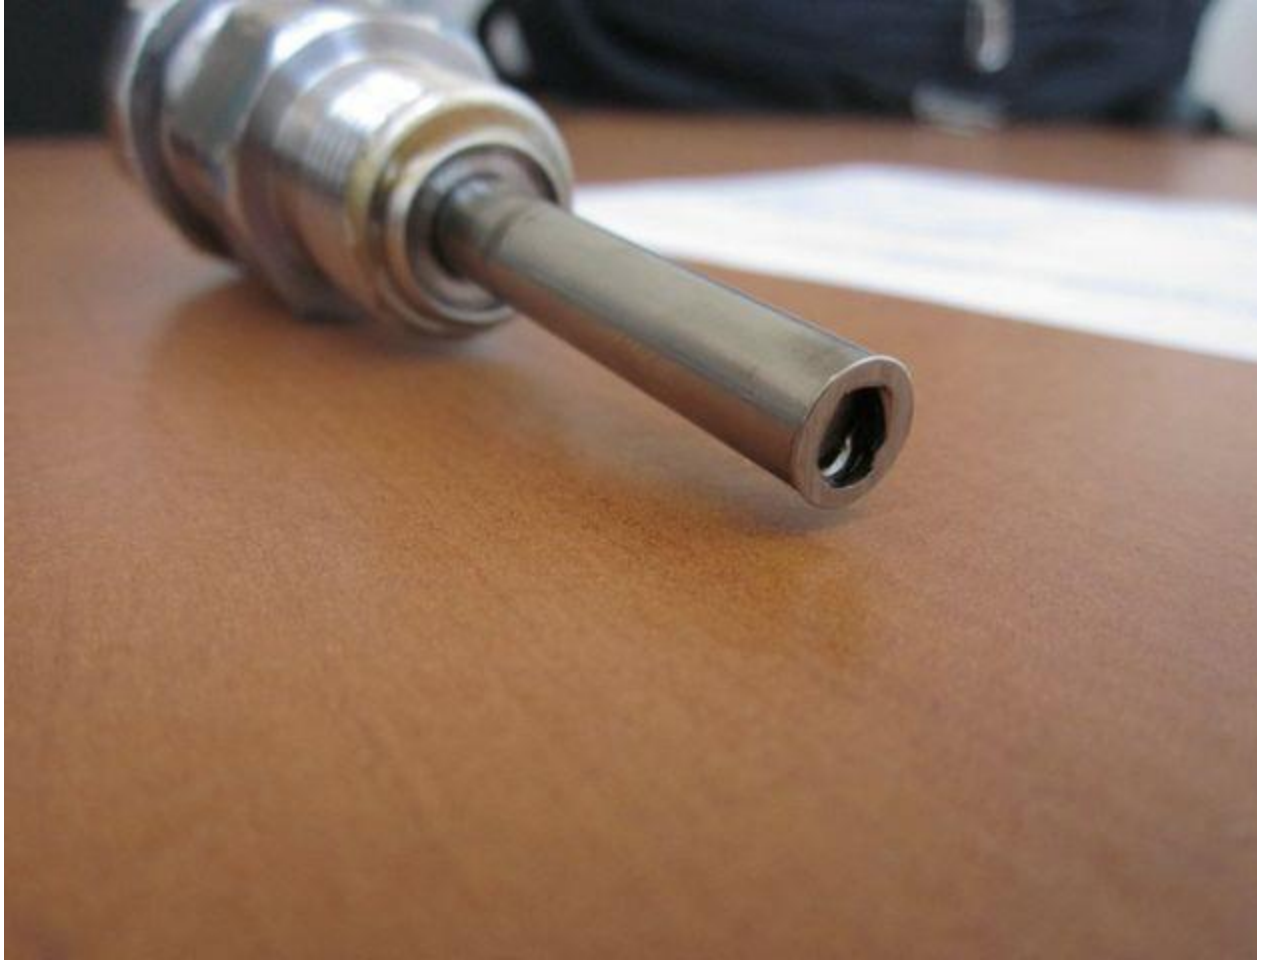
Wear on the PT100 (2):

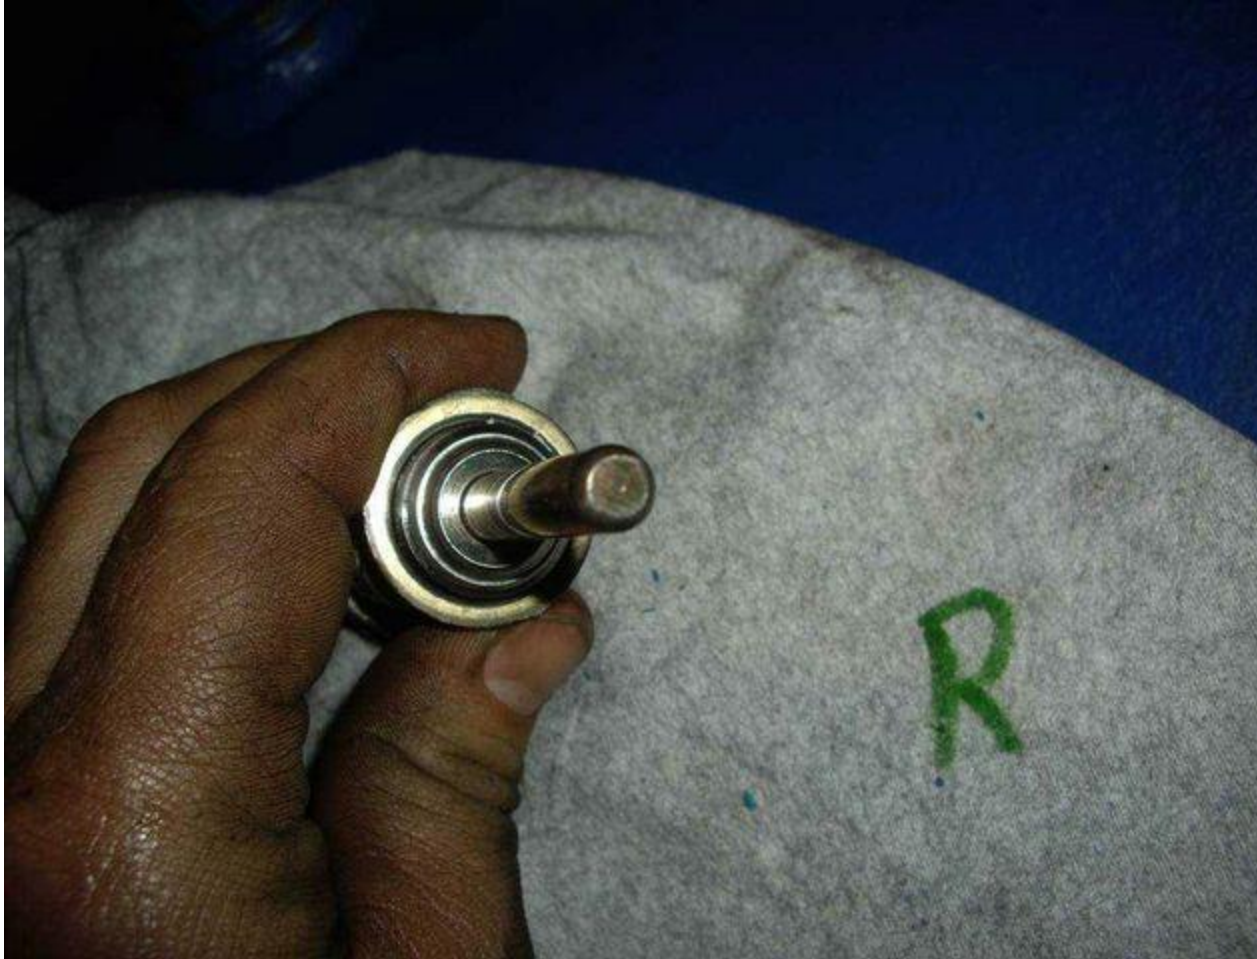
Undamaged PT100:
