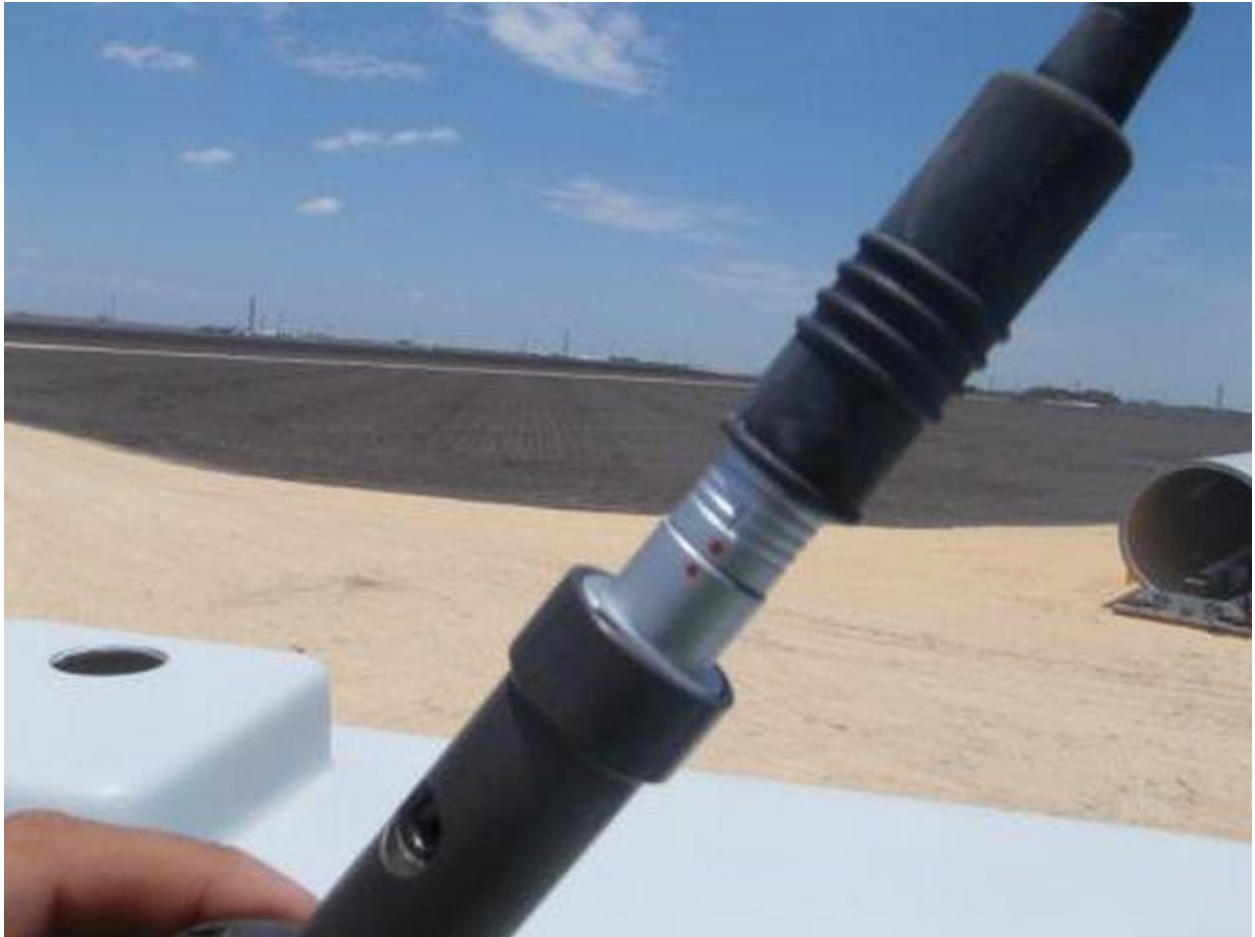
Cable plug and protective boot:

The connector can easily be mounted incorrectly.

If the cable is mounted tight and it pulls in the sensor connector, it must be connected so that it is not pulling the plug.

Disconnect and connect sensor plug.

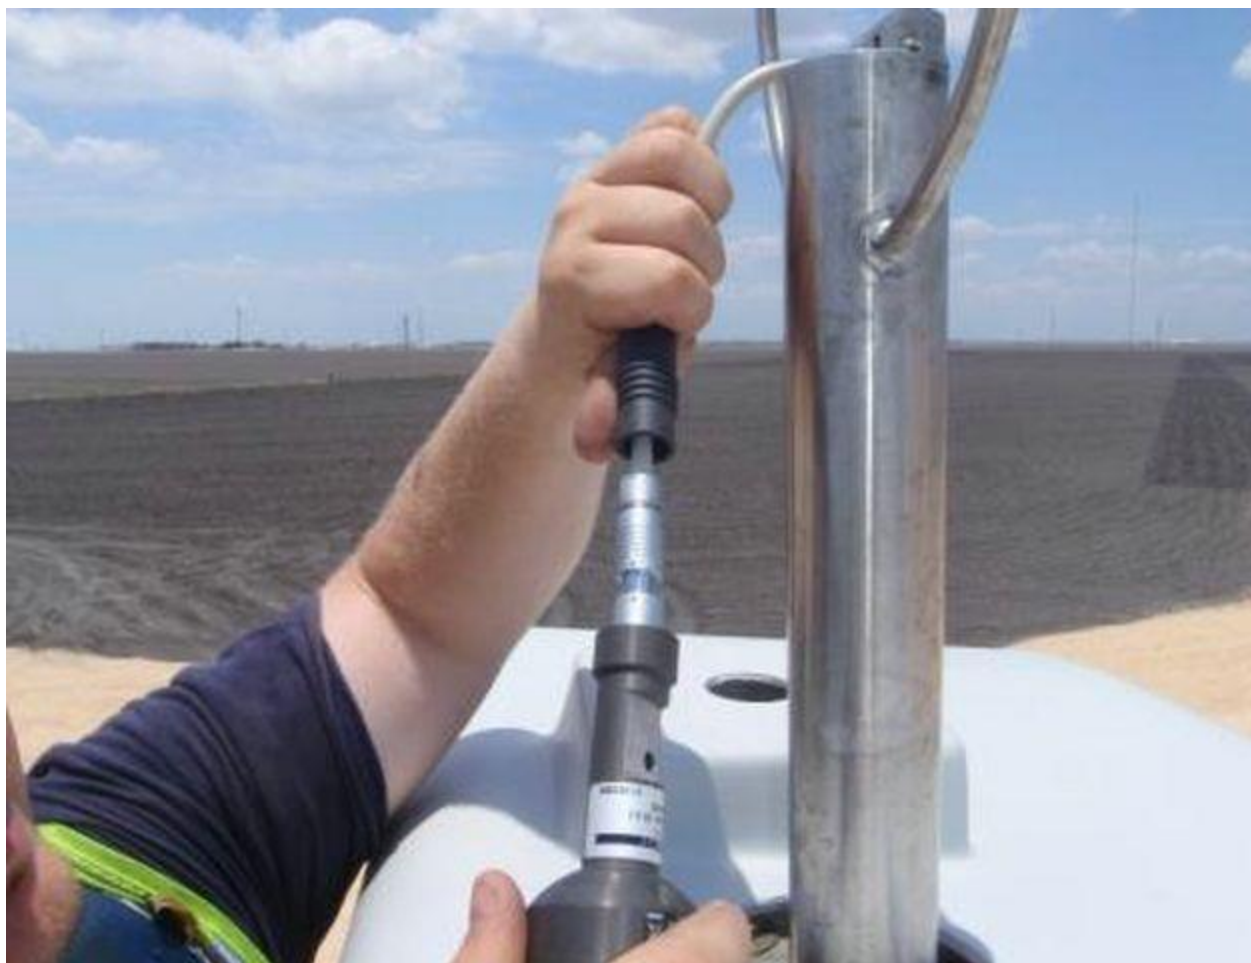
Check the sensor connection for signs of moisture and corrosion or damage:

If the cable or plug has been damaged or shows signs of corrosion that cannot be repaired, replace the respective cable with a new one; item numbers:(CABLE for FT702/LT 9m)

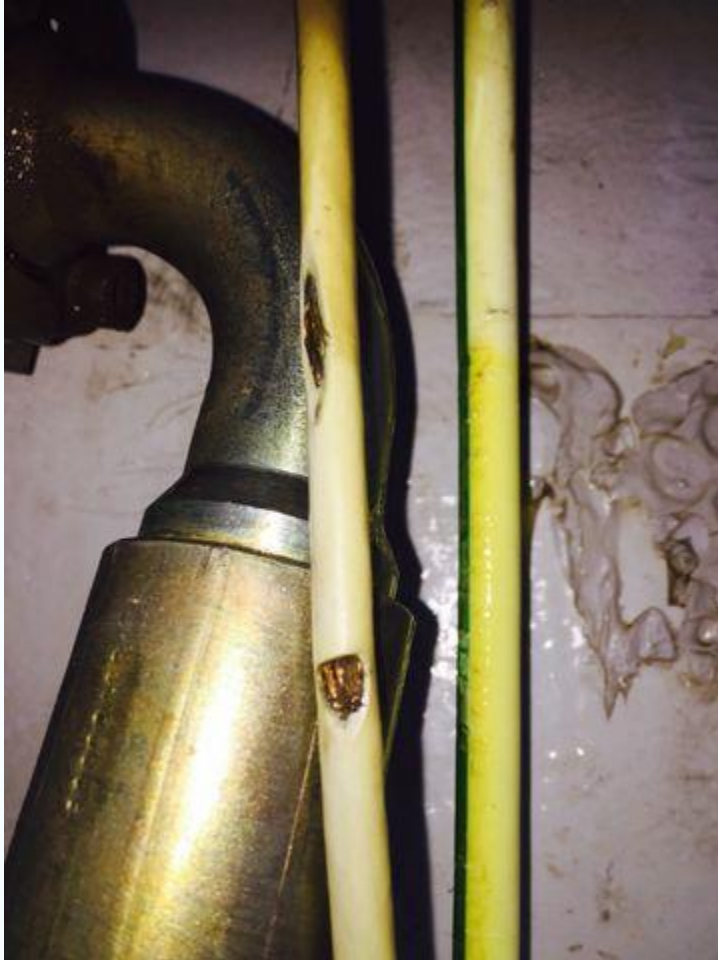
Check the routing of the sensor cables (W583, W584), due to friction with the cooler fittings it can be damaged and in wet or rainy conditions the thermal will trip due to an internal short circuit in the cable:

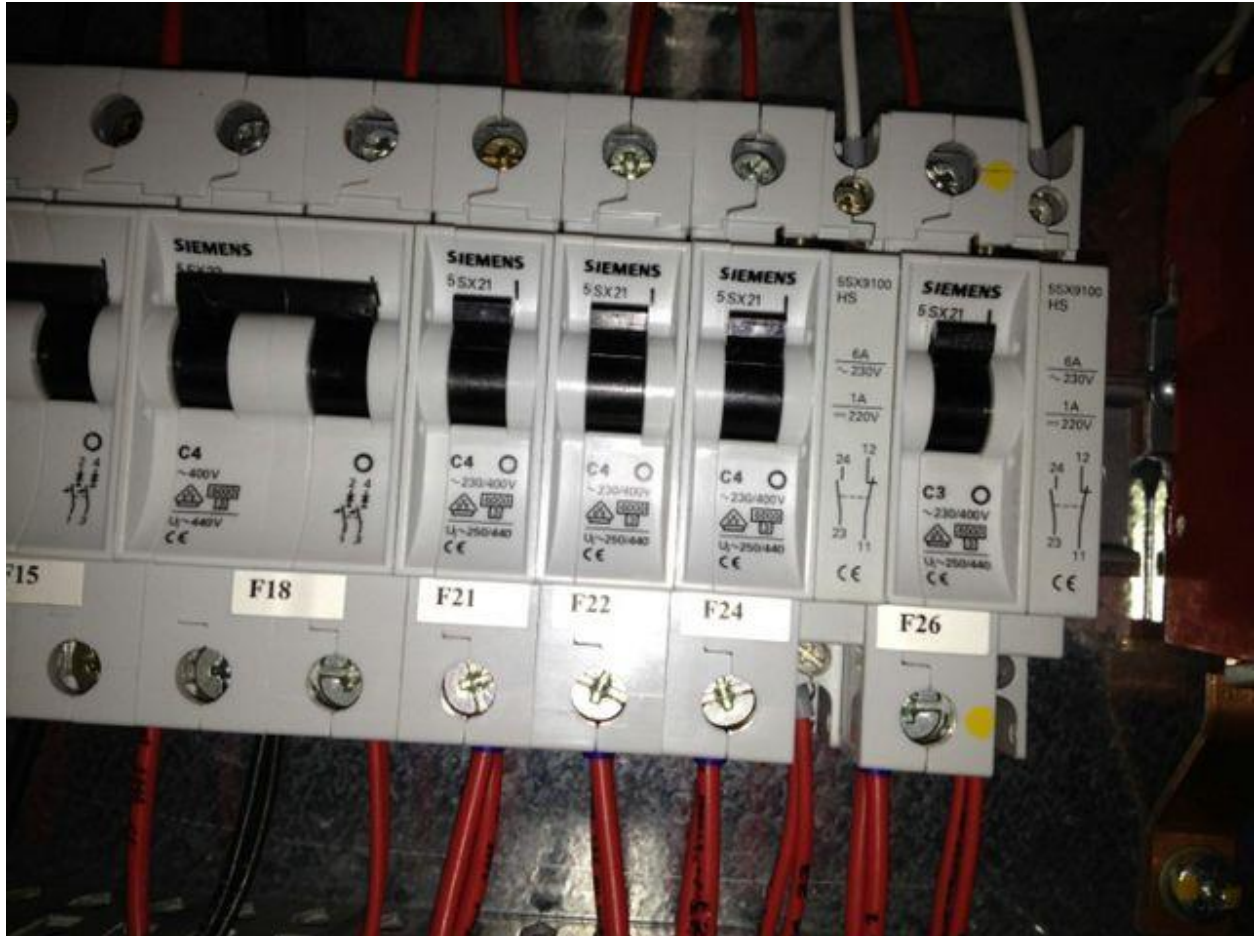
F21 & F22 Circuit breakers in AN1:

Check the circuit breakers F21 (sensor 1) and F22 (sensor 2) in the AN1 panel to see if they are open. In the AN1 measure 230 VAC on G06 Power Net power supply input and observe the green diode light. Measure 24 VDC on the power supply output, check for loose wires.

If either of the circuit breakers cannot be reset, replace the failed breaker. Item number:

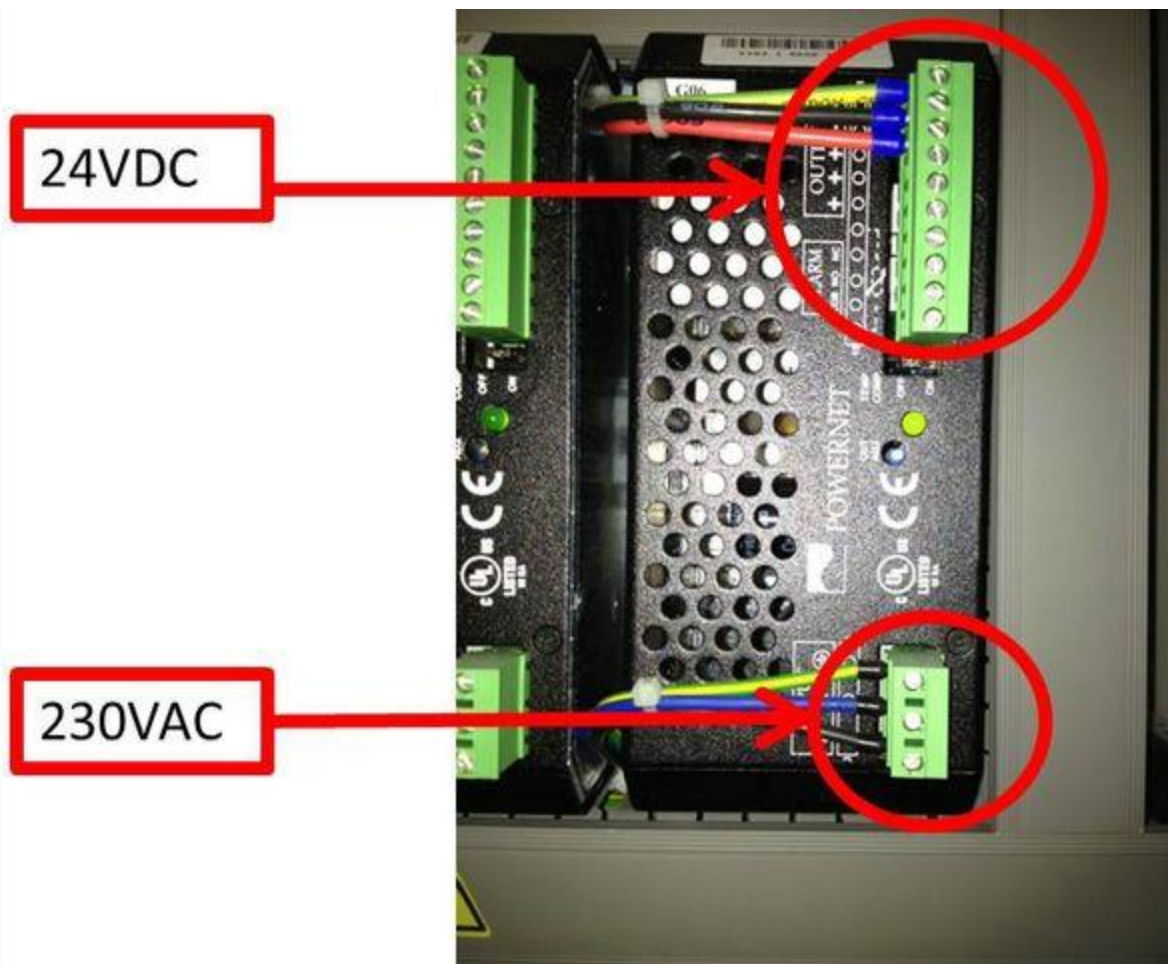
G06 Power Net:

Measure the input and output of the G06. If there is supply voltage but no output voltage and or the LED is out-replace the power supply.

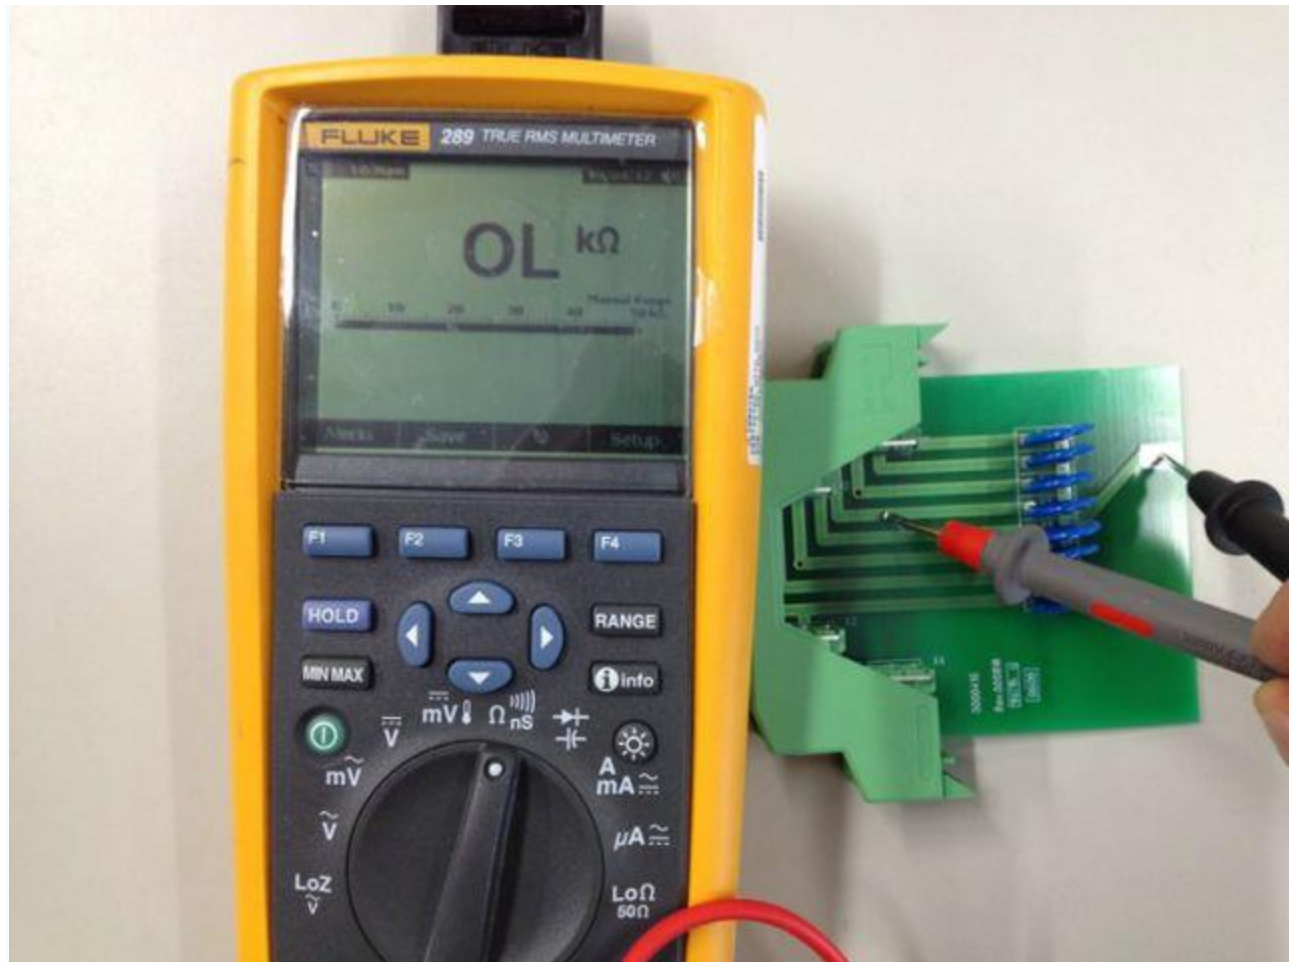
Measuring resistance across the varistors:

Measure resistance between the common varistor point and all other measurement points. Only four varistors can be measured by using the test points on the board, test the remaining four from the terminals. The resistance value over the varistor should be ∞ or in the high M Ω range. If the resistance is lower, the varistor has been damaged by an over voltage in the circuit and must be replaced.

The varistor will be damaged by an event and therefore should not be the cause but a consequence of the event. The cause of the failure may be due to lightning, fault in the power supply or short in the circuit.

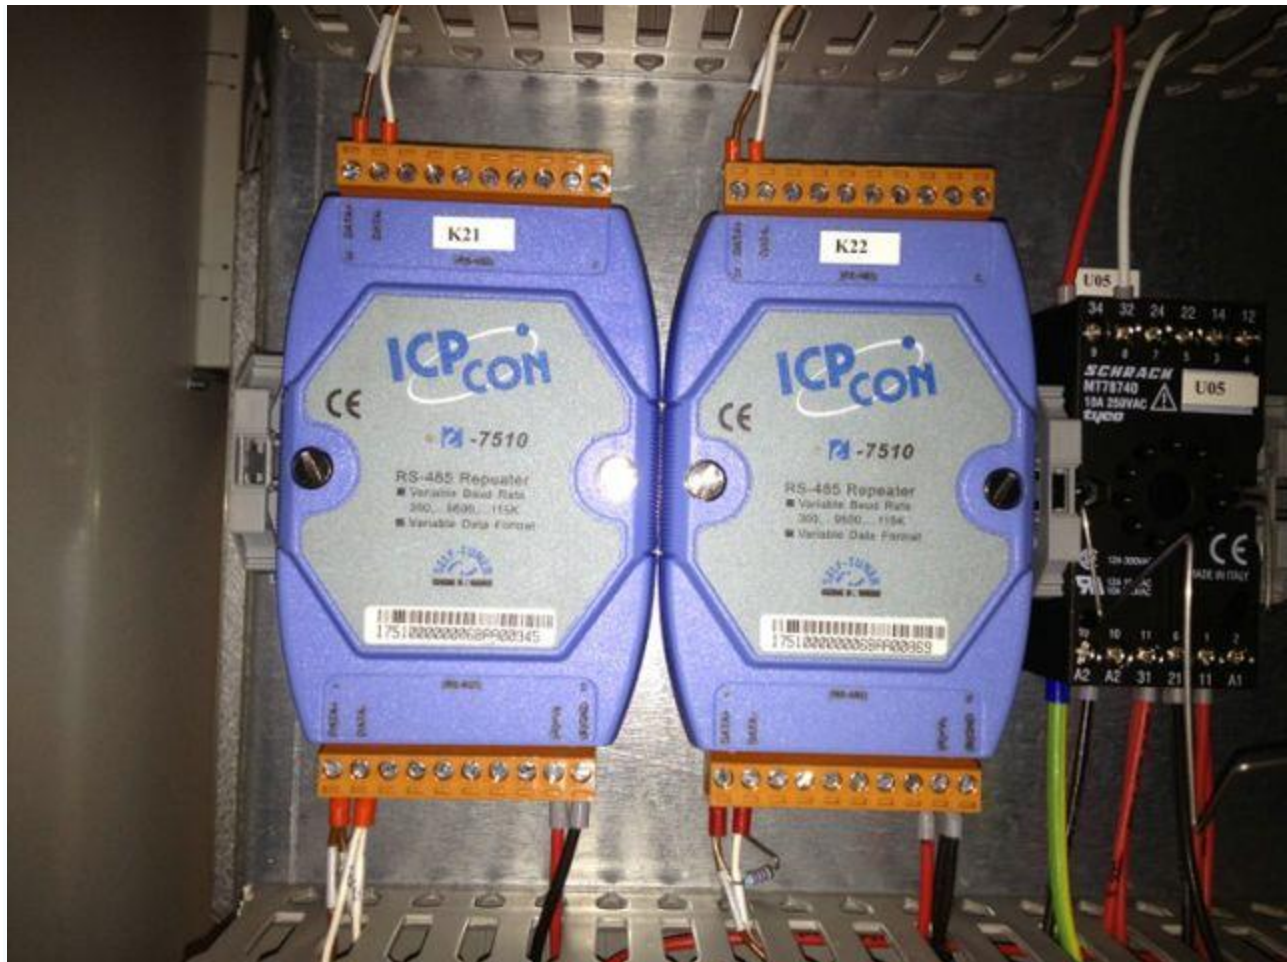
Check the connections at the ICP RS485 repeaters (K21 & K22) in the AN1. Check for loose wires and plugs or corrosion at the repeater.

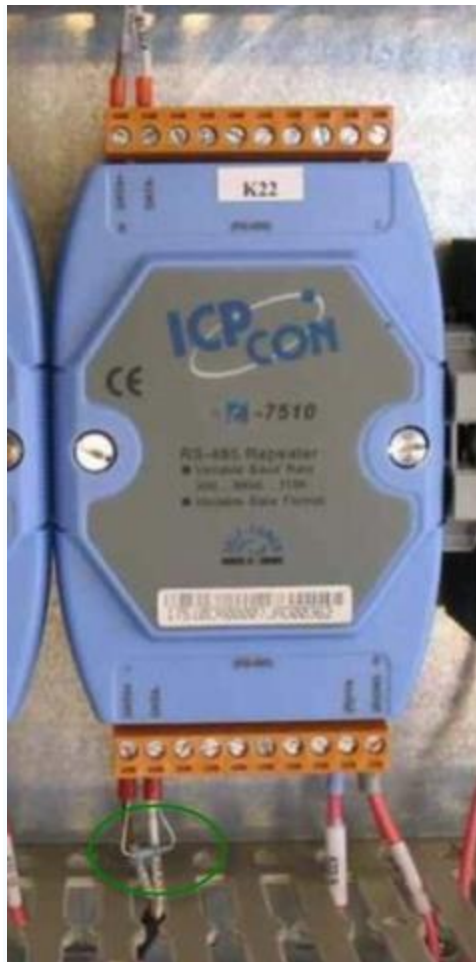
Check the loose connection and resistance value for R01, which connected across 21 (Data+) &22 (Data-) in K22. Replace the resistor, if it found resistance value other than 120 Ohms.

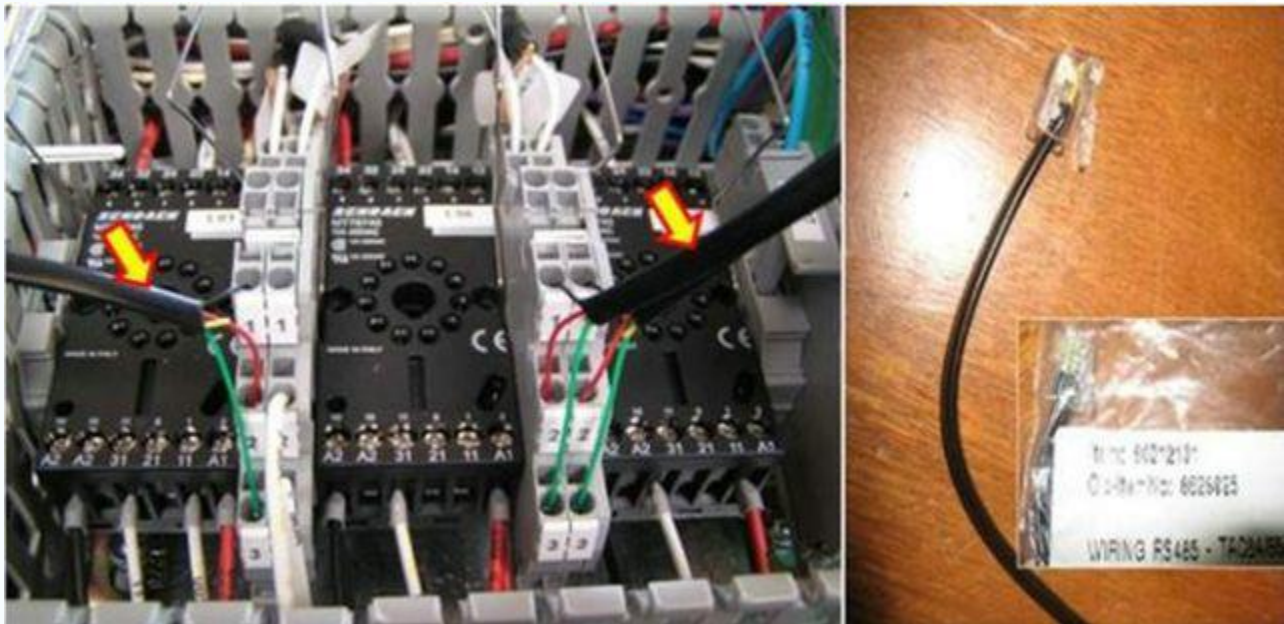
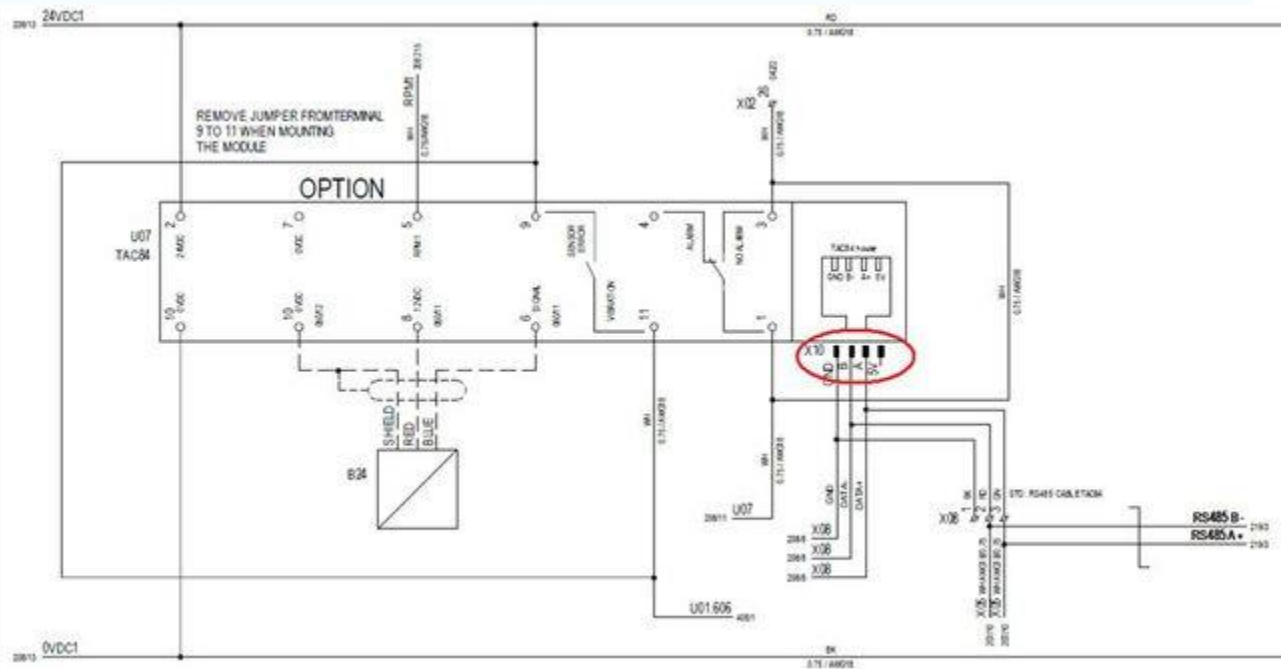
Check for poor cable connection or internal short circuit on the TAC 84 / TAC 85 communication cable.

If necessary replace the cable.

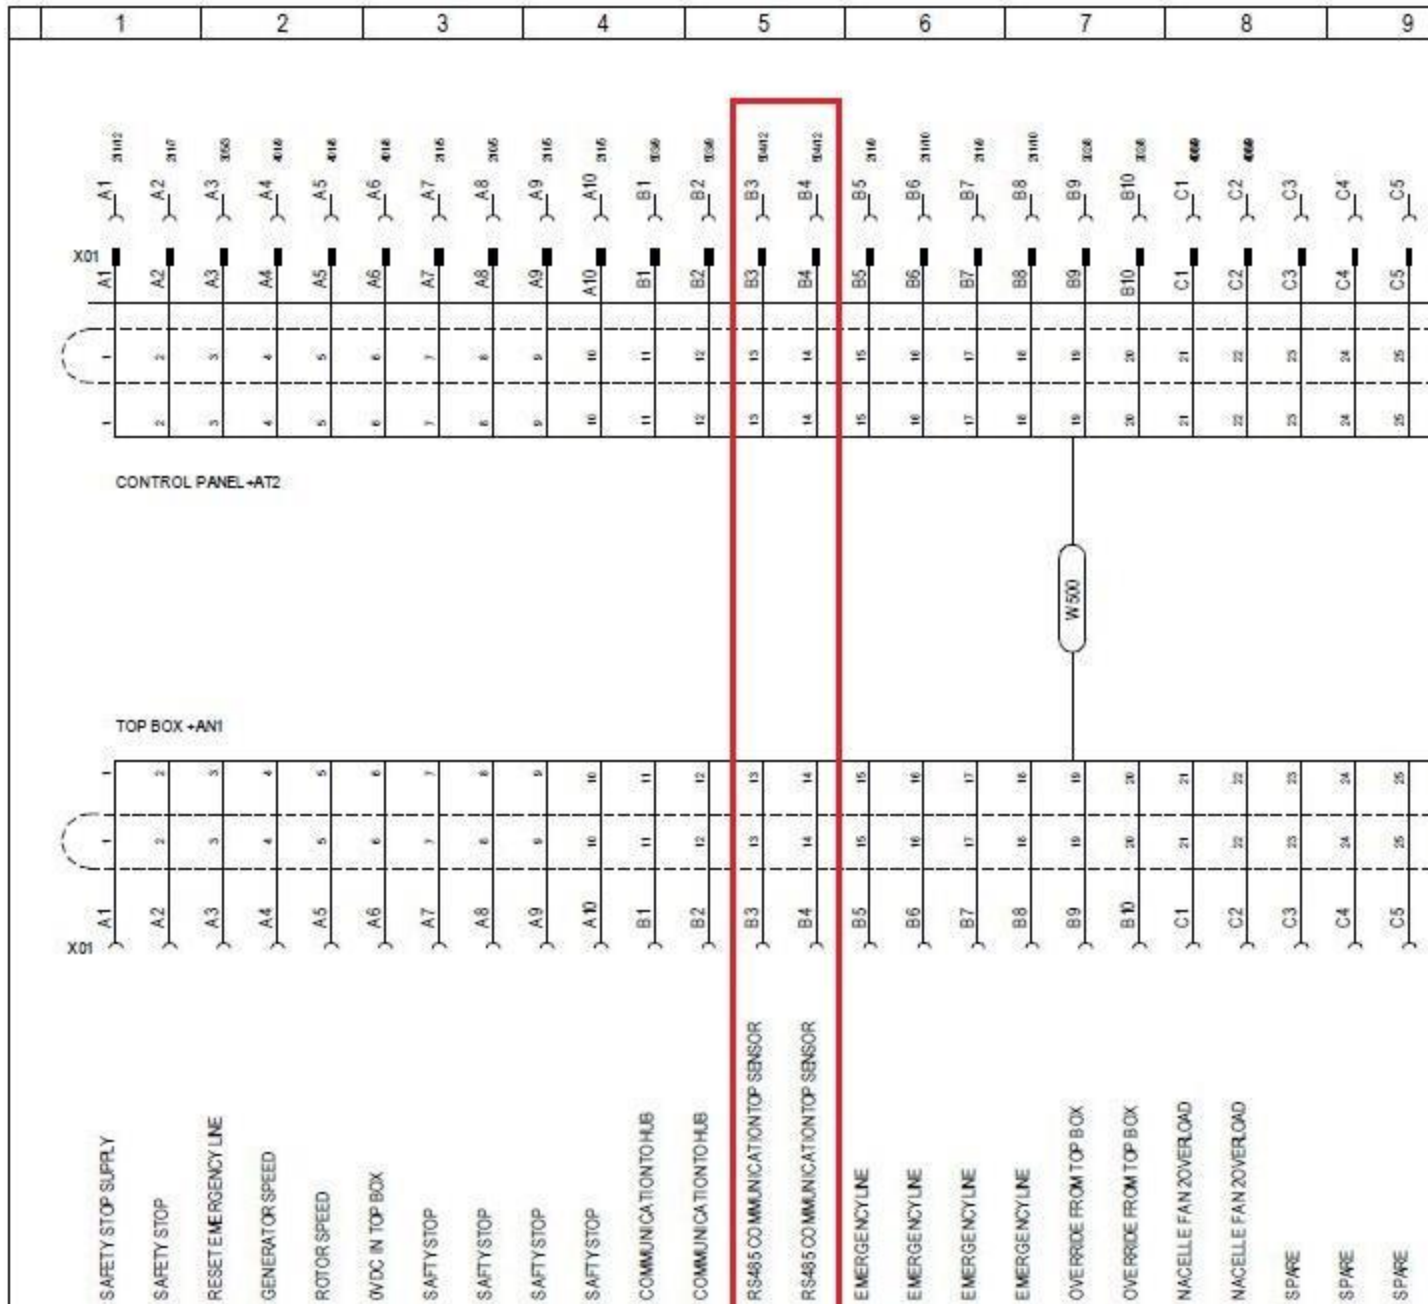
Check the continuity of B3 & B4 cores in cable W500 and replace with spare core, if no continuity.

Note: The below errors also may occur due to this defective cable core;
