Calibrate Sensor

Verify and correct parameters in TAC II Controller

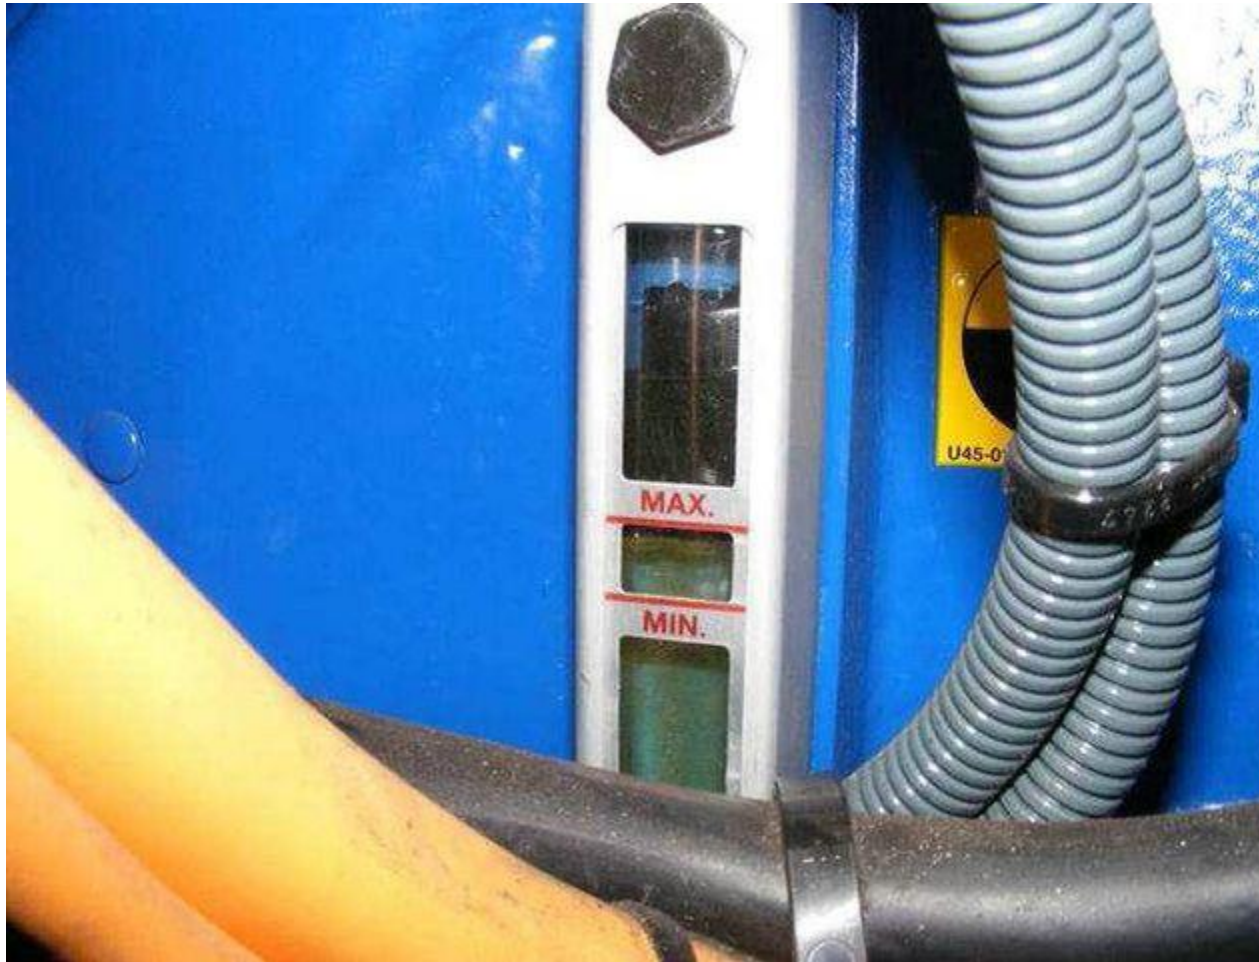
Hansen (Ja/Ke) Gearbox Oil Level

- **Explanation**
Low oil level in the gearbox will trigger this alarm (as the alarm title suggests), however, too much oil in the gearbox can cause the air breather to clog which will lead to alarm 365 as well.

Check that the gear oil is at the correct level as described in document as follows

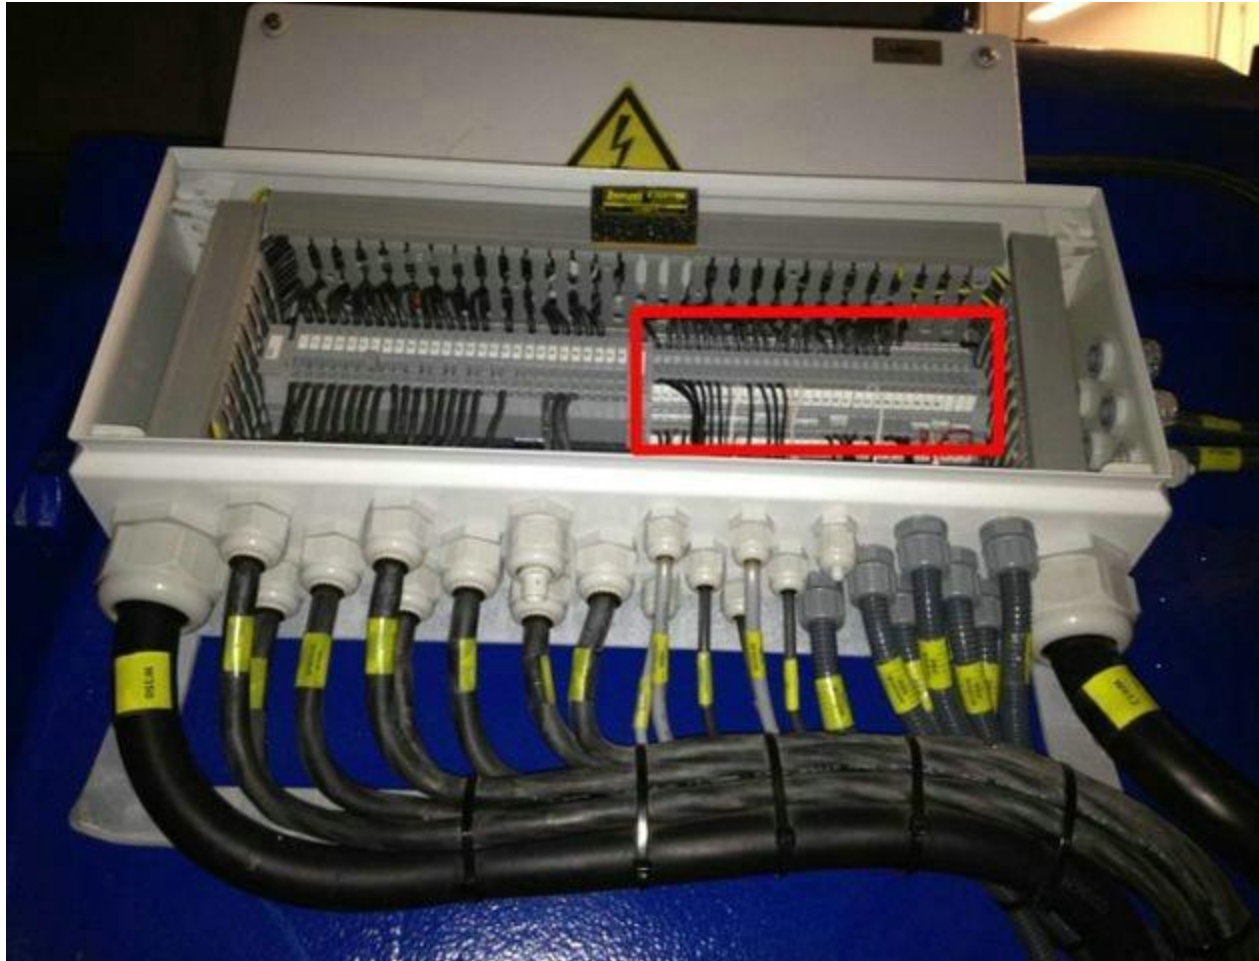
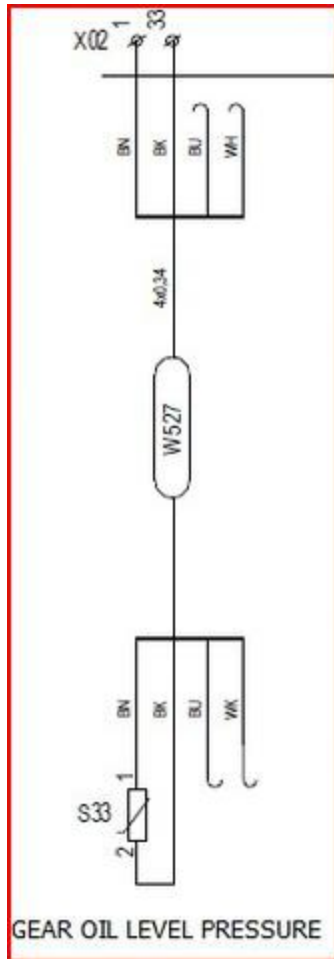
Check the connections at the gear oil level sensor, the plugs on the sensor are particularly sensitive and can be easily damaged.

Check the connections the W527 cable connected in to +AN12.

Replace the cable if it shows any signs of wear or damage.

Ensure the plug is fastened correctly and the cable is properly connected.

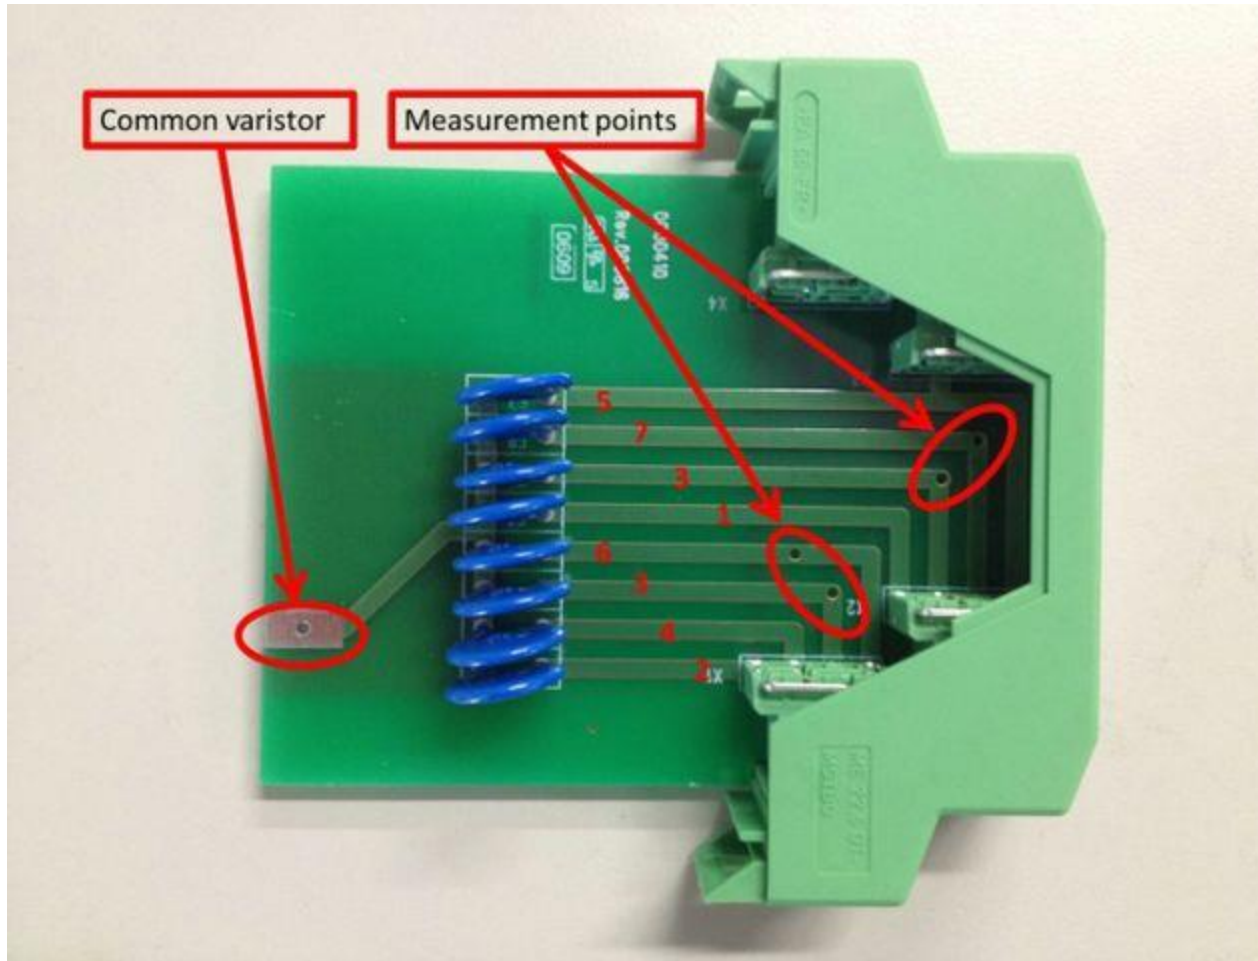
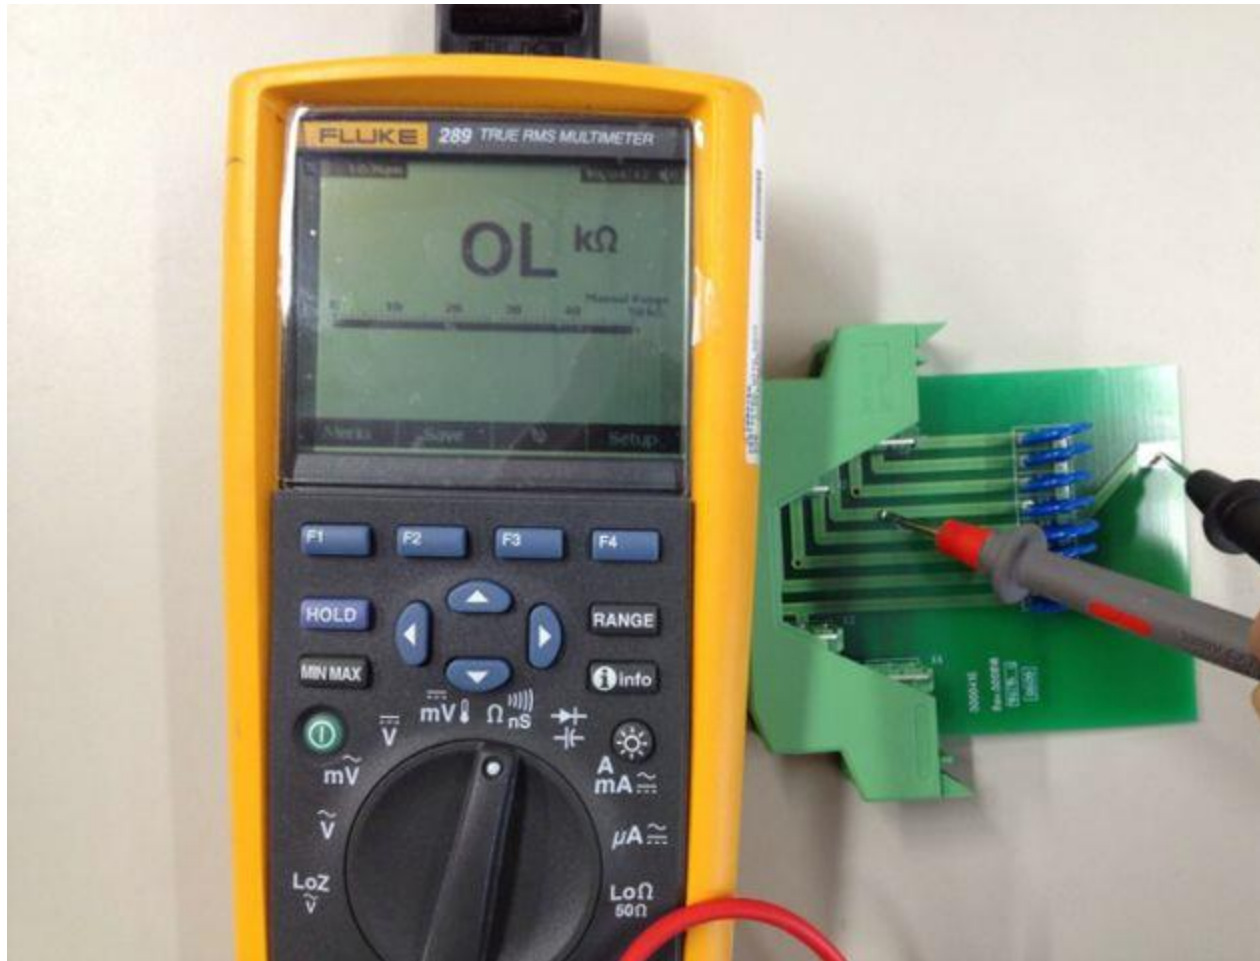
Measuring resistance across the varistors:

- **Explanation**
 - Check for loose/bad connection in Varistor F36.1 and TOI II connector U01.703
 - Faulty Varistors can be tested individually by placing a multimeter (set to measure Ω) lead on the common (earth) side of the varistors and the other on the individual varistor measurement points or at the terminals.

Measure resistance between the common varistor point and all other measurement points. Only four varistors can be measured by using the test points on the board, test the remaining four from the terminals. The resistance value over the varistor should be ∞ or in the high M Ω range. If the resistance is lower, the varistor has been damaged by an over voltage in the circuit and must be replaced.

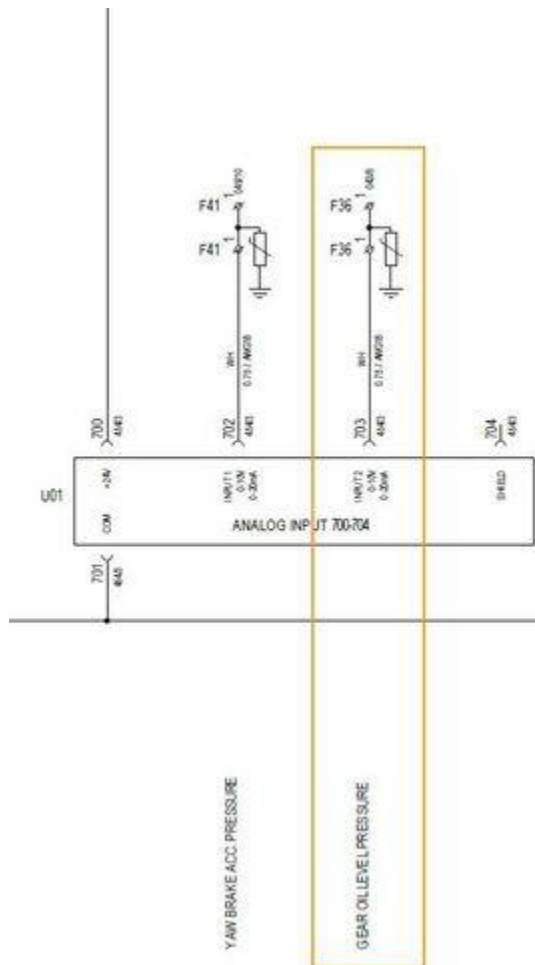
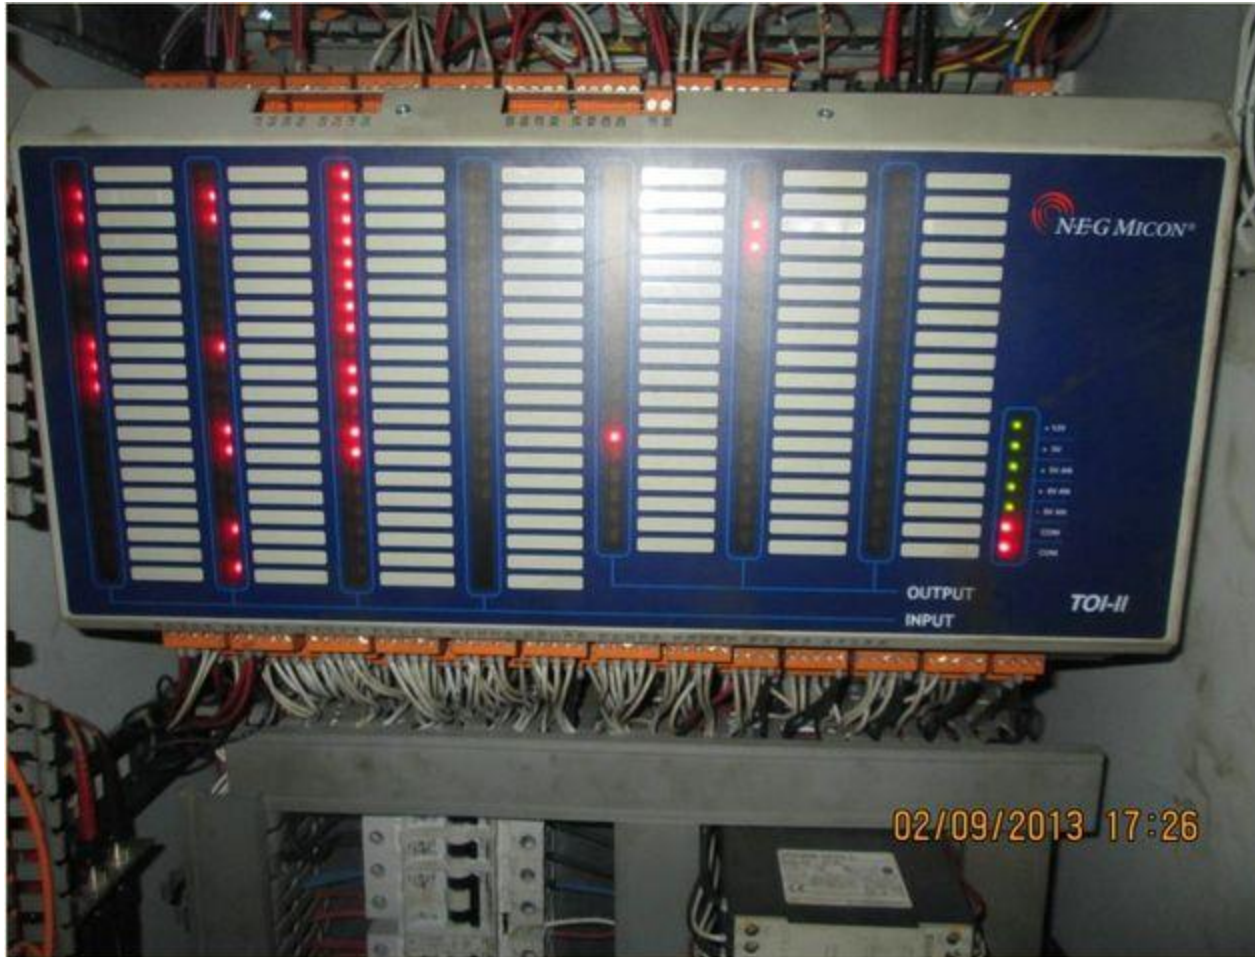
The varistor will be damaged by an event and therefore should not be the cause but a consequence of the event. The cause of the failure may be due to lightning, fault in the power supply or short in the circuit. Hence check the varistor before going for replacement of TOI-II top.

- If connections are ok, but the gear oil level pressure reads still low then the cause is likely a faulty nacelle TOI. Replace the same.
