Troubleshoot generator speed sensor

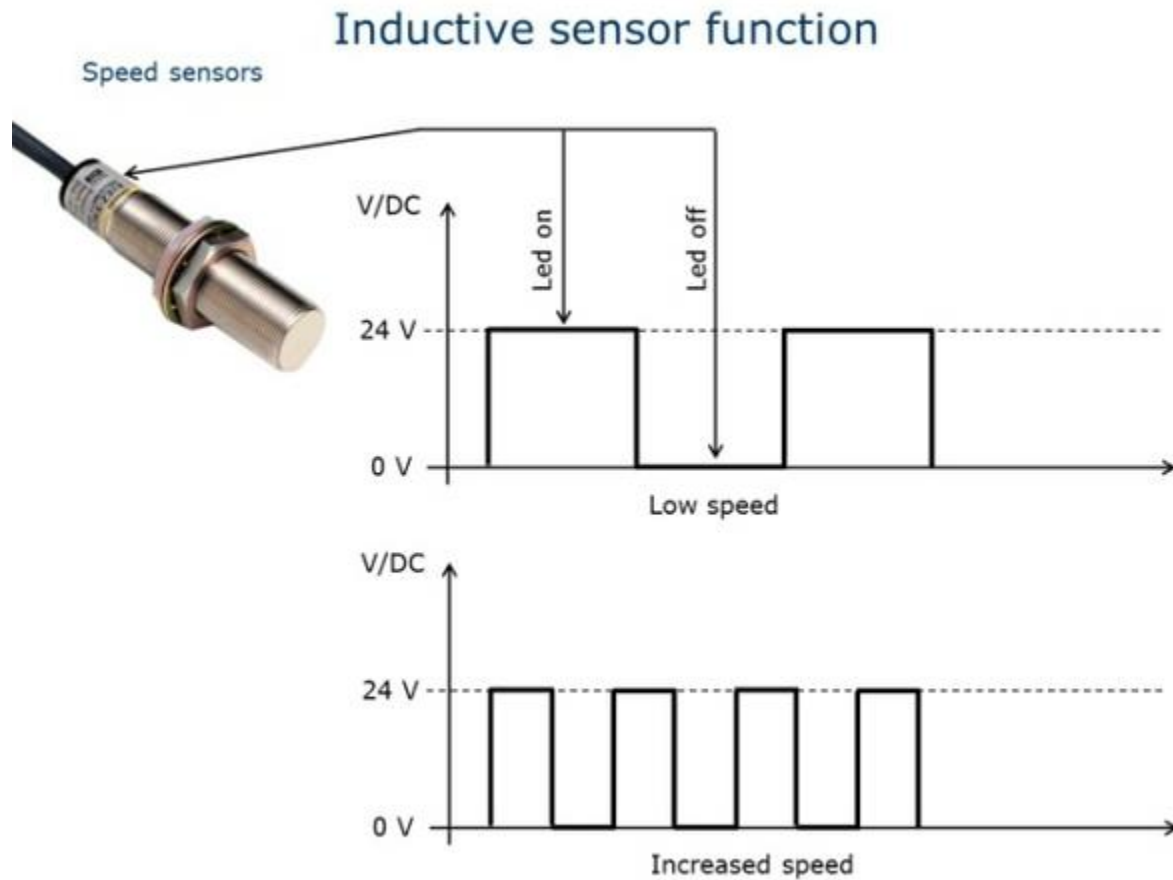
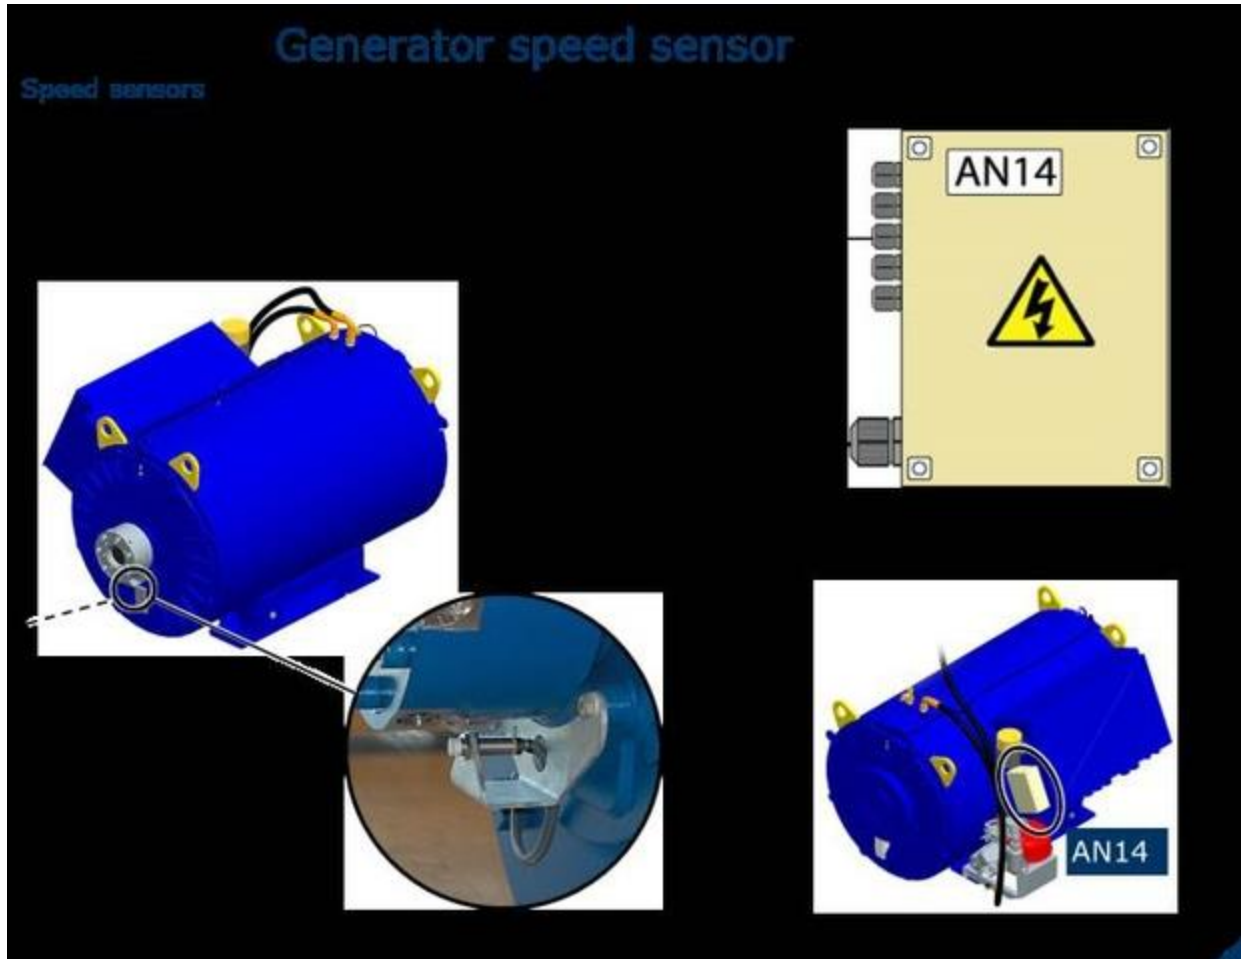
The generator speed is measured by an inductive proximity sensor which creates a pulse signal as a pickup point passes over it.

It is possible that the sensor is dirty or misadjusted and occasionally does not pick up the bolt interruption. If the sensor is contaminated, wipe it with a cloth to clean.

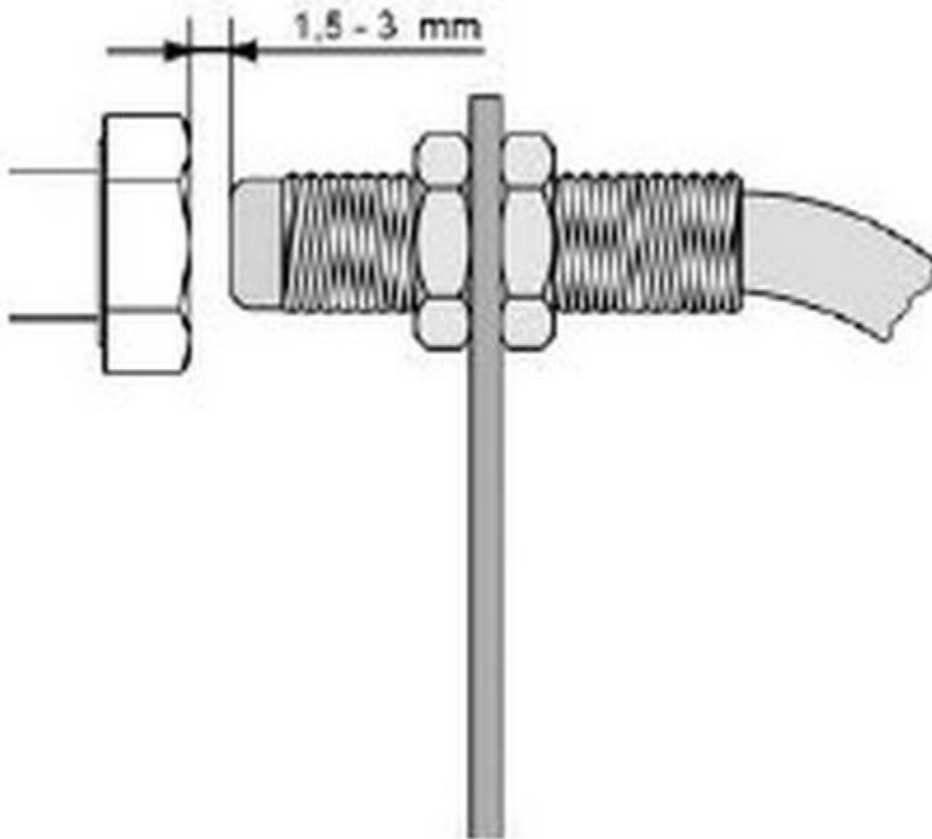
Speed sensor measurement

In the case of the generator, there are seven pickup points for every rotation of the shaft therefore the speed is calculated as $\# \text{ of pulses} / 7 = \text{generator RPM}$. If the sensor is loose or failing it can "flicker" which will simulate a higher RPM than actual. The sensor can be tested by passing a screwdriver or other ferrous object past the sensor. If it consistently emits a light the sensor is likely operational. The sensor can also be tested by rotating the generator shaft and ensuring that the sensor emits a light when each of the (7) link element bolts passes over the sensor.

If the sensor does not emit a light each time a link element bolt passes over it, lock the shaft and check for correct sensor adjustment. Check the bolts on the speed sensor bracket and ensure that they are properly tightened. The end of the sensor should be within 1,5-3 mm from the pickup point. Adjust the sensor by loosening the nuts that clamp it to the mounting bracket and move it forward or back to achieve the required distance from the pickup point.

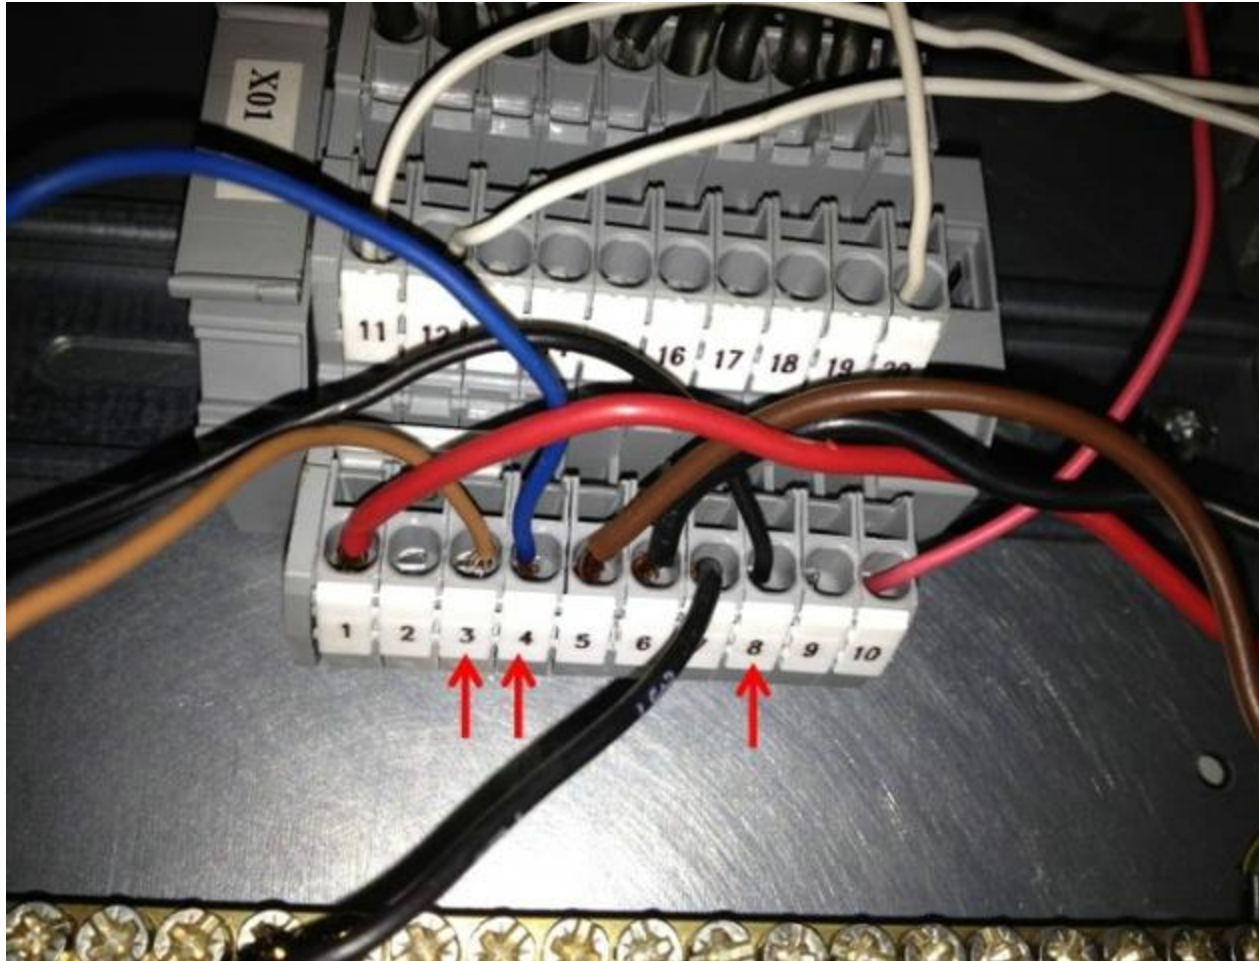
Terminal block -X01 terminals 3, 4 & 8:

Check for loose sensor terminations in the AN14 panel. (The AN14 terminal panel exists only in V82 1.65 Mw. NM72/82 1650Kw generator speed sensor cables terminate directly at the AN1 Top Box).

Before replacing the sensor or components, check the circuit for loose connections.

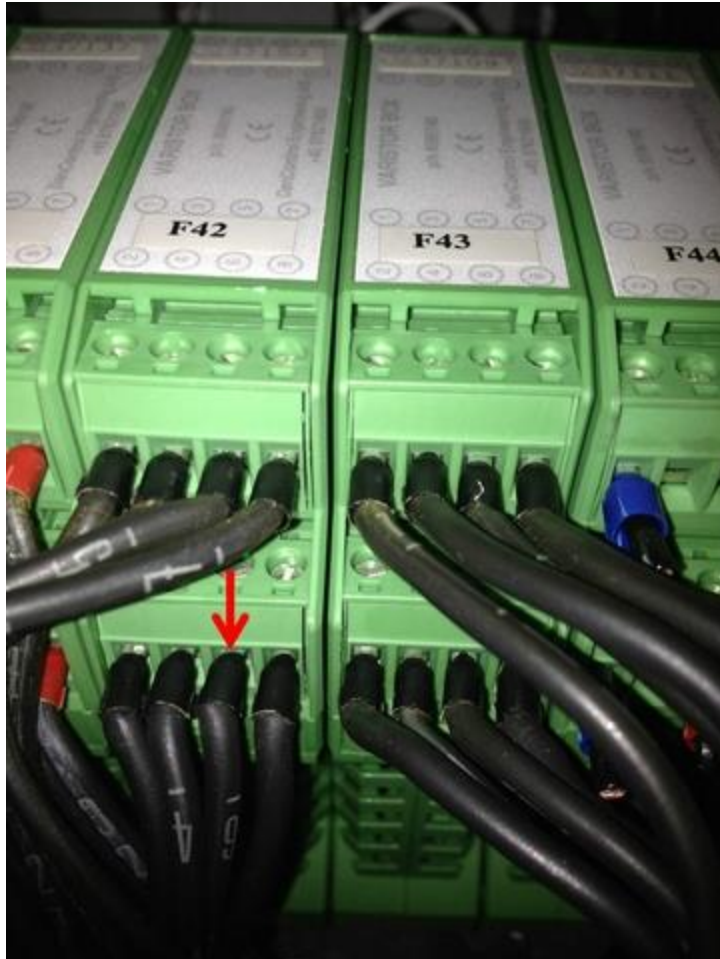
Check for loose wire terminations in the AN1 Top Box (sensor wire from the AN14 terminates into F42 Varistor Box terminal 6)

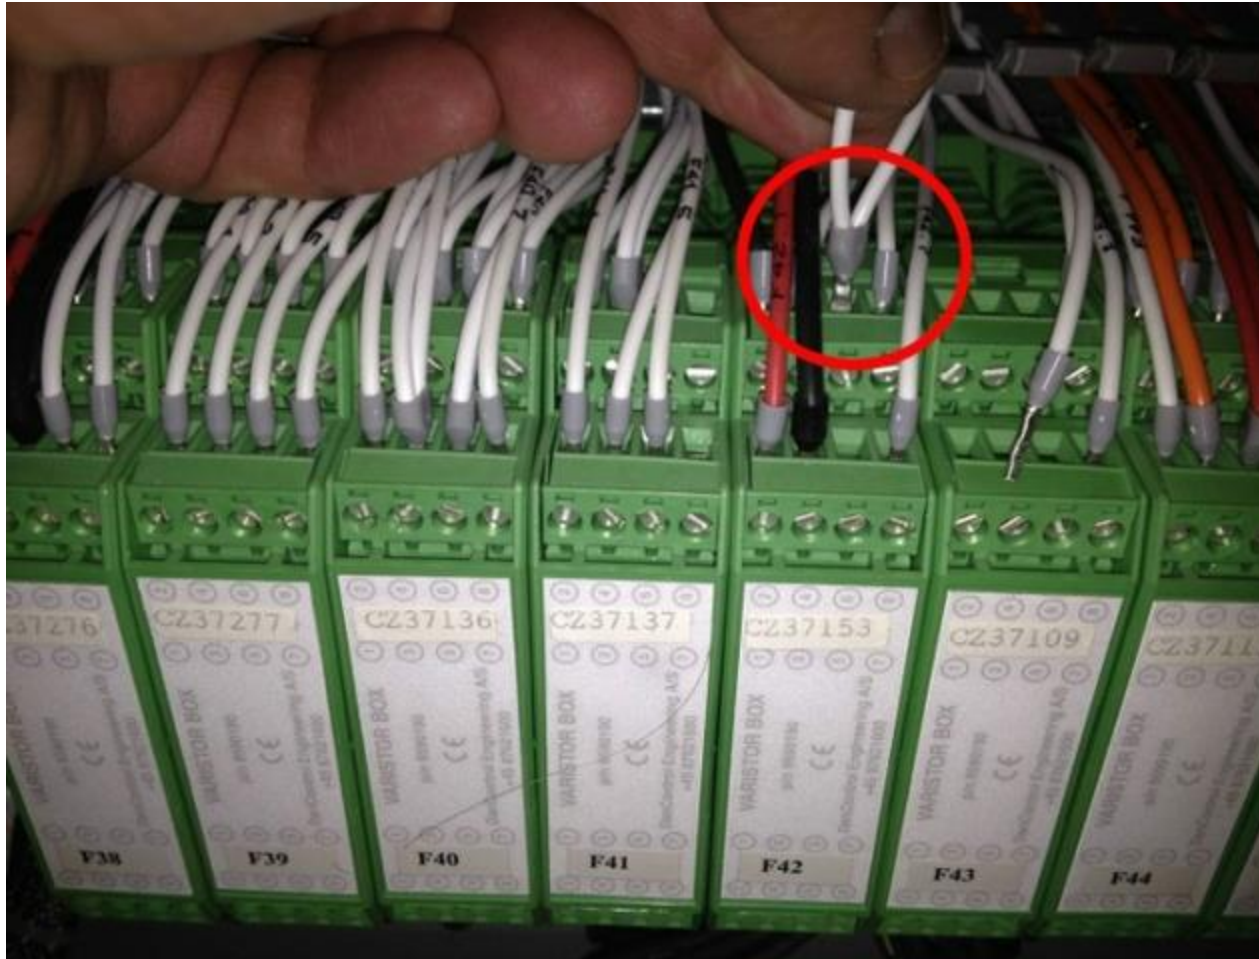
The signal wires from the F42 varistor box are double stacked, pay close attention to this crimped connection as the wires may be loose:

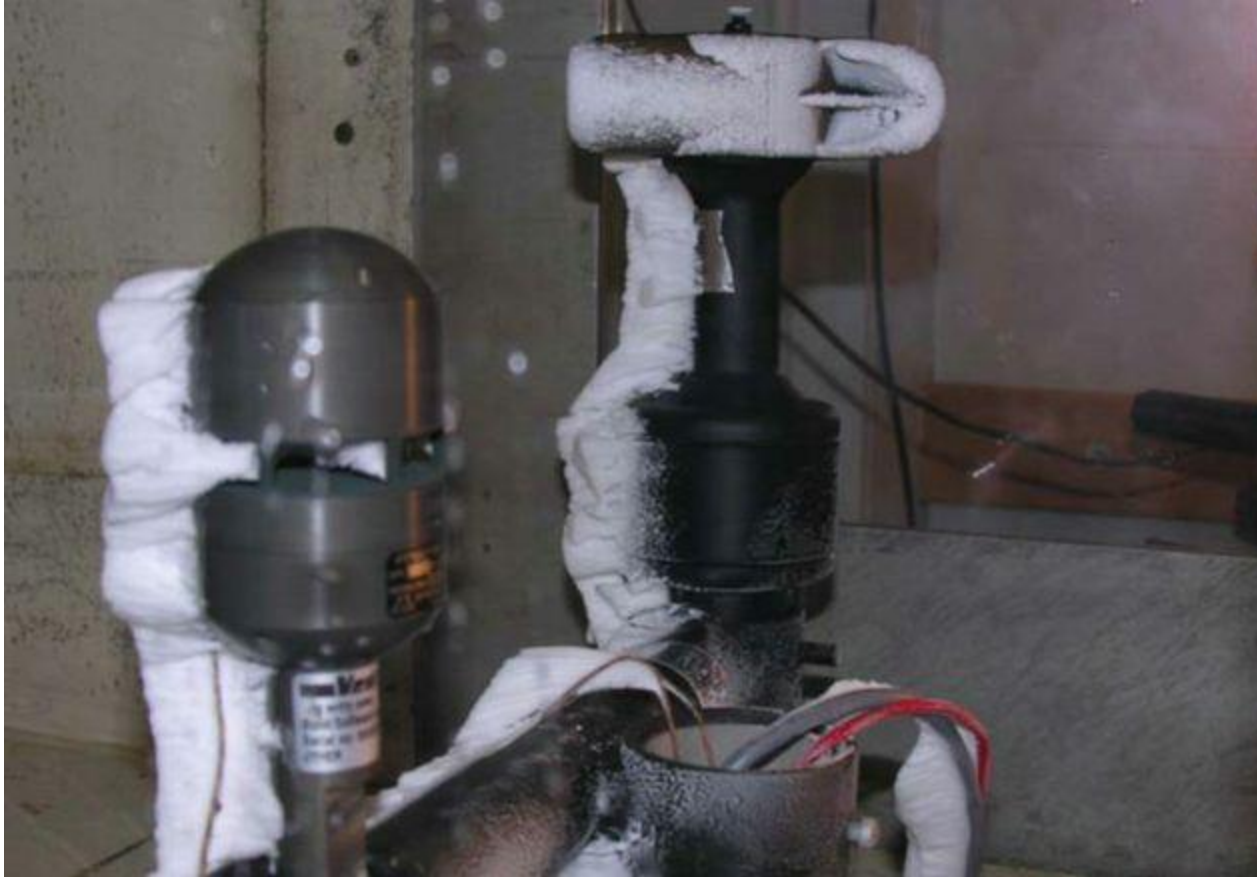
If multiple turbines at site are affected and conditions support the formation of ice, it is likely that ice has accumulated on the wind sensors. If this is the case, the fault will clear when the conditions no longer support the formation of ice. If the above conditions exist but only one turbine is affected, check the sensor heater settings in the TAC controller (Test the heating of the wind vanes and the anemometer in the TAC controller => TEST FUNCTIONS => HEAT TOP SET => ENTER). If settings are okay, physically check the sensors for heater operation.

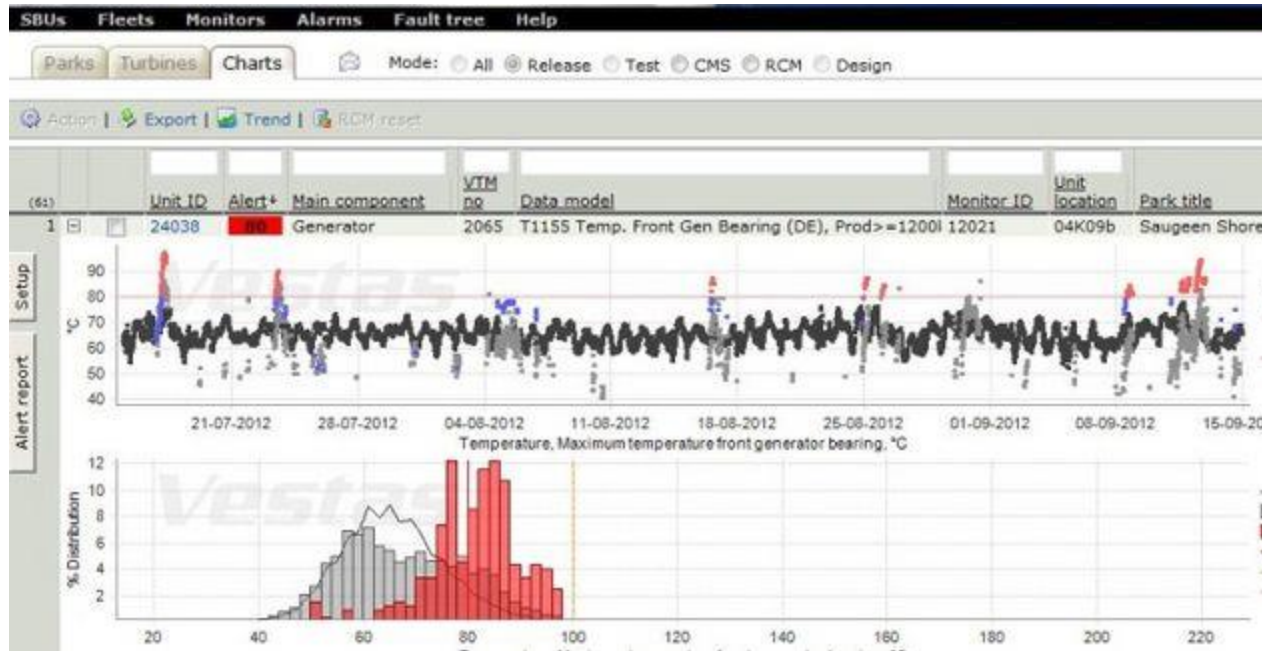
Check VTM for any bearing temperature alerts.

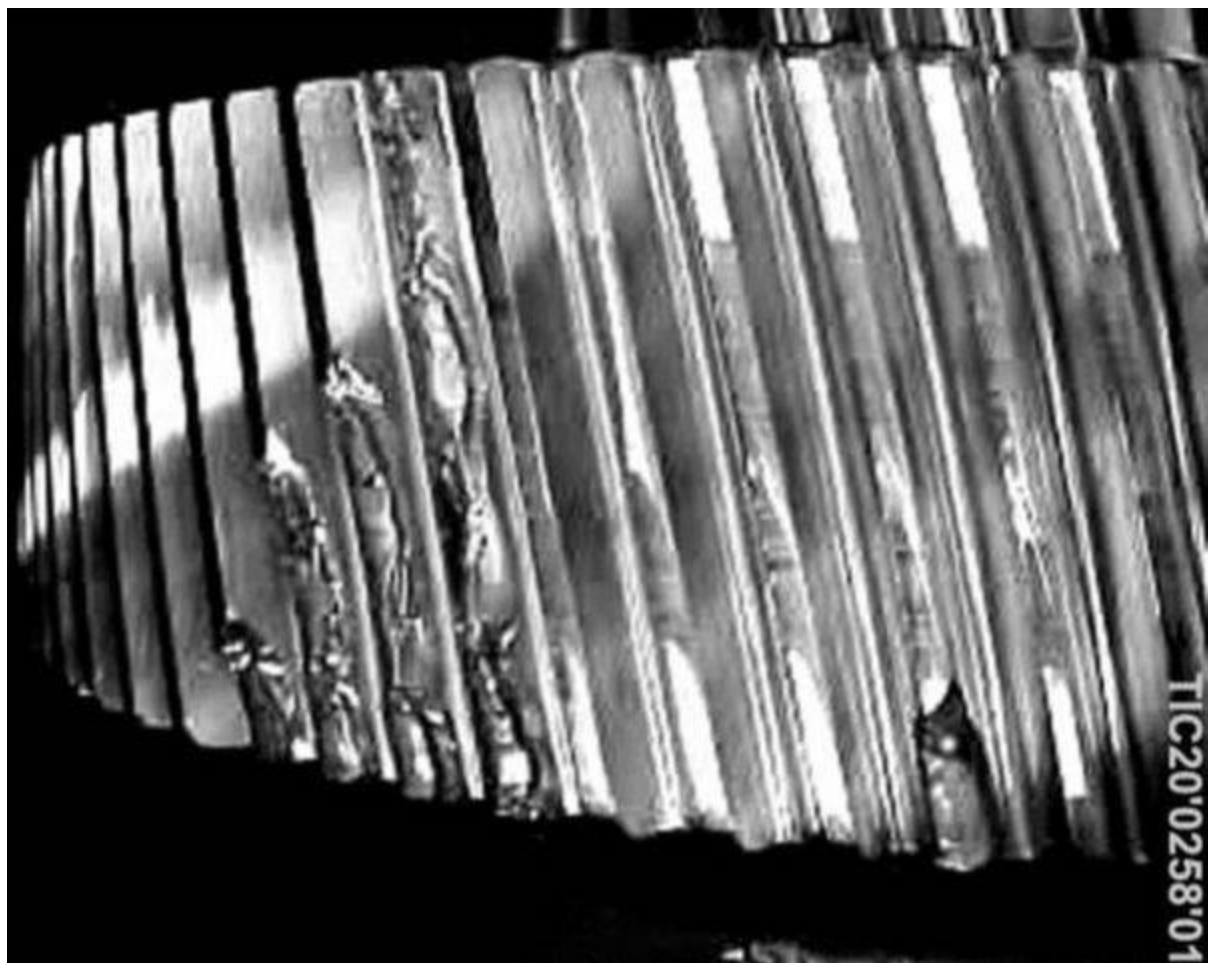
Check for damaged bearings in the drive train by listening for unusual noise during freewheeling. Rolling resistance in the drivetrain can result from failed bearings in the generator, gear-box, or main bearing. Visually inspect gearbox internally for damage in accordance with the service manual for the gearbox (WKI 1001058). If a failed bearing is found, and it is possible- replace the bearing.
