VOLTE的分析方法及主要问题

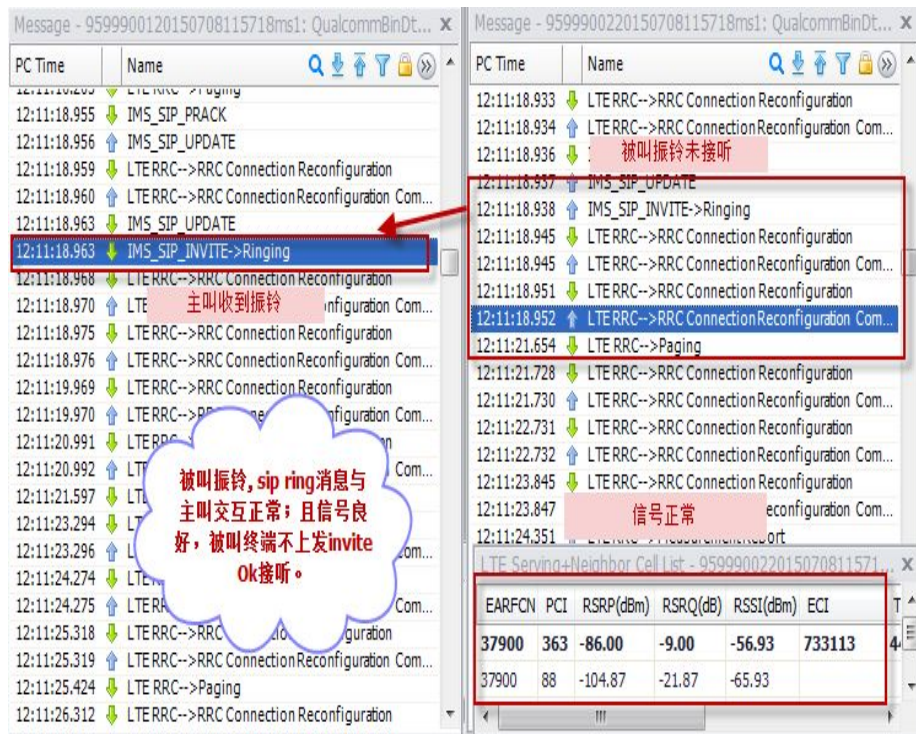
2. 被叫振铃不接听案例

分析：被叫上发振铃后，按照软件设置应在1秒后立即接听，怀疑软件触发的接听AT指令未起作用。

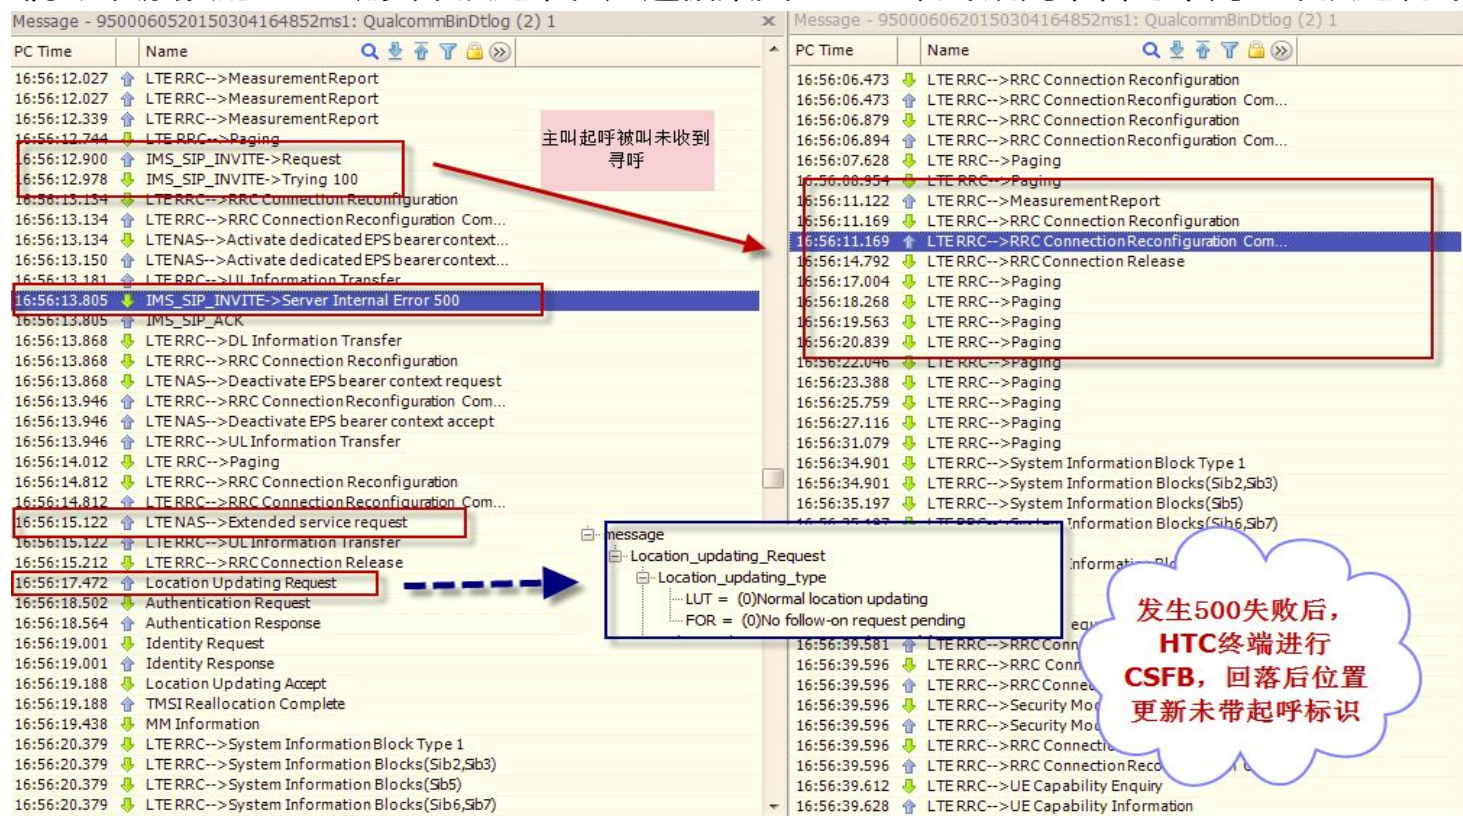
统计规则问题：VOLTE起呼失败触发CSFB且未接通

现象：1次VOLTE呼叫后，发生sip 500错误，2秒触发CSFB再起呼，但该次CSFB起呼也未接通。

规则：集团统计认为，该现象实际是1次用户按键行为触发了2次信令起呼，对客户感知来讲是1次失败，而非两次失败，当前认定前1次VOLTE失败计入未接通统计，而CSFB不计失败

分析：实际该次触发的CSFB确实未接通，但是遵循集团VOLTE统计规则，暂时不列入未接通统计。

发生500失败后，HTC终端进行CSFB，回落后位置更新未带起呼标识

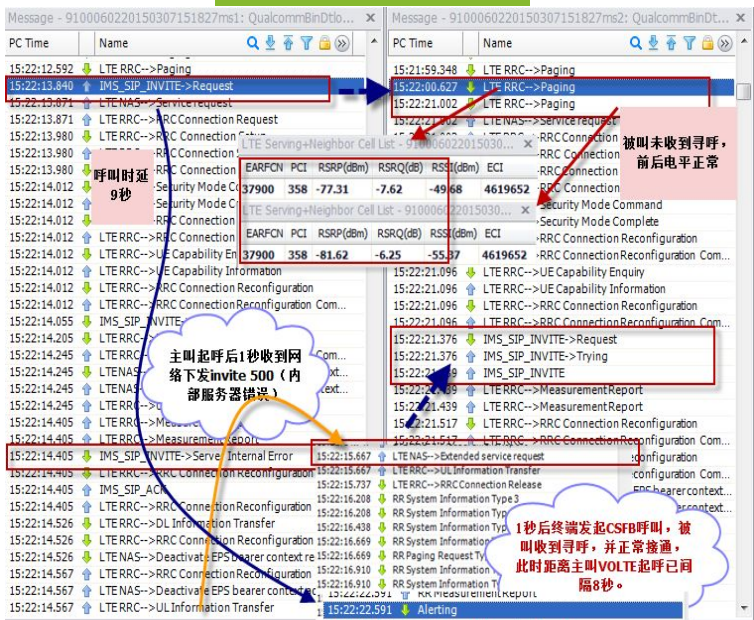
触发CSFB呼通案例

为了提升用户对VOLTE终端的接入性感知，终端厂家HTC对M8进行了版本升级（3.51），开启了silent redial功能。当VOLTE试呼不通，终端收到下述SIP消息时，立即自动触发CSFB呼叫。

另外，如15秒未接通被叫，终端上发cancel取消或收到到RRC释放呼叫后，存在一定几率终端立即进行CSFB起呼，极小概率触发VOLTE再起呼。

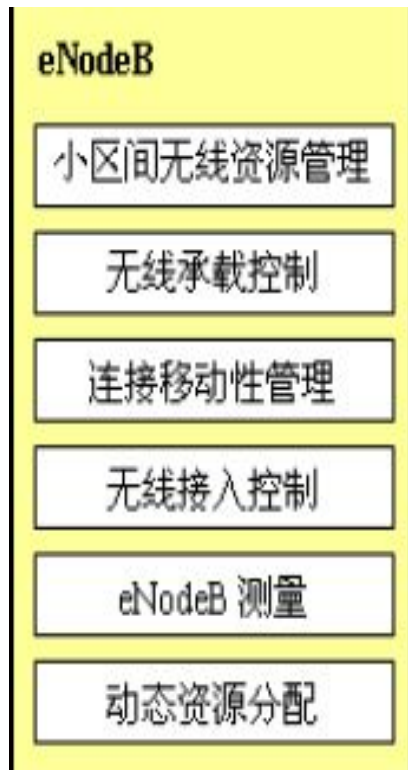
案例1：RRC重建失败，无线网问题

现象：切换失败导致RRC释放，重建RRC未成功，重新进行RRC申请，QCI=1的承载未建立成功，导致掉话

分析：呼叫重建失败后，新小区重新申请RRC，未能建立VOLTE专载，导致掉话。该流程均由ENODEB控制执行。而切换失败的原因往往是无线环境问题、参数配置不合理、邻区漏配、非竞争随机接入异常等，均为无线网问题。

VOLTE接通中发生1次切换失败

1次切换失败后发生呼叫重建但未成功，重新申请RRC，QCI=1的承载未重建

结论：切换失败与RRC重申请流程均与EUTRAN相关，因此认定为无线网问题。

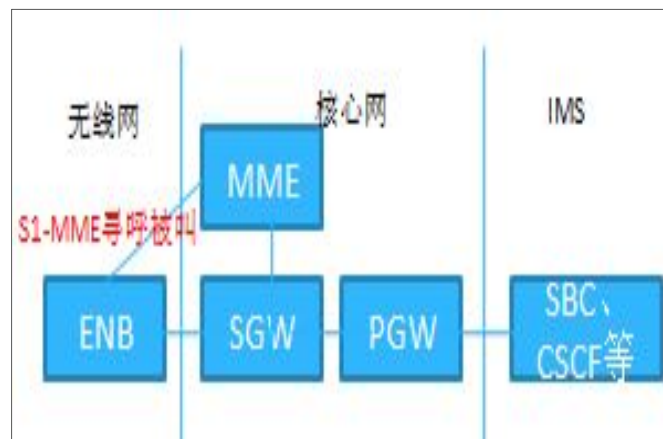
案例1：被叫收到寻呼但未收到INVITE请求，核心网问题

现象：主叫上发了invite，被叫收到了寻呼且建立RRC成功，此时应收到下行的invite，但始终未收到。

分析：被叫响应寻呼并进行了RRC申请，表明MME已收到由SGW触发的数据业务请求，即sip invite消息应由IMS网元的SBC下发给了PGW、SGW。

- ① Sip invite消息由IMS网元SBC下发到被叫核心网网元PGW
- ② PGW转发给SGW，SGW通过S11触发MME进行寻呼被叫
- ③ 被叫被寻呼到，并完成RRC连接与建立默认承载所需RAB，接收数据

结论：收到寻呼消息表示sip invite数据包已经到达了LTE核心网，未能继续下发当前怀疑是sip数据在S/PGW异常丢失。

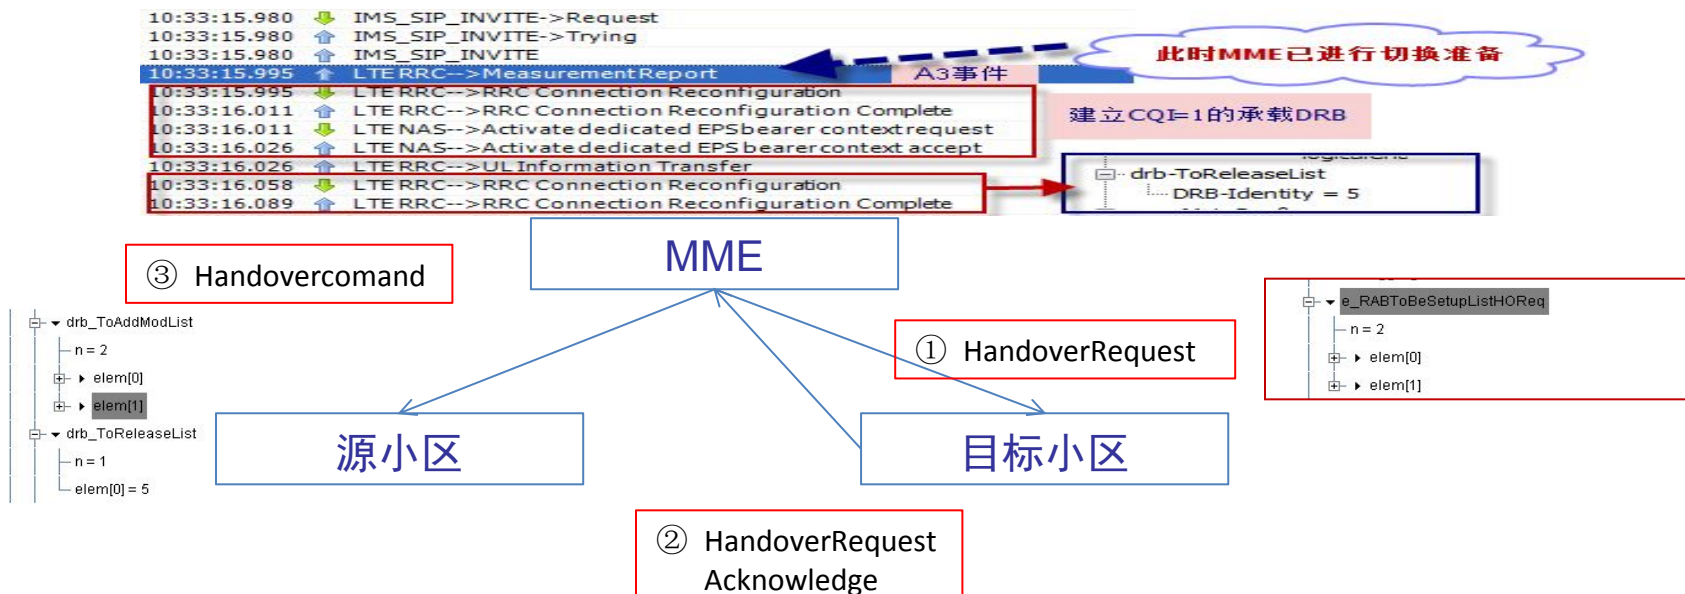
案例2：重配置消息释放DRB承载，无线网与核心网配合问题

现象：被叫上发sip183后，在激活EPS承载之前，终端上报了1条A3测报，激活EPS后，发生切换重配置消息中释放了QCI=1的DRB。

分析：起呼时MME进行激活EPS承载流程过程中，恰好发生S1切换时，由于EPS承载建立未完成，MME在切换准备阶段，对下发到目标小区的切换准备的请求消息中不携带QCI=1的VOLTE专载，导致VOLTE专载源小区完成的情况下，在目标小区被释放，切换完成后呼叫中断

- ① 切换准备时，MME向目标小区发切换请求，RAB建立请求表只有2条，无QCI=1的专载
- ② 目标小区收到MME的切换请求后，回复的切换确认消息里仅有2条RAB建立
- ③ MME向源小区下发的切换命令消息中，只建立2条承载，导致ENODEB释放了QCI=1的VOLTE专载。

结论：切换与EPS激活流程碰撞，无线网与核心网配合问题。在进行激活EPS专载过程中，发生切换时，均会造成上述问题，目前还无较好的解决办法。

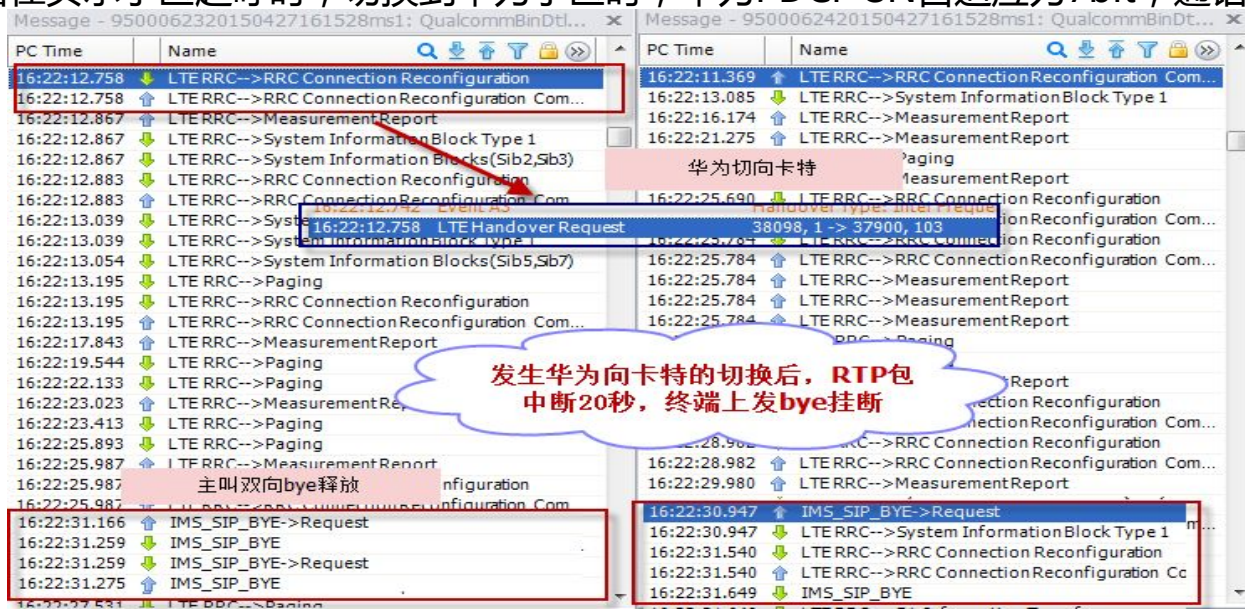
现象：主被叫接通状态下，在发生一次由华为设备到卡特设备的切换后，20秒后主被叫终端同时上发了bye request消息，网络侧回复bye(487 Request Terminated)，后网络去激活了EPS承载，掉话。

分析：PDPC SN SIZE长度有12bit和7bit，目前华为基站配置为12bit,贝尔配置为7bit，两个厂家配置数据不统一。华为enodeb设备具有自适应功能。

- ① 在华为小区起呼时，切换到卡特小区时，卡特无自适应功能，PDCP SN不一致导致组包混乱。
- ② 当在贝尔小区起呼时，切换到华为小区时，华为PDCP SN自适应为7bit，通话正常。

结论：临时解决方案：华为PDCP SN Size修改为7bit，进行拉网测试主叫呼叫56次，未出现终端主动上发bye的掉话。异常掉话及切换后单通问题基本解决

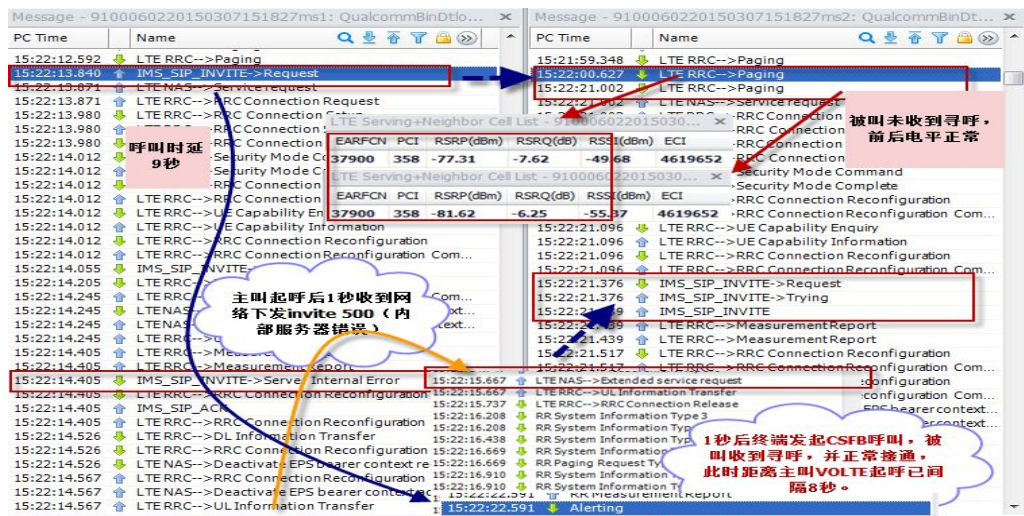
■ 案例5：华为EPC、中兴IMS协议理解不一致。IMS网络问题（升级SBC解决故归此类）

现象：VOLTE起呼后，EPS承载激活完成，有一定几率1秒后直接收到网络直接下发sip 500消息（Server Internal Error），中断呼叫。

分析：EPC按照3GPP规范产生的计费标识中包含“0a”的内容，但在IMS网络中，按照SIP协议将“0a”解析成换行符，造成对计费标识的误读。导致中兴IMS网与华为EPC网元PCRF对RX接口中字符串格式理解不一致；中兴不支持PCRF通过Rx接口返回的不可见字符，导致了IMS直接下发了内部服务器错误

- ① 中兴IMS网元SCSCF返回500错误，原因为收到SBC转发的invite request消息携带的PCV头部有问题，发现换行符（0A），导致S-CSCF网元上解码认为头部结束，从而认为不合语法规则，获取ecid失败
- ② 华为EPC网元PCRF通过Rx接口返回接入网络计费标识（Access-Network-Charging-Identifier-value），至中兴IMS SBC，而后中兴SBC通过ecid参数来HEXDIG编码上述计费标识信息

结论：即3GPP该计费标识可以包含字符串形式，中兴按IMS SIP协议理解ecid只能是可见字符，对字符串形式不进行HEXDIG转换，导致了上述问题。临时解决方案，中兴SBC进行相应的版本或补丁解决，支持不可见字符
