3rdParty MCAL Integration

Technical Reference

Infineon TC3xx

Version 2.2.3

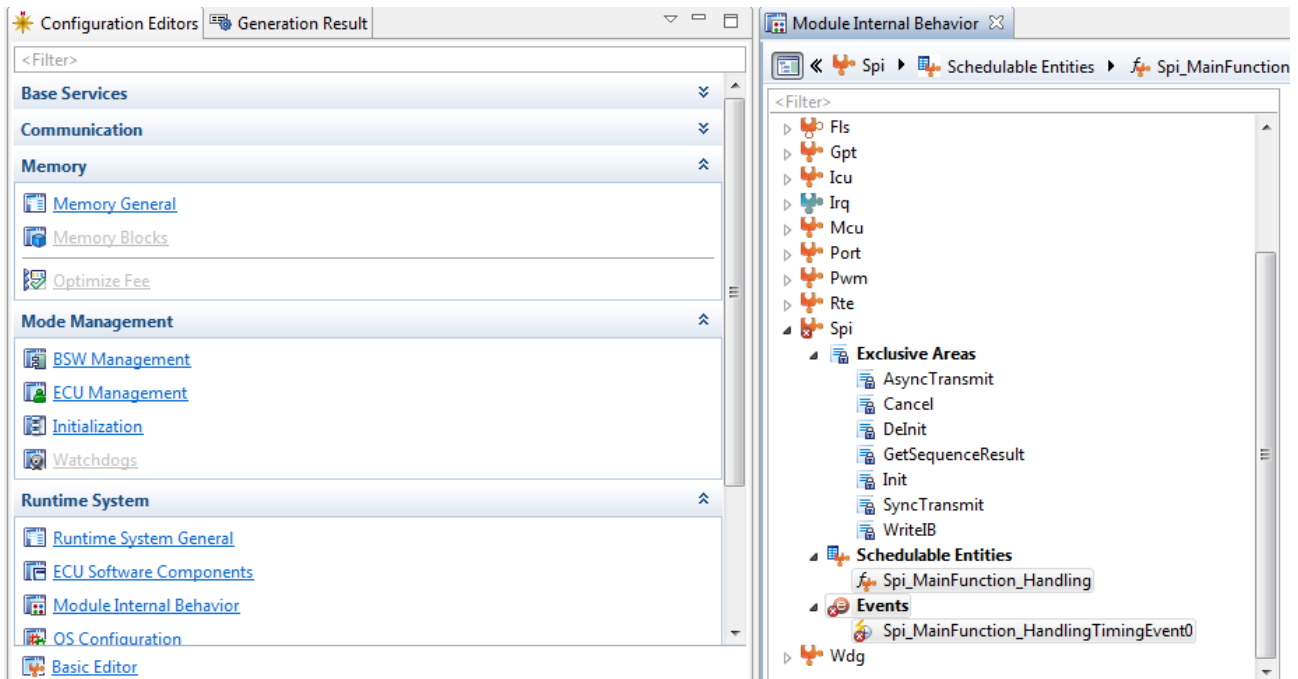
2.1.1.1 Extern Definition for the function `Spi_MainFunction_Handling` is defined with a compiler switch.

The function `Spi_MainFunction_Handling` is called unconditionally in the file `SchM_Spi.h` without any compiler switch but the extern definition of this function is defined in `spi.h` file with a compiler switch.

This leads to an error as below.

`gendata/SchM_Spi.h:33: arguments given to macro 'Spi_MainFunction_Handling'`

Remove the configuration for Spi_MainFunction_Handling in

Runtime System → Module Internal Behavior → Spi → Schedulable Entities and Events

Please see the below image for some more information.

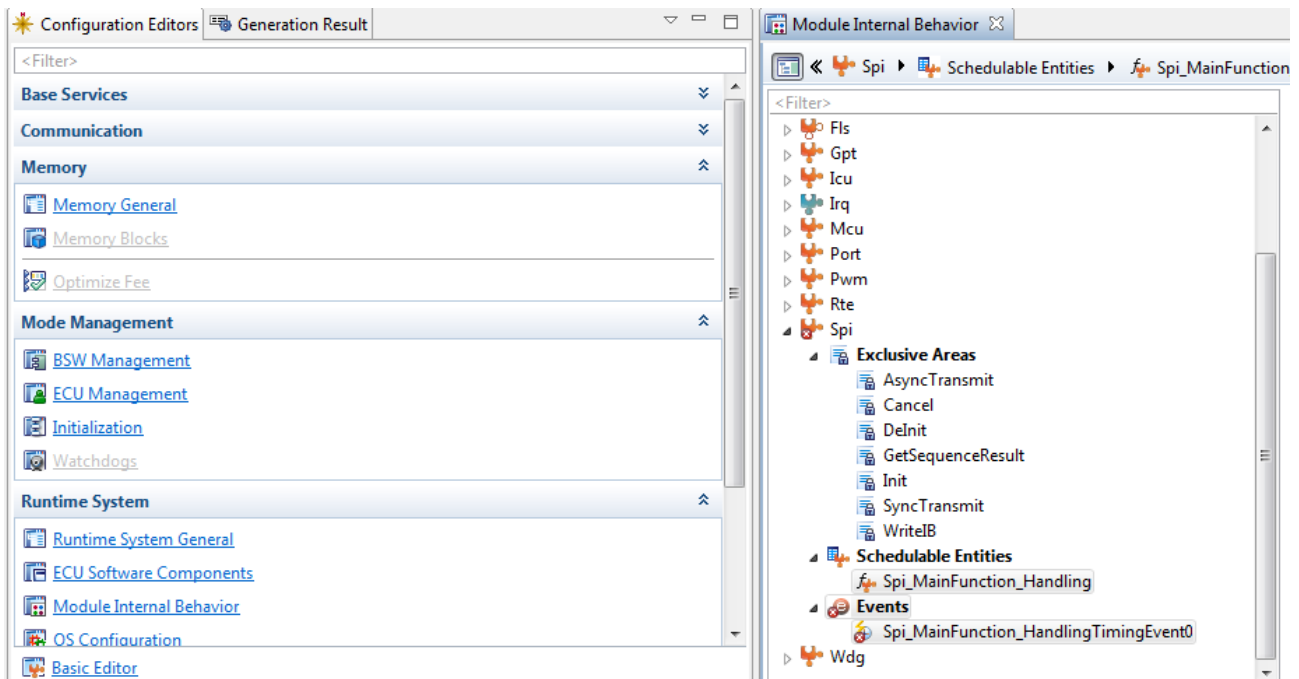
2.1.2.10 Extern Definition for the function Spi_MainFunction_Handling is defined with a compiler switch.

The function Spi_MainFunction_Handling is called unconditionally in the file SchM_Spi.h without any compiler switch but the extern definition of this function is defined in spi.h file with a compiler switch.

This leads to an error as below.

In file included from ../../external/BSW/./ThirdParty/Mcal_Tc3xx/Supply/MC-ISAR_AS42x_AURIX2G_TC38xA_TC39xB_BASIC_1.0.0-beta/McIsar/Src/Mcal/Tricore/Spi/ssc/src/Spi.c:75:
gendata/SchM_Spi.h:33: arguments given to macro `Spi_MainFunction_Handling'

Remove the configuration for Spi_MainFunction_Handling in

Runtime System → Module Internal Behavior → Spi → Schedulable Entities and Events

Please see the below image for some more information.

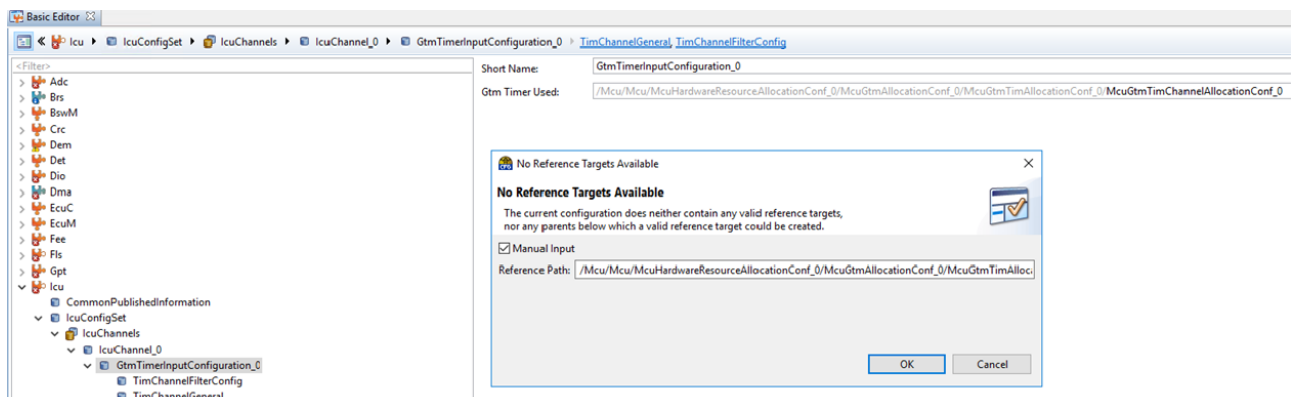
2.1.2.12 Icu: Wrong Reference Value to Gpt Timer Configuration

The Icu module description file Icu.bmd contains a wrong value for the parameter GtmTimerInputConfiguration_0 in the container /Icu/Icu/IcuConfigSet/IcuChannel_0. As a workaround, you might add the following manual input for the reference value in the DaVinci Configurator 5 Basic Editor view (consider the configured names of the Mcu containers):

```
/Mcu/Mcu/McuHardwareResourceAllocationConf_0/McuGtmAllocationConf_0/McuGtmTim
AllocationConf_0/McuGtmTimChannelAllocationConf_0
```
