2111 PLUM ST,  
AURORA, IL, 60506

Roof Condition:

THE CINCINNATI  
INSURANCE COMPANIES

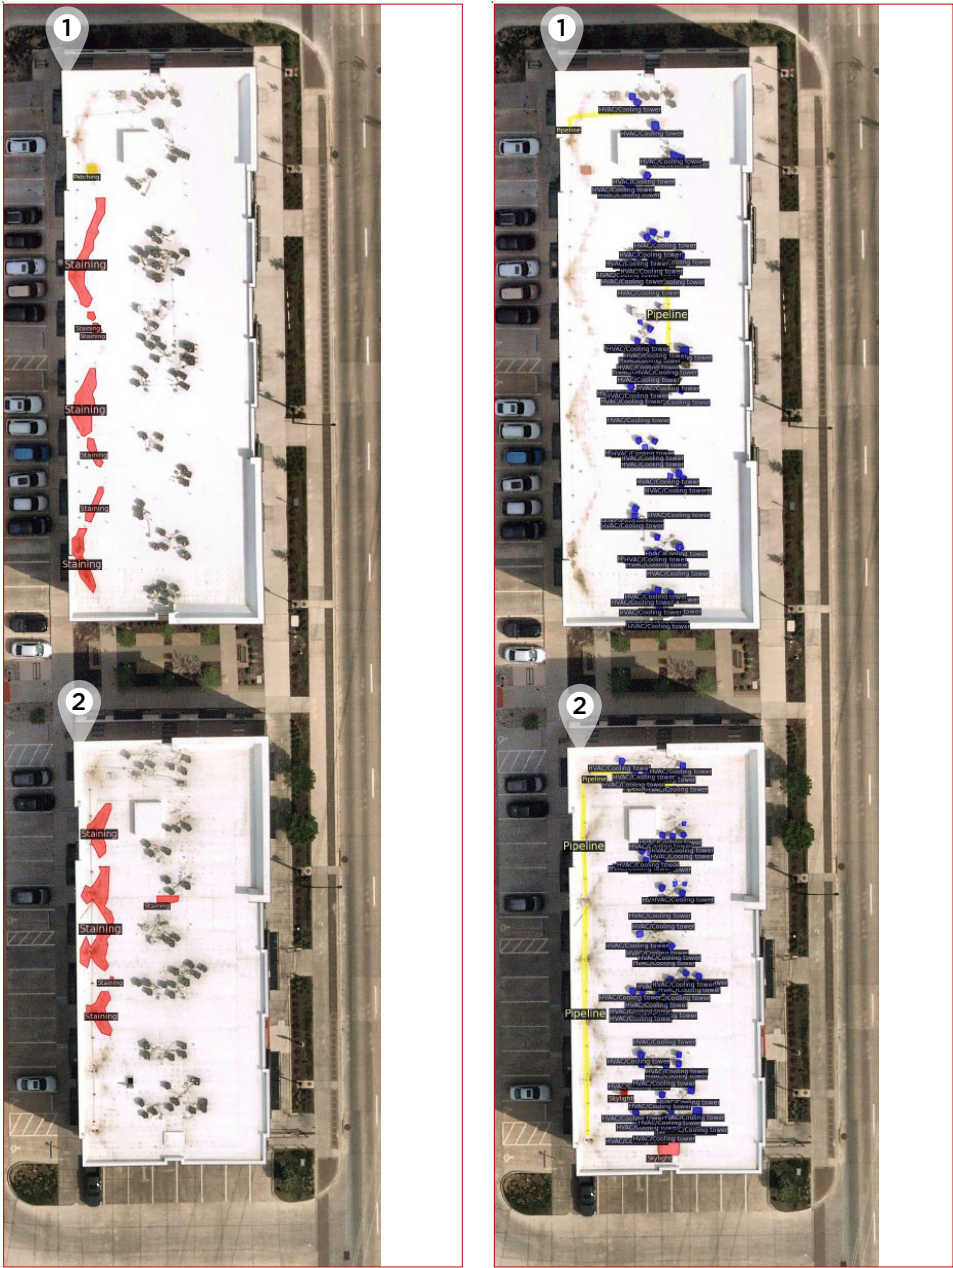
DAMAGE:

EQUIPMENT:

2

1

Patching

Staining

Water pooling
