FAILURE ANALYSIS AND SCENARIO PROBABILITY IN GAS LEAK CONTAINMENT SYSTEMS

*ASSESSMENT TASK 3 – QUANTITATIVE RISK
ASSESSMENT AND DECISION MAKING*

49006 RISK MANAGEMENT IN ENGINEERING - SPRING 2024

Lucien GHEERBRANT

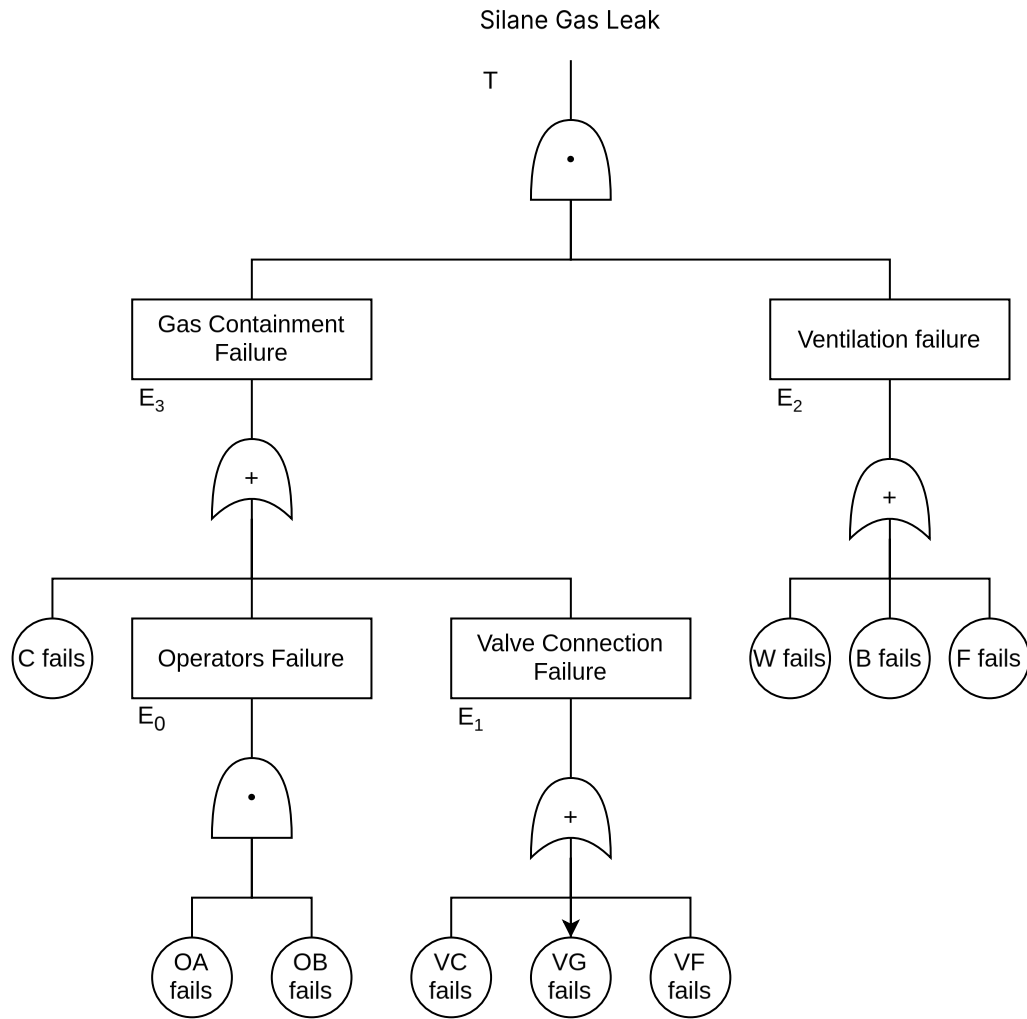
Figure 1: FTA of the saline gas incident

[Figure 1](#) illustrates the FTA of the silane gas leak incident. The top event is the Silane Gas Leak, which can occur due to either Gas Containment Failure or Ventilation Failure.

The Gas Containment Failure branch is driven by two key factors: Operator Failure and Valve Connection Failure. Operator failure arises when the operators fail to follow the proper procedure, which is compounded by the absence of a second operator. Valve connection failure occurs when any of the components involved in the gas transfer, including the Gas Cylinder Valve (VG), the Valve Connection System (VC), or the Furnace Valve (VF), malfunctions.

The Ventilation Failure branch highlights the failure of the ventilation system to evacuate the leaked gas. This includes failure to open the Ventilation Window (W), and mechanical failures in either the Ventilation Blade (B) or the Ventilation Fan (F).

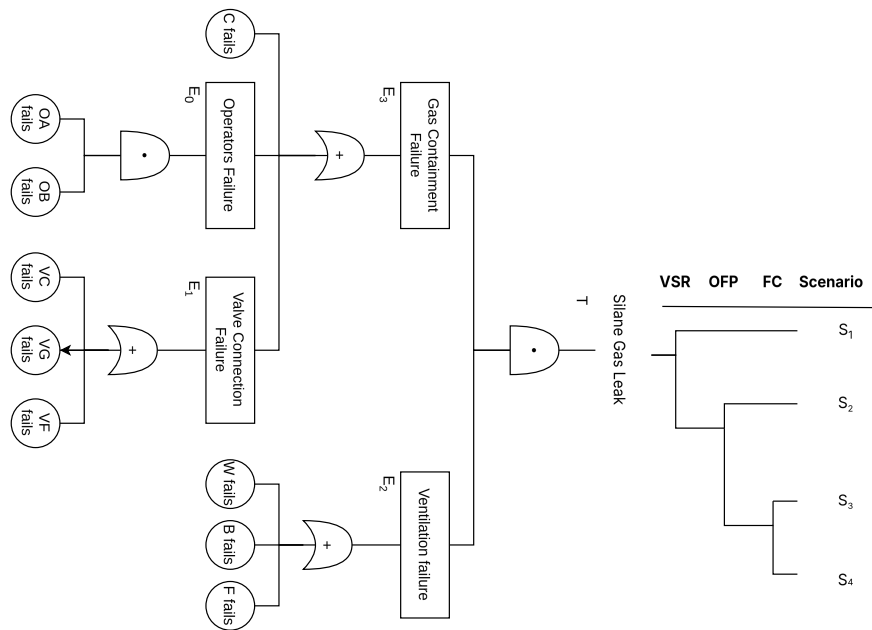
Table 5: BT of the incident

Table 5 illustrates the BT of the incident, with the gas leak as the central event. On the left side, the diagram identifies key causes of the gas leak, including operator failure and valve connection failure under gas containment, as well as ventilation failure. Notably, the operator appears twice—first as a cause when procedures are not followed, and later as a barrier tasked with detecting the gas leak through proper testing, such as the post-purge and leak test.

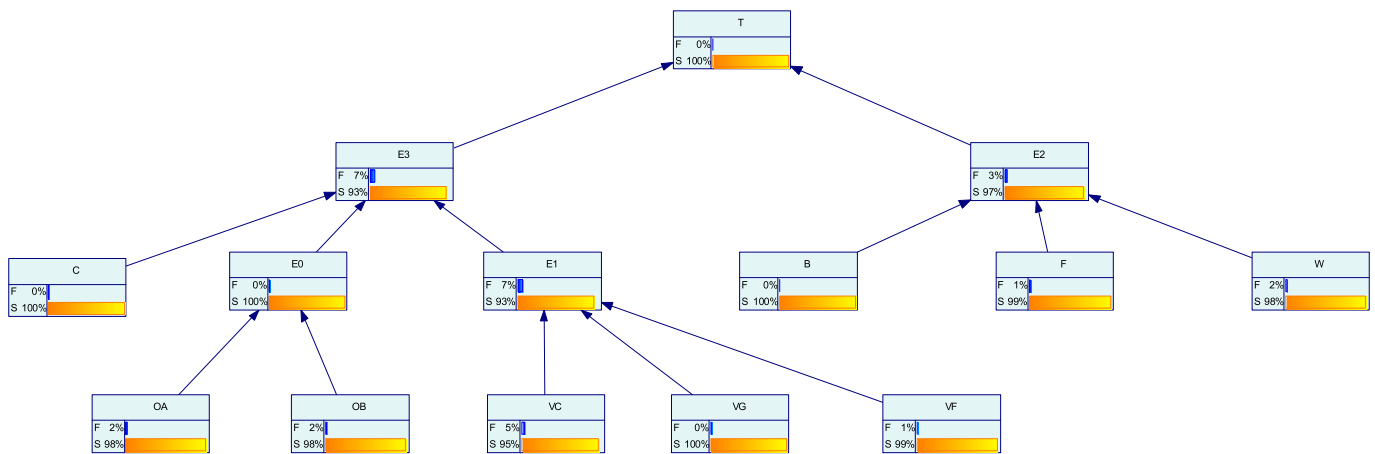
Figure 2: FTA to BN Conversion

Figure 2 illustrates the conversion of the FTA into a BN for the silane gas incident using the GeNIe software. These values align with those listed in Table 3.

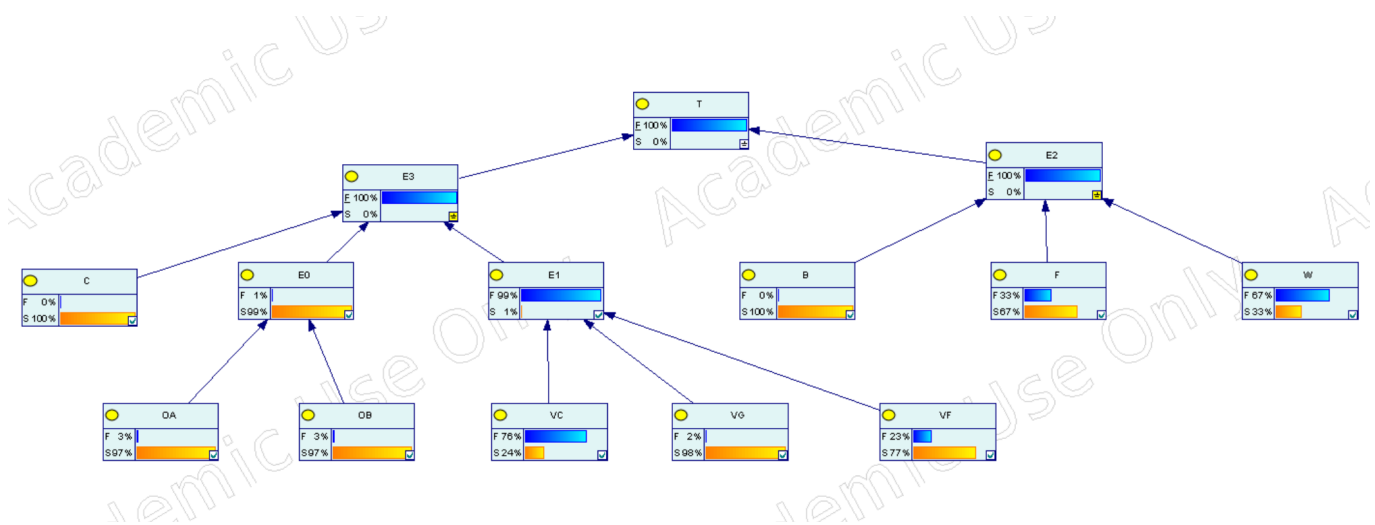
Figure 3: BN, Posterior variation

Figure 3 is a posterior BN. It reflects the updated probabilities after adding evidence of the accident event (gas leak). With this evidence, the failure (F) and success (S) probabilities for each component have been recalculated. The updated values for each component are provided in Table 9.

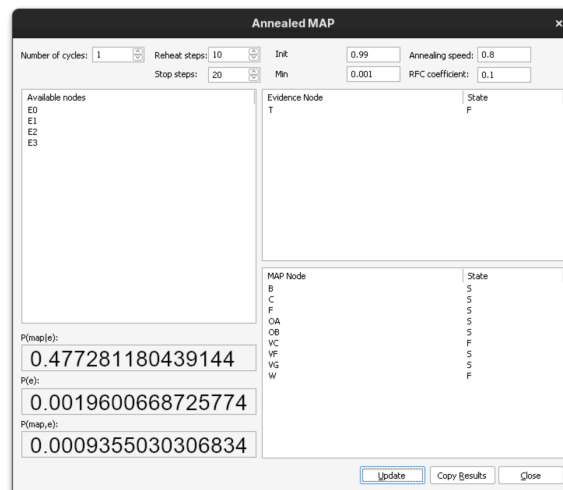
Figure 4: Most probable scenario calculation

The Annealed MAP (Figure 4) analysis in the image above shows the most probable scenario leading to the gas leak, indicating that the Valve Connection System (VC) and the Ventilation Window (W) are failing, while all other components state. $P(\text{MAP}|e)$ is 0.0477, making it the highest-probability configuration for explaining the failure.

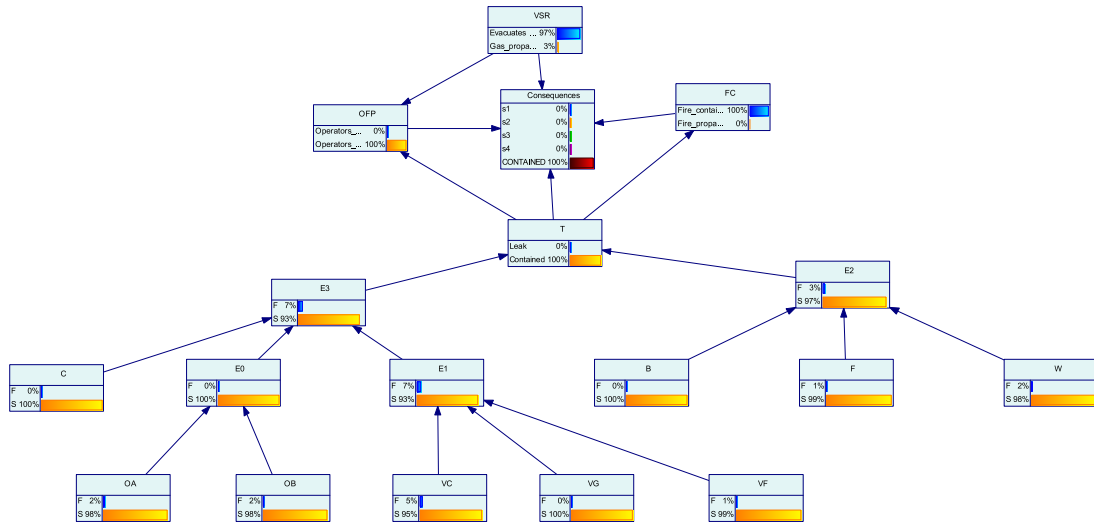
Figure 5: BT to BN Conversion

Figure 5 shows the BN derived from the BT analysis of the silane gas incident.

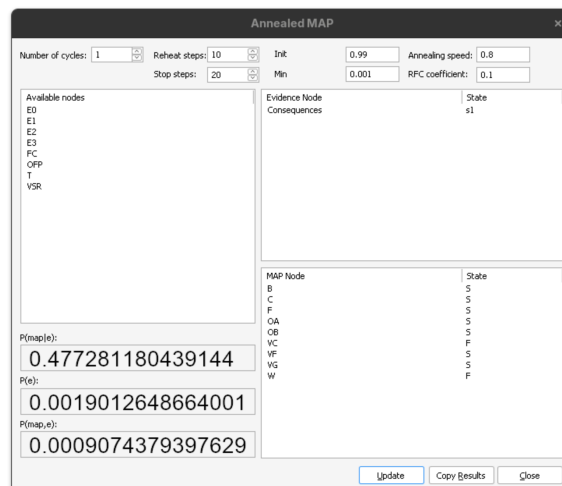
Figure 6: MPE analysis for minor damage scenario (S₁)

In the Annealed MAP (Figure 6) analysis for this BT to BN model, the most probable explanation was determined with S1, which is the most probable scenario. According to this scenario, the most likely cause involves failures in both the valve connection and ventilation window, with all other components operating successfully. It has a probability of 0.48.
