# INFRASTRUCTURE DIRECTORATE

MONTHLY REPORT – FEBRUARY 2019

MATJHABENG MUNICIPALITY

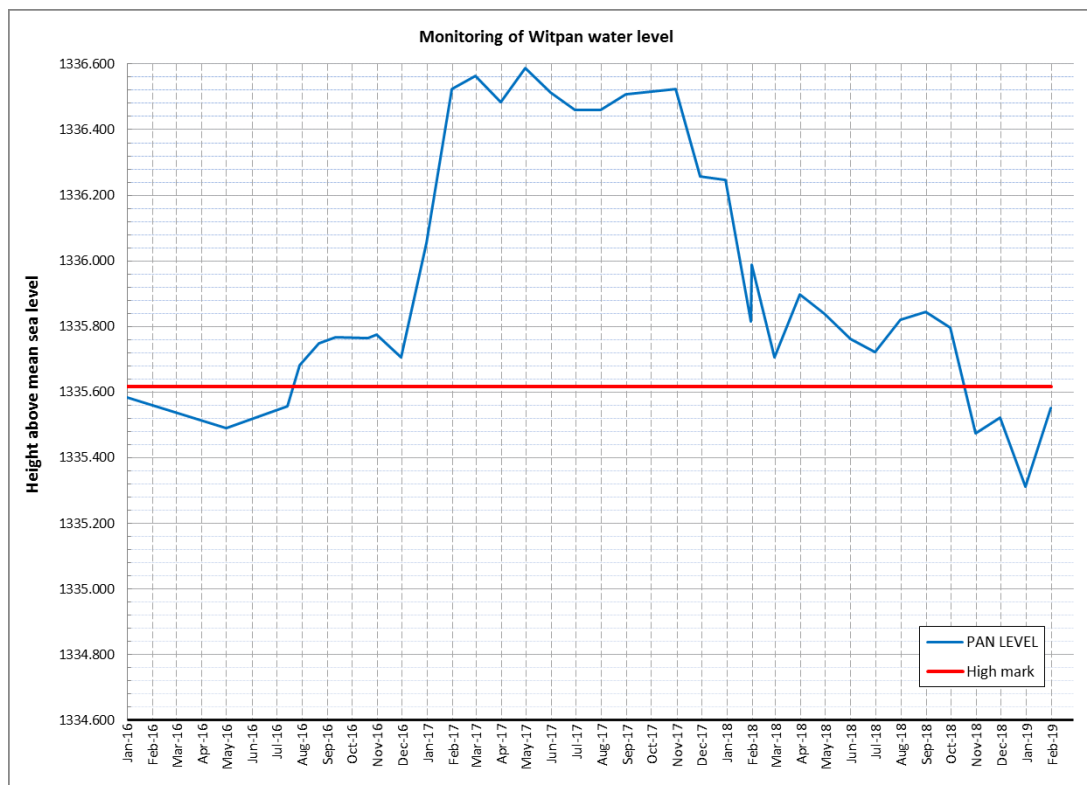
### WITPAN

The pan's level has been relatively stable during the past few months. It is however rising and it is now just below our critical level (Klippan Road). It is critical that the pump station be made more effective.

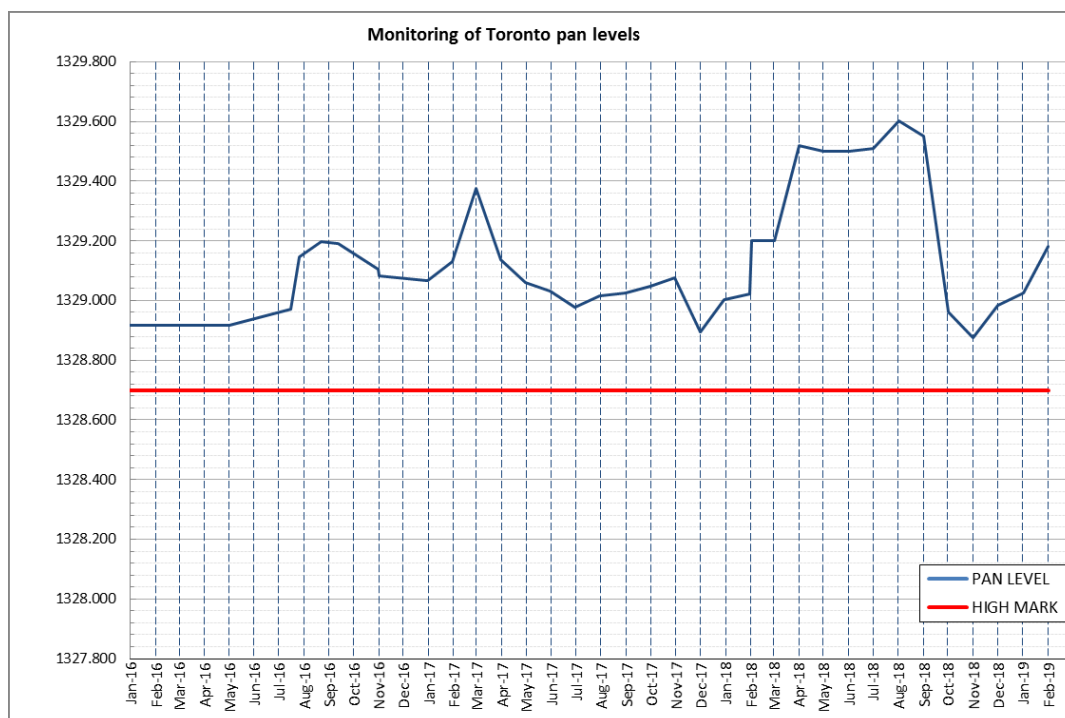
### TORONTO PAN

The pan's level has steadily risen during the past few months. The upgrading of the Geelwortel Channel is urgently required..

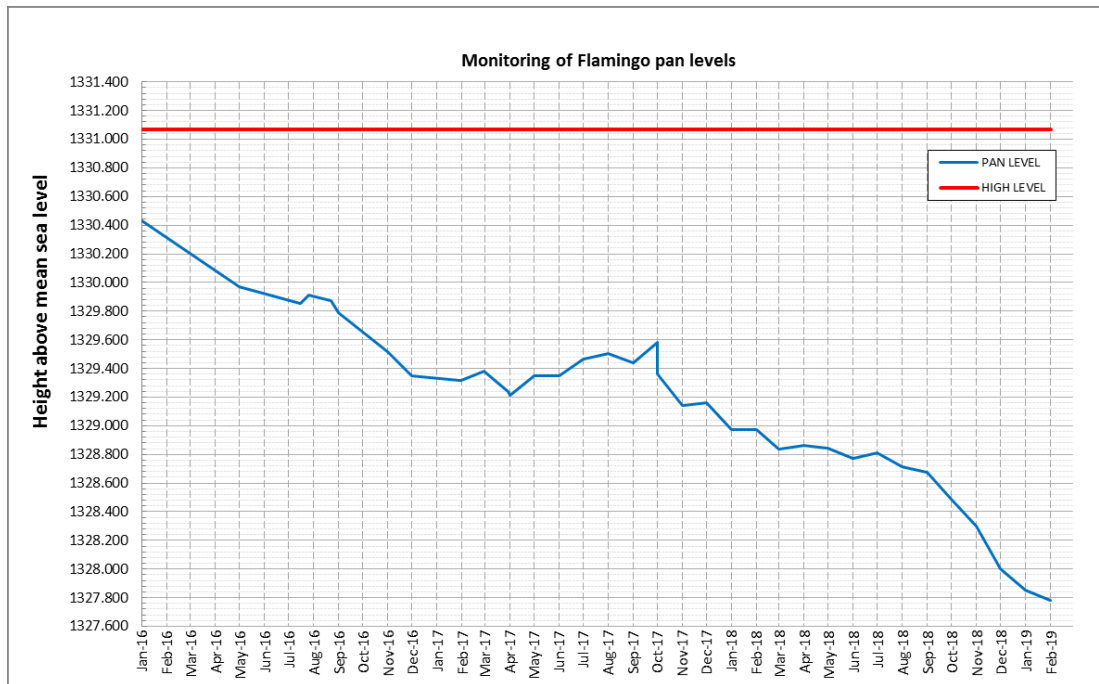
### FLAMINGO PAN

This pan's level has steadily dropped during the past few months. This was mainly due to no inflow from Theronia Pan as well as no or little rainfall. It is recommended that the purified irrigation system urgently be made operational again to ensure long term management of the level.

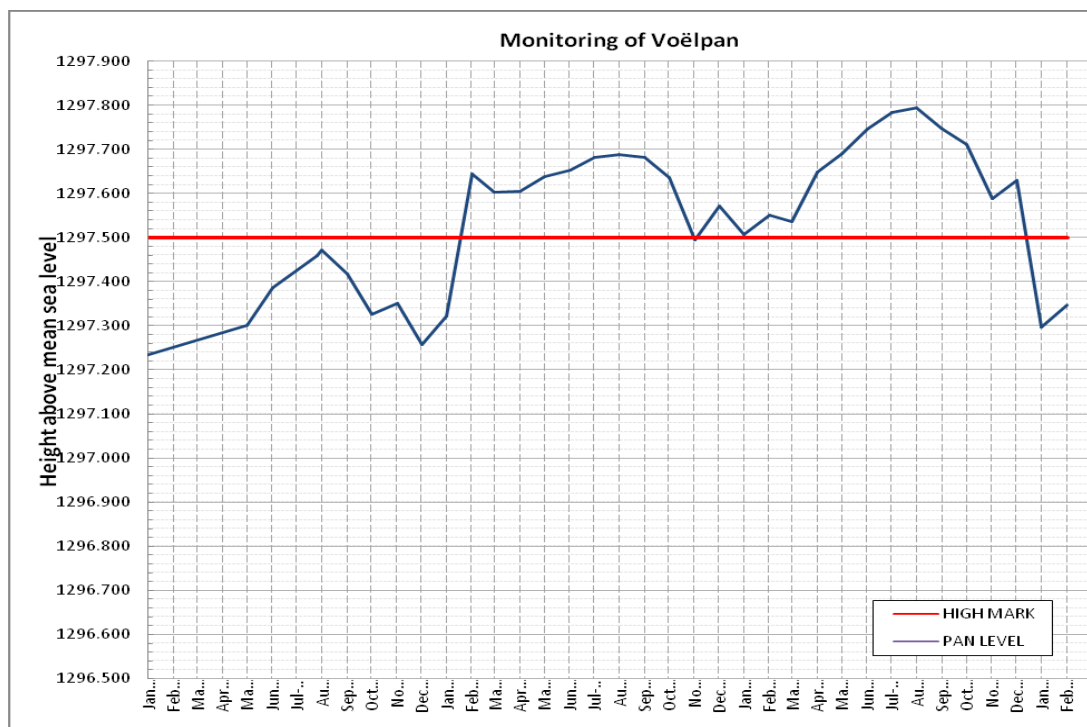
#### VOëLPAN (ALLANRIDGE)

This pan's level has slightly risen during the past month. No immediately problem is foreseen.
