# Solar Array Charging Test Report

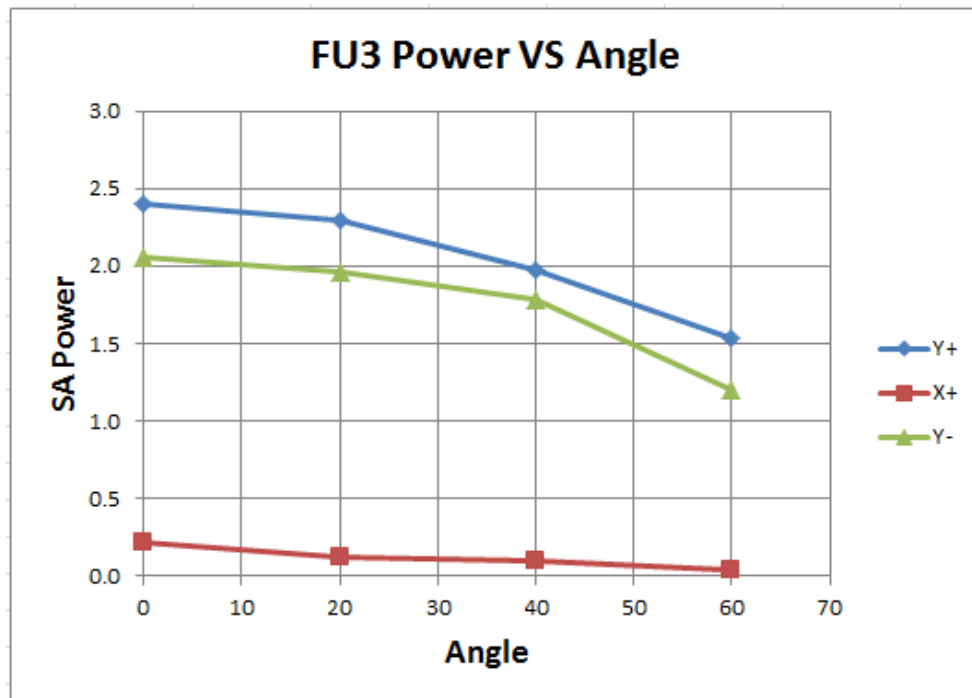
**Figure 2: FU3 SA Power VS Angle**

Figure 2 shows FU3's SA power vs the angle.

This test showed that the Y+ and Y- sides of both flight units provide adequate power. What is troubling is that the X+ sides of both Flight Units provide little power compared to the others. While it was originally thought during the tests that this was caused by the batteries being full, this turned out not to be the case because the Y- side on FU3 was providing adequate power and the Y- side was tested after the X+ side.

Other hypothesizes is that it may be an issue with the actual solar cell or an issue with connectivity. Further testing would need to be done to find the issue with the SAs on the X+ sides of the flight units.

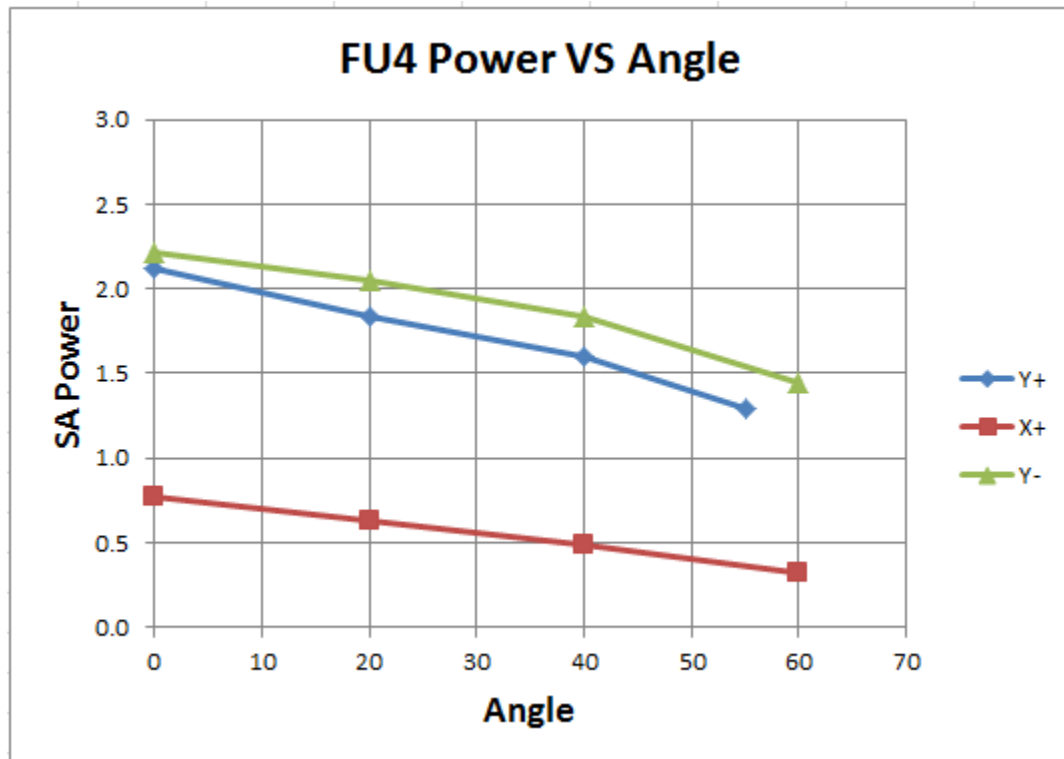
Figure 3: FU4 SA Power VS angle

Figure 3 shows FU4's SA Power VS angle.
