WEEK3

18.Mar-25.Mar

Xingchen MA

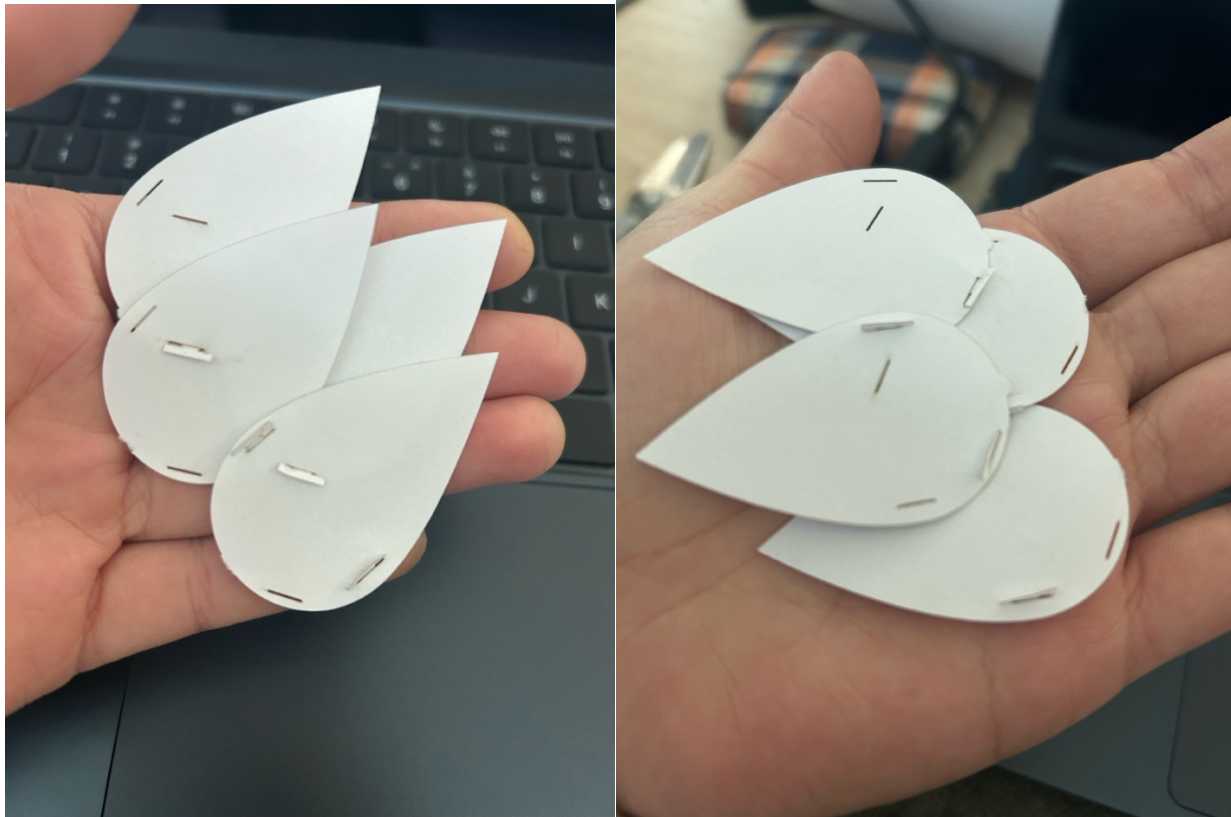
I adjusted the problem that occurred last time, re-laser cut, and now it is successful

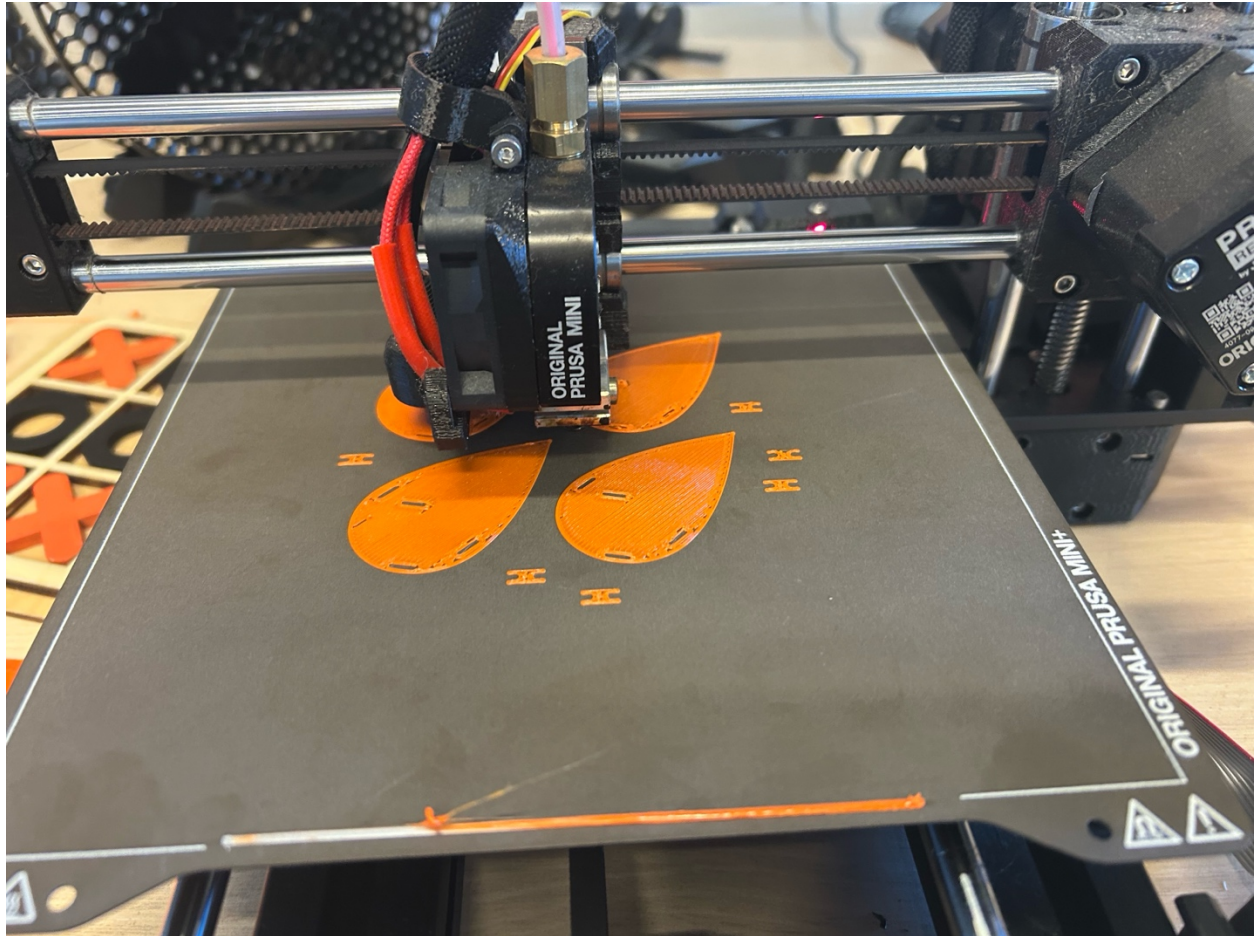
The printing result is a failure. The reasons are as follows: 1. Due to precision issues, my connection part cannot be inserted into the gap. I can scale my design to solve this problem; 2. Even if the connection part can be inserted, it is not long enough to provide a certain degree of mobility for the entire component.
