Anterior and posterior  
maryland bridge &  
posterior indirect  
restoration  
Mrs J

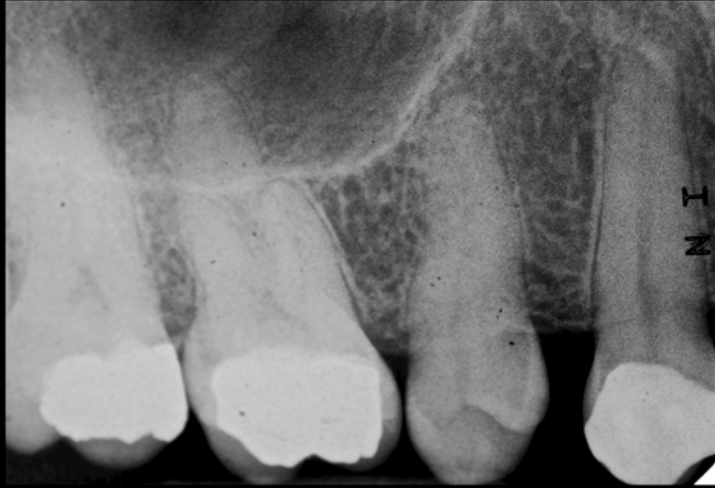
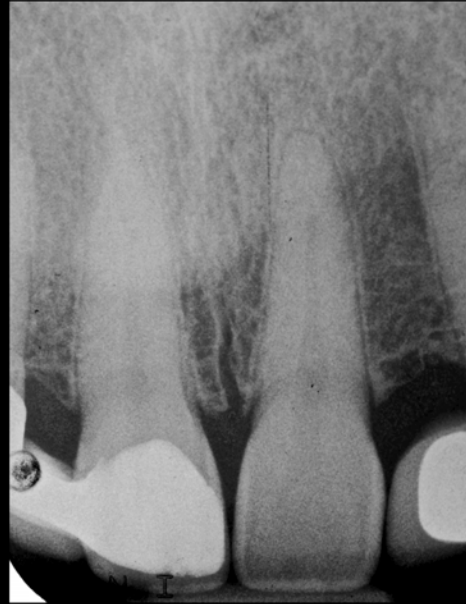
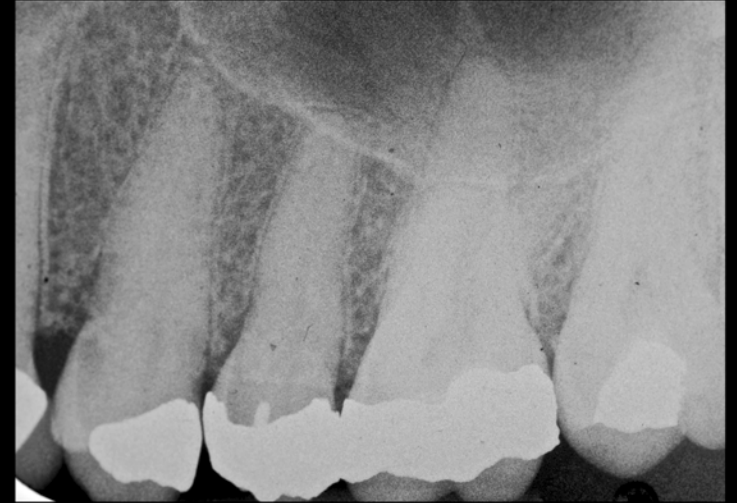
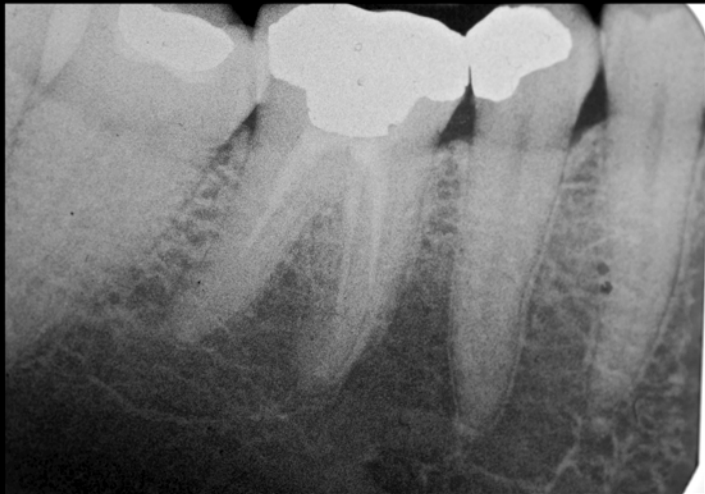
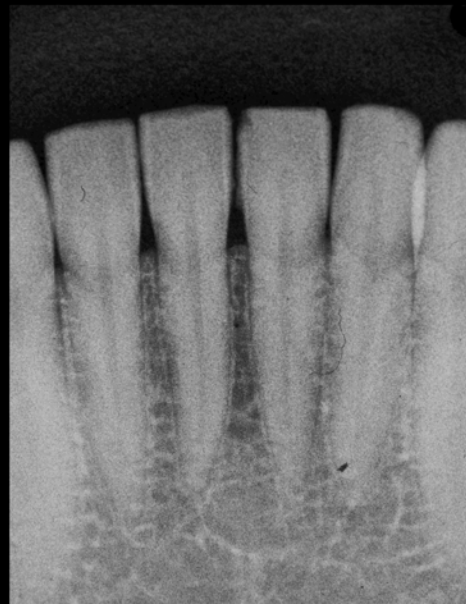
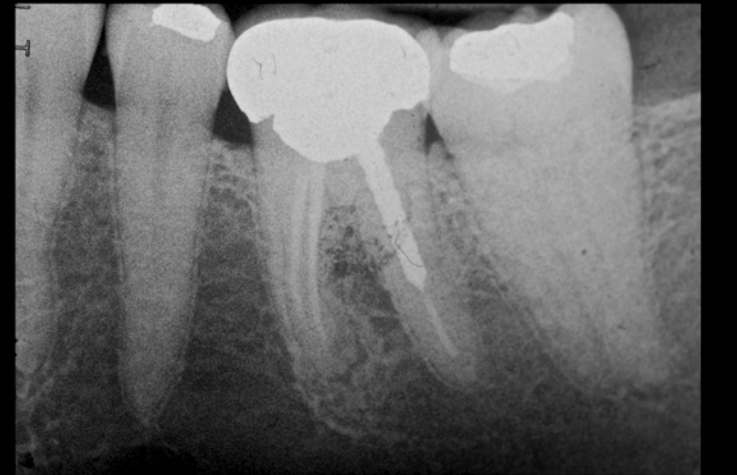
# Radiographs taken 21/3/12 & 2/1/09

- Bone levels good
- very heavily restored dentition
- 46 RCT is very short though there is no associated peri apical pathology
- 36 RCT is short also with periapical pathology associated with the mesial roots
- Drifting of the roots has made the 14,12 and 22 spaces unsuitable for implants as it stands

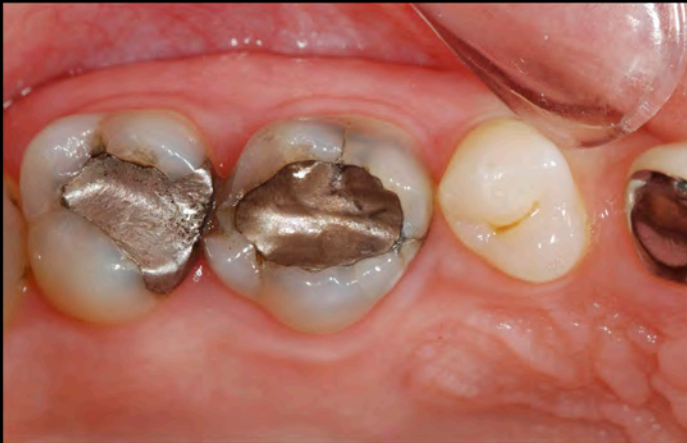
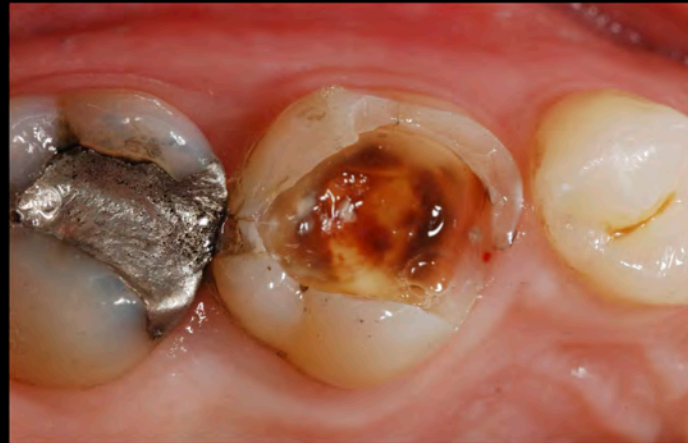
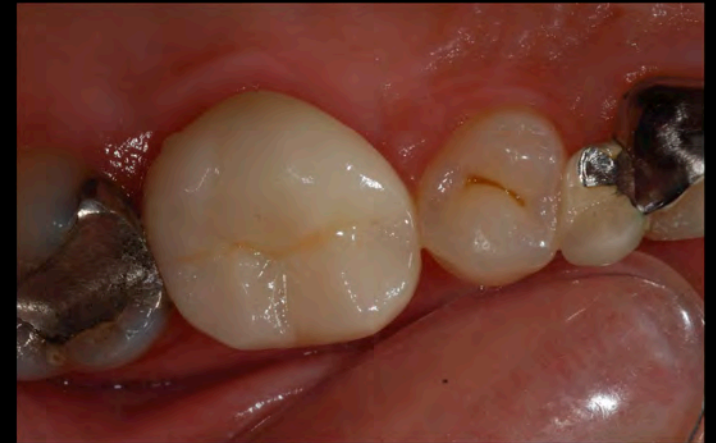
# Restoration of 16

Tooth 15 was heavily filled with thin walls and caries. All of the old amalgam and active caries was removed leaving very little coronal dentine and thin enamel walls. This vital tooth required full occlusal coverage preferably without requiring RCT. Based on Mrs J's aesthetic demands an e max ceramic onlay was chosen. The tooth was prepared with a 1mm chamfer and all the internal edges were rounded. The preparation was then immediately dentine sealed with optibond FL as per manufacturers instructions. Impressions were then taken and the provisional constructed using glycerine jelly to ensure it did not bond to the preparation

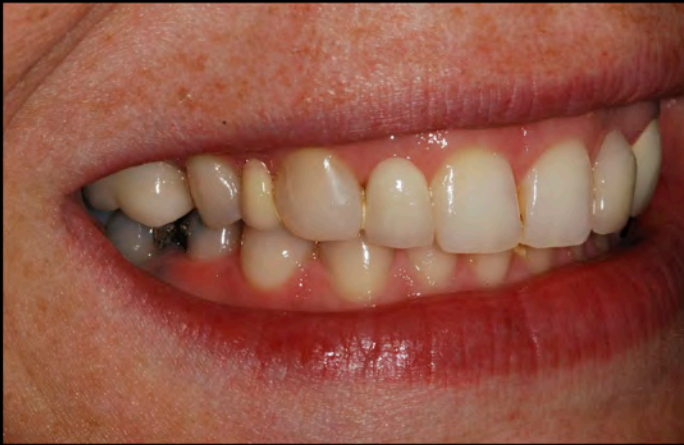
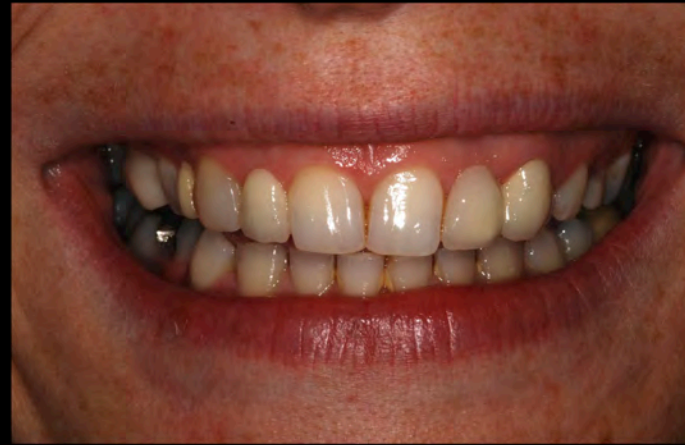
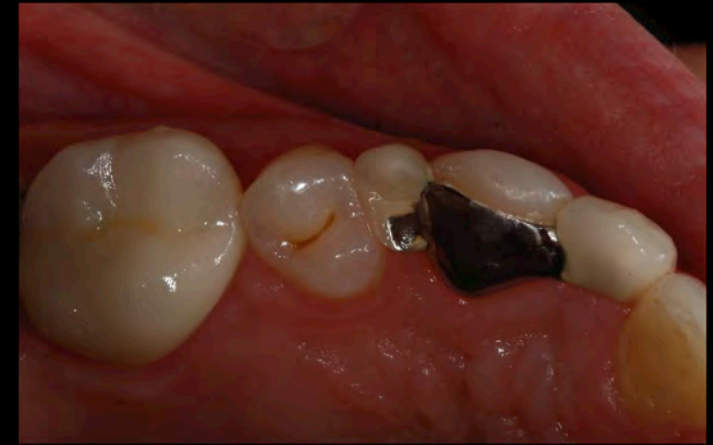
# Finished treatment photos 17/6/12

The bridge and crown have integrated well into this lady's smile and occlusion. As there had been a metal wing previously the occlusion was restored. Perhaps there is more cement evident between 13 and 12 than would be ideal. Obviously the porcelain on the 14 wing is at an increased chance of # as it appears realitively unsupported palatly, however the forces applied in this area should be minimal.

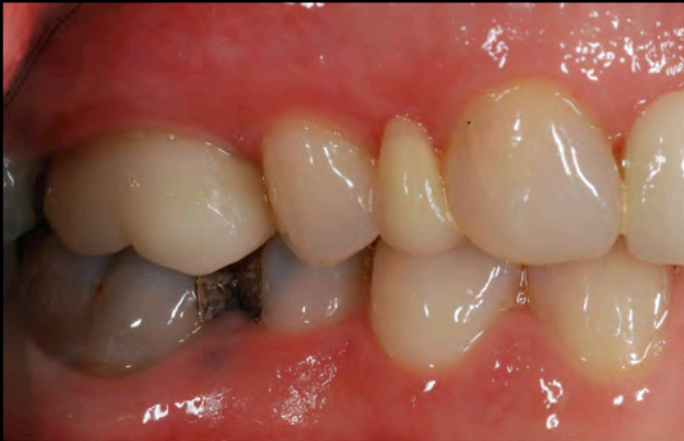
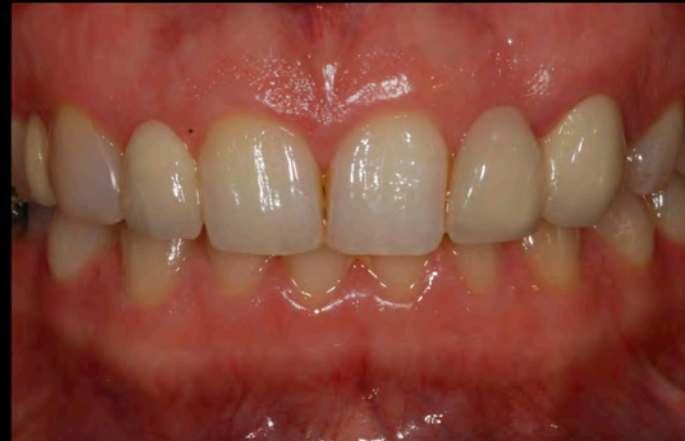
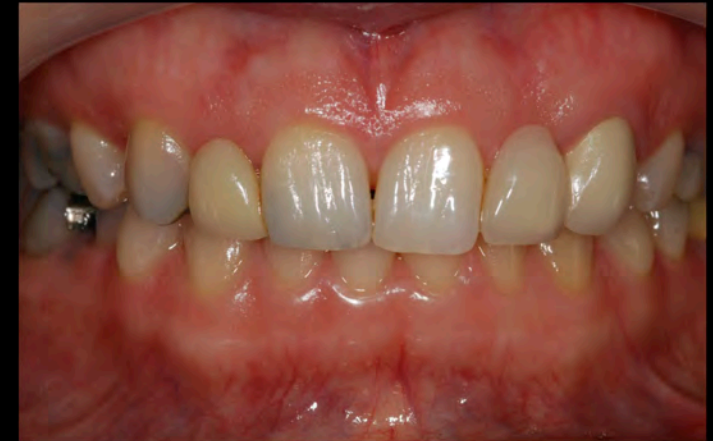
The E max crown has integrated well while preserving the vitality of 16.
