**DEPARTMENT OF CIVIL AND  
CONSTRUCTION ENGINEERING  
MATERIALS AND STRUCTURE TEST  
CT3902301**

# **Final Project Report**

**8th June, 2024.**

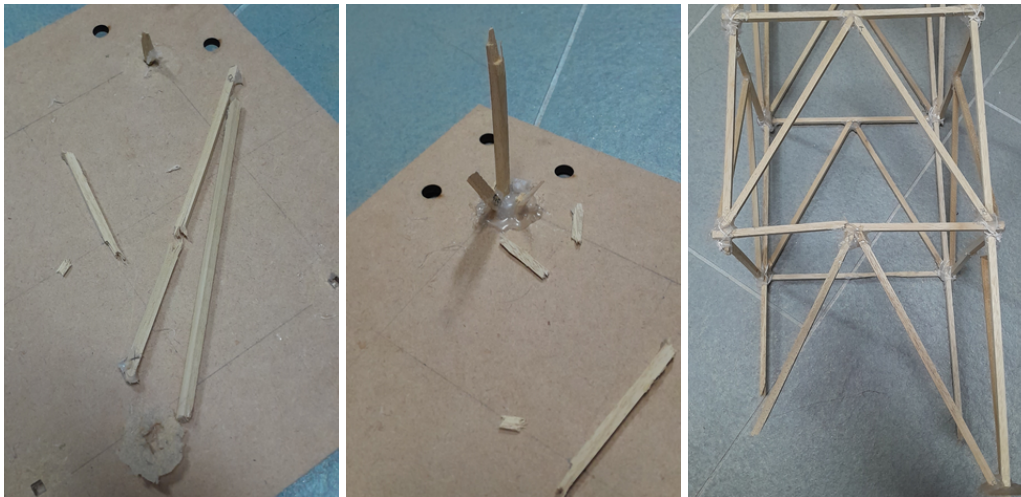
***Figure 18.*** Failure points of the structure.

During the test in the shake table, when the first 250 gal was applied, our structure showed a very elastic behavior, having among the other 3 structures the most displacement, however no sign of failure was visible in columns, this was not the case for one of the trusses on the first floor. For the second test of 400 gal, our structure suffered several failures in the trusses, especially on the first floor, and even failure on one of the beams was visible, however the structure did not collapse and the beams stayed intact, it was during the 500 gal test when the columns of our structure fail, with three out of four breaking and causing the structure to collapse, during the collapsing we could see that the base of the structure was still attached to the base indicating a well-designed foundation, so the causing of collapsing was the columns breaking on the first floor. Our structure sustained the 250 gal, 400 gal, and it failed during the 500 gal test.

Unfortunately, our structure failed during testing, with columns breaking in half. This failure highlighted the importance of column thickness in withstanding seismic forces. Additionally, we observed that trusses at the base failed while those on upper floors remained intact, suggesting weak joints in the base trusses. Strengthening these joints could have improved the structure's resilience.
