**mcHF Hardware modifications as of April 29, 2015
as compiled by KA7OEI for
Version 0.3/4 UI and Version 0.4 RF boards**

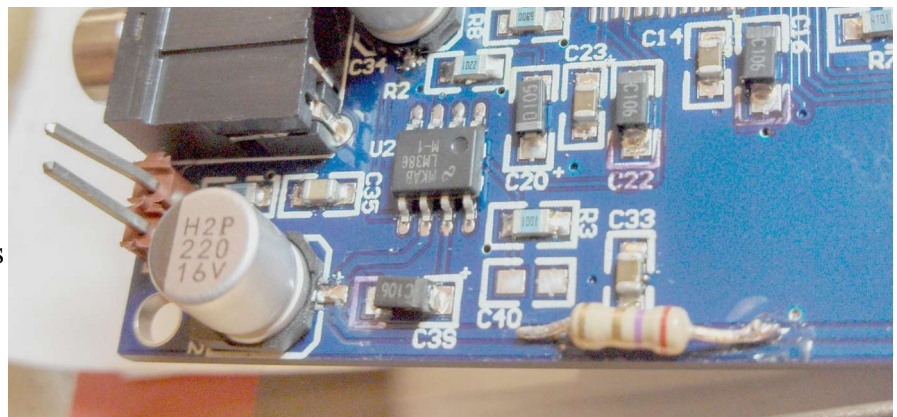
This is an important modification that fixes one source of oscillation at high volume levels.

The 4.7 ohm resistor added to the UI_8V line feeding U2, the audio amplifier.

from appearing on the 8 volt line which, in turn, causes audio to appear on the ground busses and other power supplies in the radio which can cause feedback, particularly at high volume levels with wider audio filters.

The insertion of a 4.7 ohm, 1/2 watt resistor in series (or two 10 ohm 1/8 watt resistors in parallel) with the +8 volt line, near the LM386 audio amplifier.

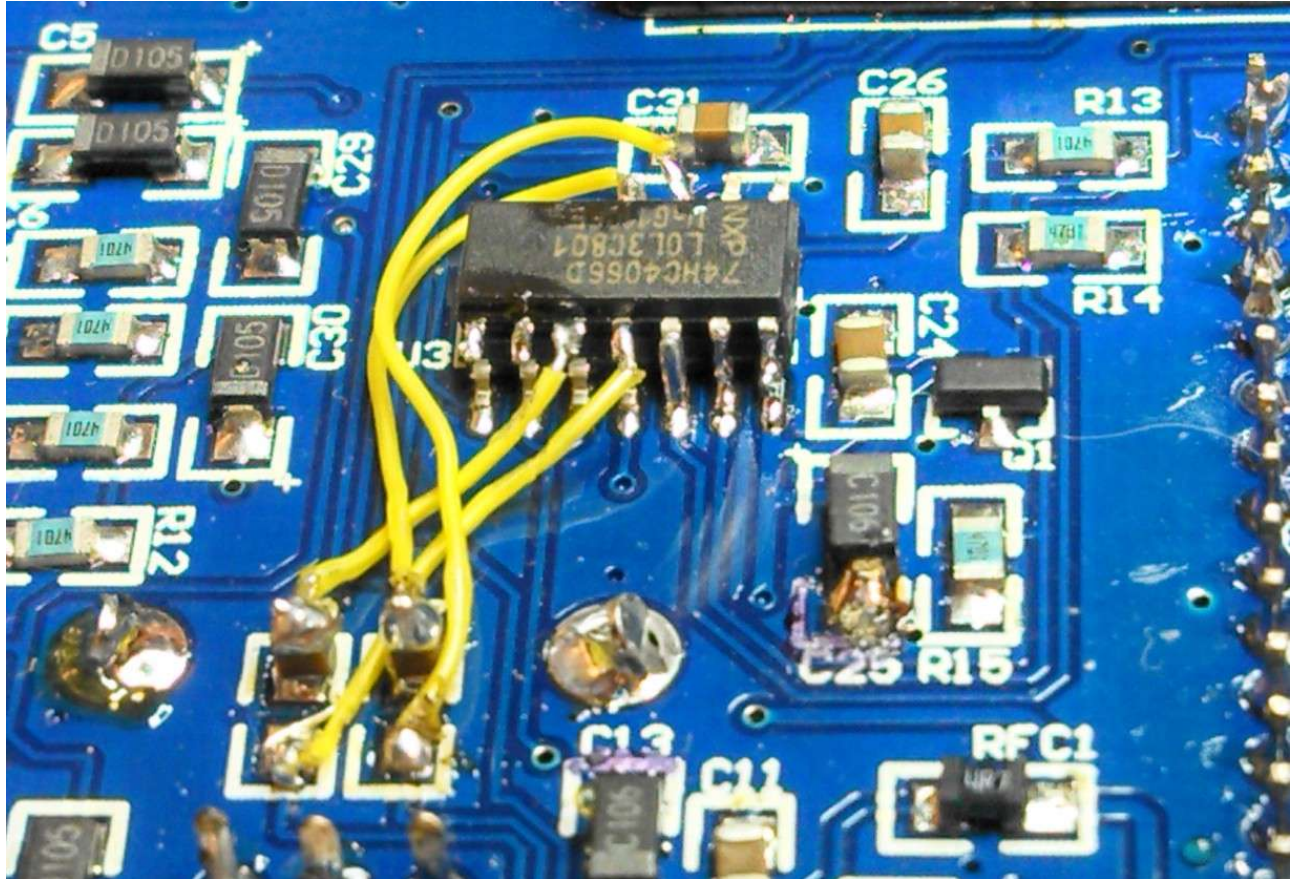
This fixes a source of distortion/oscillation in the receiver, particularly at high volume levels and on high bands: **This is a very important modification that all users of this transceiver should perform.**

The "U3a" modification, piggybacking another 74HC4066 atop U3 to prevent feedback into the receiver.

This modification prevents “breakthrough” of the TX QSD mixer (U17) caused by the fact that the Codec's DA is shared both for RX audio and TX modulation. Because the audio drivers for the TX modulator (U20-U23) are powered from 8 volts it is possible for high RX level audio to violate logic levels at U17, turning it “on” on voltage peaks: The result of this is highly-distorted, on-frequency noise/feedback.

Take a 74HC4066 chip, of the same type and package as U3 and piggyback it atop U3 (on the UI board) and use its power supply and control signals. This chip will now be able to turn on/off the TX I and Q signals with a bit of fairly simple rewiring. Let us call this new chip "U3a"

- On the new 74HC4066, U3a, bend pins 5, 6, 7, 12, 13 and 14 straight down using a VERY FINE pair of needle nose pliers or tweezers. Bending these leads down will cause them to be just long enough to allow them to be overlaid atop U3 and connected to it.

- Bend pins 1, 2, 3, 4, 8, 9, 10 and 11 of U3a straight out using a the same pair of very fine needle nose pliers or tweezers.
- Set this chip atop U3, making sure to align pin 1 with pin 1.

- Using a VERY FINE tip, solder pin 14 of U3a to pin 14 of U3.
- Align pin 7 of U3a to U3 and solder.
- Now solder pins 5, 6, 12 and 13 of U3a to U3.
- Remove capacitors C7 and C8 and stand them on end, attaching them to the pad closest to U3, the upper pad. This will leave the lower pads of C7 and C8 empty. *You may turn C7 and C8 around, the “open” end facing U3 rather than standing them on end, if you prefer.*

- Using fine-gauge wire such as #30 AWG wire-wrap wire, run leads to sections 1 and 4 of U3a. For example, the wires connecting across the connection of C8 would go to pins 1 and 2 of U3a and the connection of C7 would go to pins 10 and 11 of U3a. Which wire goes to which side of the switch does not matter, nor does which connection goes to which switch.

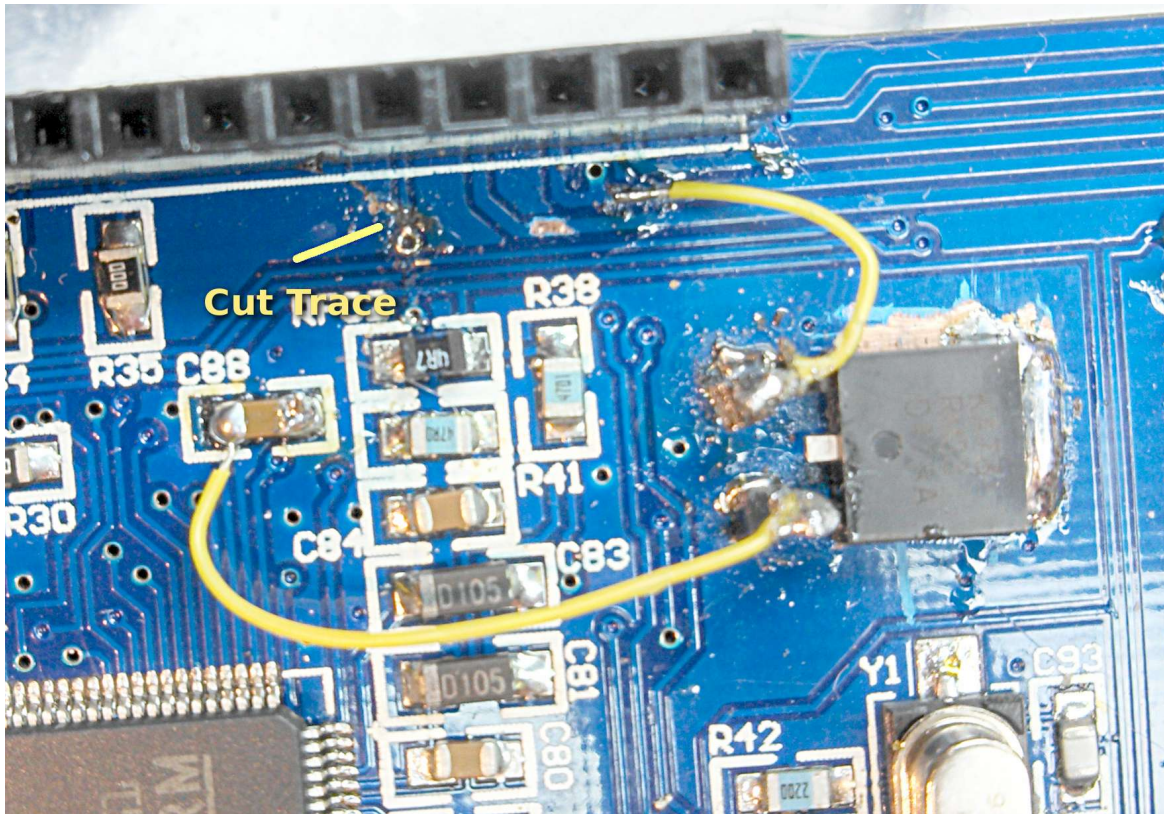
It has been determined that the *most sensitive power supply is the main +5 volt supply*. This appears to be due to the fact that receive QSD mixer (*U15 and related components*) have minimal capability for power supply rejection. Because of this, even millivolt-level modulation of the +5 volt power supply with audio frequency signals will yield artifacts that are readily audible at low/no signal levels.

The added 3.3 volt regulator to deliver an isolated power supply to U4a, the MCU. This reduces a noise source that can get into low-level RF and audio stages. The trace is cut just above the via. Note that this picture was taken before the addition of the 4.7 ohm resistors and additional capacitors described below and is included for clarity.

This leads to the recommended installation of another 3.3 volt regulator on the UI board for the MCU: This mod is actually easier than the "U3a" mod and uses the same type of parts as those that you'd already have gotten (e.g. another 3.3 volt regulator and two more 10uF capacitors.) This reduces one source of low-level noise – much of it in the form of a 1.5 kHz “whine” – getting into the receiver due to the MCU's modulation of current on the 3.3 volt line shared with low-level audio circuitry. Taken together, these two modifications can improve the receiver sensitivity by 2-3 S-units, depending on band.

The trace to isolate the 3.3 volt supply feeding the MCU is indicated on the picture and it should be cut **just above the via** that goes through to the other side of the board. The 3.3 volt output from the added

regulator is shown connected to the left-hand side of C88, below.

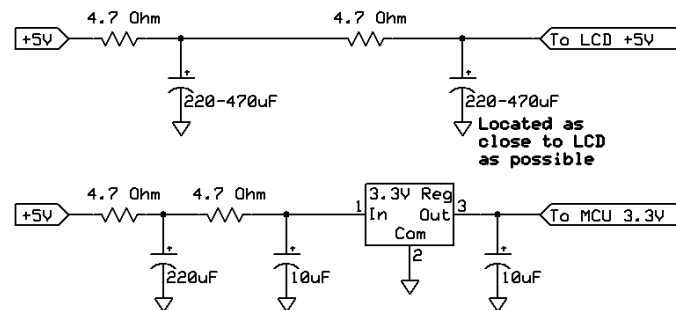
The diagram shows the filtering in schematic form. There is a voltage drop associated with each resistor, but each is well within the range of the associated device.

Diagram depicting the MCU's own, isolated 3.3 volt power supply. This also shows additional isolation of the LCD power supply as well as the suggested, separate 5 volt power supply for the UI board - see text.

- The LCD has an internal 3.3 volt regulator that has a (worst-case) dropout voltage of 600mV – and less than 1 volt is dropped across the two 4.7 ohm resistors.
- The MCU regulator drops less than 250 mV per 4.7 ohm resistor, leaving well over a volt of headroom for the low-dropout regulator.

For LCD filtering, place the noted capacitor as close to the LCD's pins as possible – preferably **at** the LCD itself! The 4.7 ohm resistors and the other capacitor may be placed farther away, but the second capacitor should be placed as close to the LCD's ground as well.

On the 3.3 volt MCU regulator, the 220uF capacitor on the input side of the 3.3 volt regulator, along with the 4.7 ohm resistors, form a low-pass filter that provides an impedance path between the noise source at the input of the regulator and the capacitor, greatly improving its ability to filter. The other 4.7 ohm resistor provides isolation between the noise that remains at the 220 uF capacitor and the rest of the 5 volt bus in the transceiver.

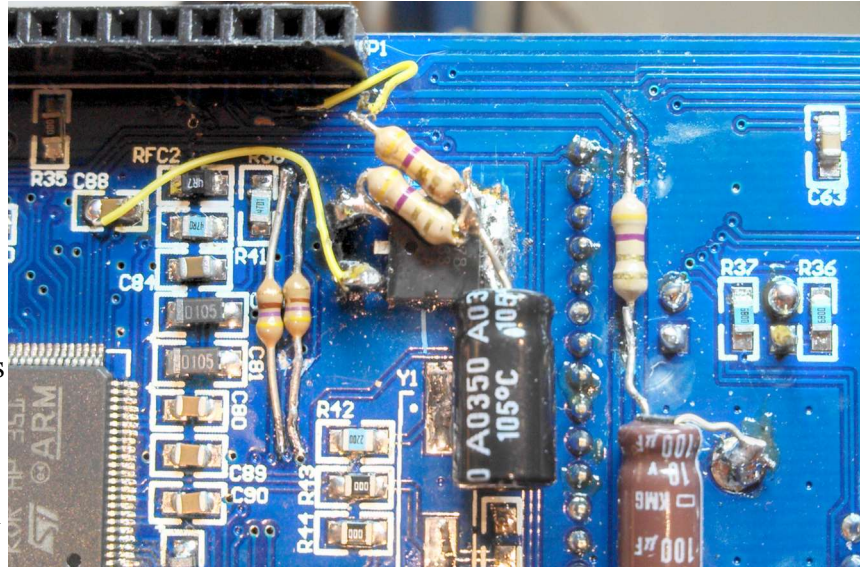
With the increase in sensitivity due to the reduced receiver background noise there may be the additional tendency for audio feedback to occur at high volume levels, particularly with no antenna connected *when using a speaker*. This is related to circulating currents on the UI board, some of which were addressed with the addition of the 4.7 ohm resistor in series with the 8 volt line on U2 noted earlier in this document.

The modifications showing the 3.3 volt regulator (center) and increasing the capacitance of C32 to filtering and the additional filtering of the 5 volt LCD line (right). 1000uF can reduce this effect, as The resistor to filter the "tick" (see next section) are also visible. can the use of headphones or an external audio amplifier.

If this describes what is happening to you, this fix is also quite simple: Increase the capacitance at C32. It has been found that adding another 1000 uF of capacitance across C32 seems to prevent audio feedback, having done all of the other modifications.

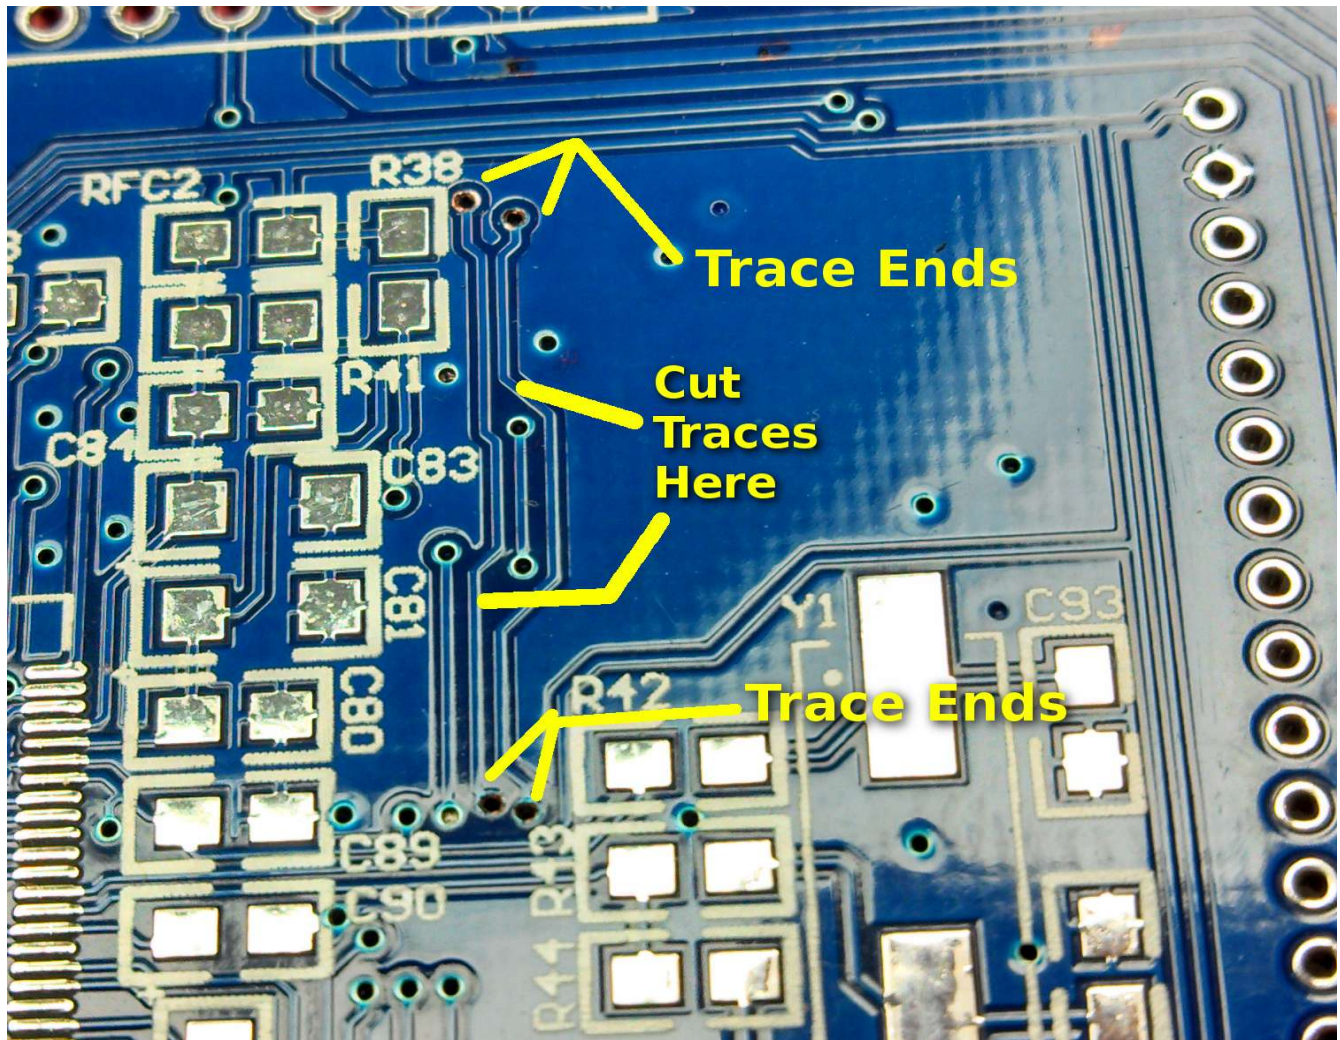
If the above modifications are made, with no antenna connected – or even with an antenna connected when listening on higher bands (especially 20 meters and above) a fairly strong “tick” may be heard every second. This is due to the polling of the onboard temperature sensor and the fact that the “fall” time of the on the I2C line from the MCU is extremely fast and rich with harmonic energy. This problem can be easily “fixed” with the addition of resistors on the UI board in series with the SCL and SDA lines which effectively reduce the slew rate of these lines, quashing the RF energy.

This picture shows the location of the traces and where the cuts should be made. This is found to the right and above U4a, the MCU. A picture of a “bare” board is used for clarity.

A reasonable value of resistor to install is 470 ohms and the installed components may be seen in the picture.

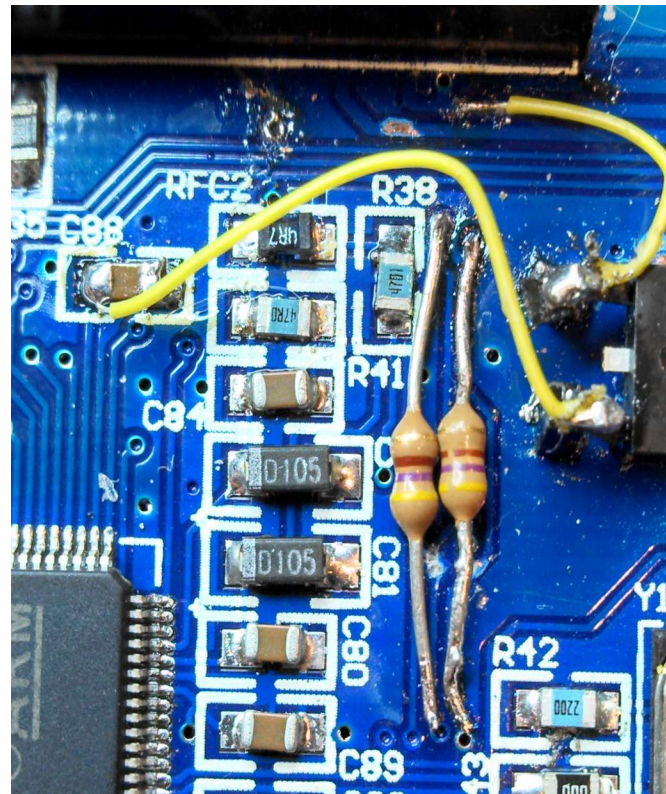
The added 470 ohm resistors in series with the SCL and SDA lines. Note that this picture also shows the added 3.3 volt MCU regulator mentioned above. 1/8 watt, leaded resistors are used, but surface mount resistors could be used, if desired.
