# (wafer2,2,0,-1,-1,0,1) Characteristics

- **Cell Size:** 15um
- **Times Accessed:** 6
- **Last Measurement:** 2022/March/23 at 04:09:35PM

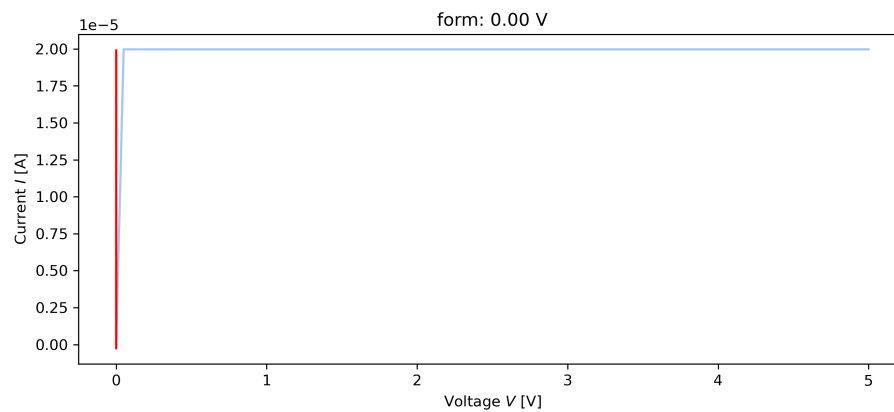
## form

- **Time:** 04:01:03PM
- **Icc:** 20.0uA
- **Voltage Range:** 0V  $\rightarrow$  5V
- **Target Ramp Rate:** 1V/s
- **True Ramp Rate:** 1.836 V/s\*
- **Cycle:** 1
- **Error:** Set failed

Probe A on copper, B on platinum. Already set. Possibly due to minor layer short in wafer, around countour edge of bottom platinum layer.

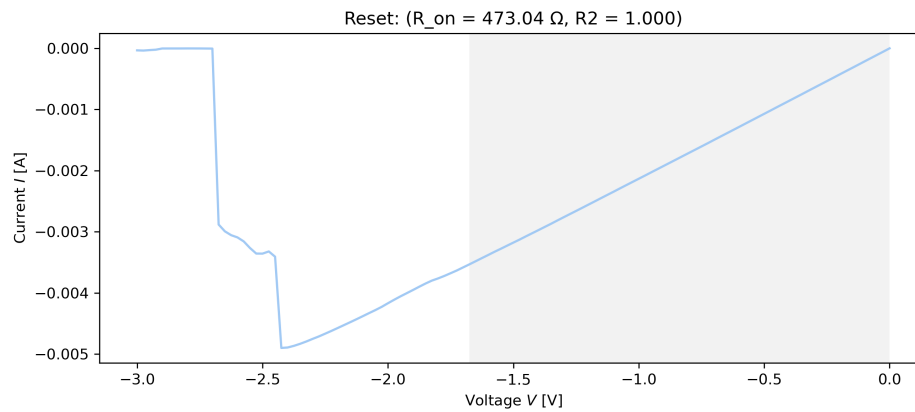
## reset

- **Time:** 04:03:36PM
- **I<sub>cc</sub>:** 6.0mA
- **Voltage Range:** 0V → -3V
- **Target Ramp Rate:** 1V/s
- **True Ramp Rate:** -0.765 V/s\*
- **Cycle:** 1
- **Resistance:** 473.04 Ω
- **Linear Fit R<sup>2</sup>:** 1.000

reset success

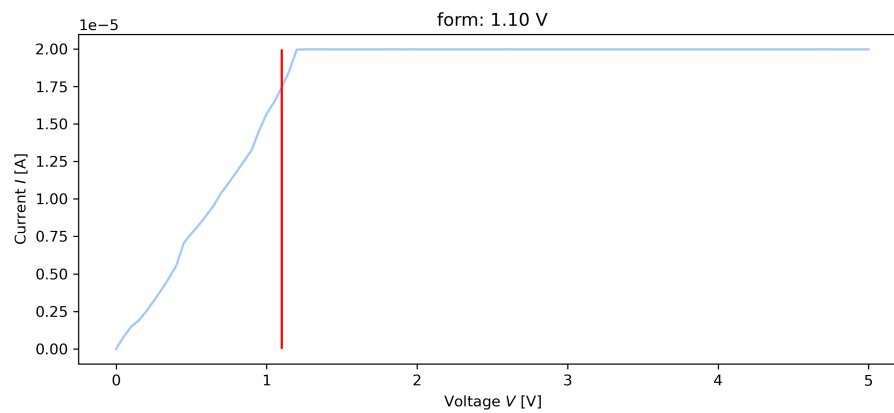
## form

- **Time:** 04:04:26PM
- **Icc:** 20.0uA
- **Voltage Range:** 0V  $\rightarrow$  5V
- **Target Ramp Rate:** 1V/s
- **True Ramp Rate:** 1.353 V/s\*
- **Cycle:** 1
- **Set Voltage:** 1.10 V

Set success, but at v low voltage of 1.2V. Therefore weak filament.

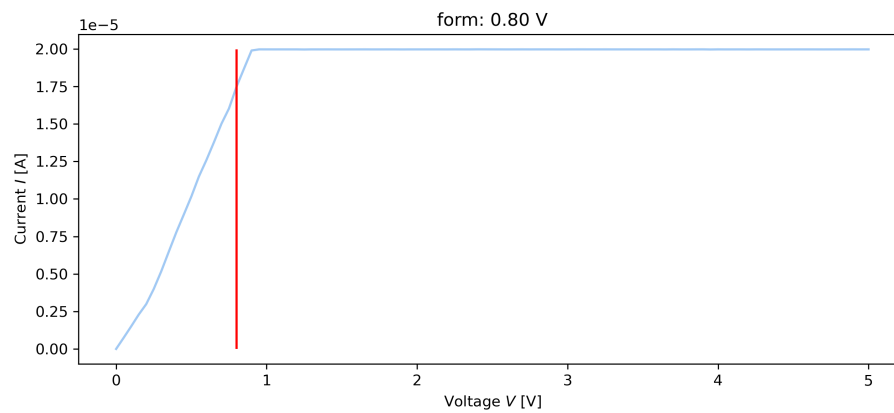
## form

- **Time:** 04:06:40PM
- **Icc:** 20.0uA
- **Voltage Range:** 0V  $\rightarrow$  5V
- **Target Ramp Rate:** 1V/s
- **True Ramp Rate:** 1.429 V/s\*
- **Cycle:** 2
- **Set Voltage:** 0.80 V

shows ohmic pattern. Short maybe present.
