(wafer2,2,0,-1,-1,0,1) Characteristics

Summary

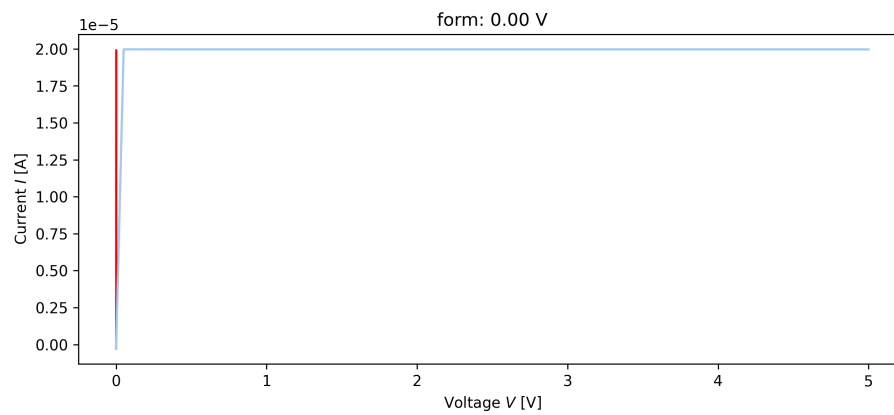
form

- **Time:** 04:01:03PM
- **Icc:** 20.0uA
- **Voltage Range:** 0V \rightarrow 5V
- **Target Ramp Rate:** 1V/s
- **True Ramp Rate:** 1.836 V/s*
- **Cycle:** 1
- **Error:** Set failed

Probe A on copper, B on platinum. Already set. Possibly due to minor layer short in wafer, around countour edge of bottom platinum layer.

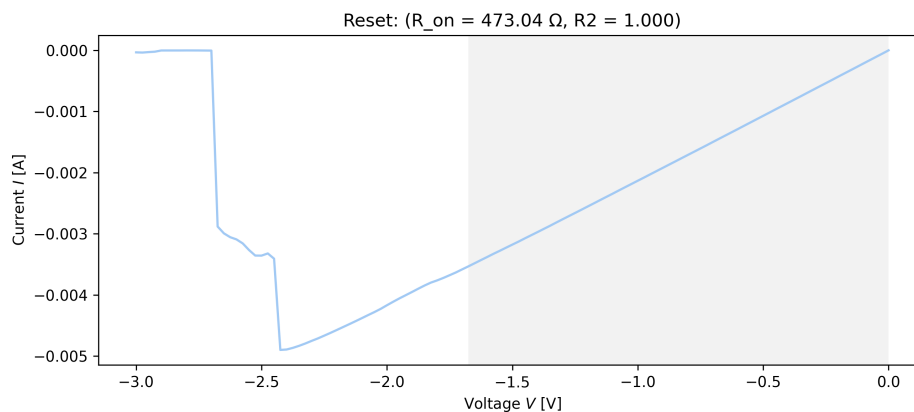
- **Time:** 04:03:36PM
- **I_{cc}:** 6.0mA
- **Voltage Range:** 0V → -3V
- **Target Ramp Rate:** 1V/s
- **True Ramp Rate:** -0.765 V/s*
- **Cycle:** 1
- **Resistance:** 473.04 Ω
- **Linear Fit R²:** 1.000

reset success

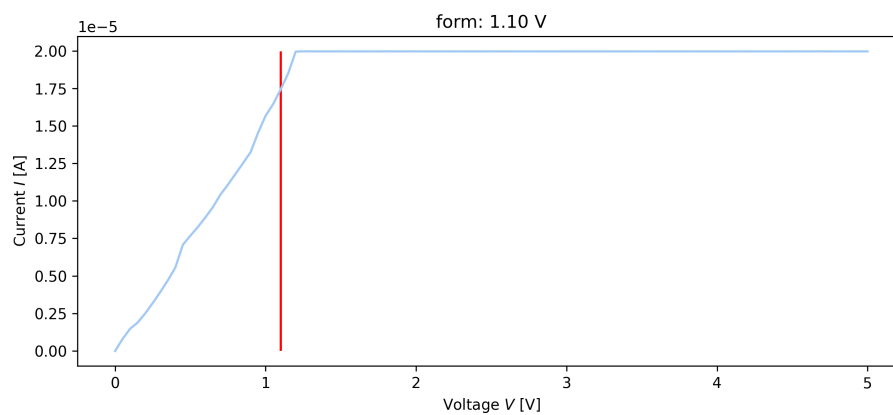
form

- **Time:** 04:04:26PM
- **Icc:** 20.0uA
- **Voltage Range:** 0V \rightarrow 5V
- **Target Ramp Rate:** 1V/s
- **True Ramp Rate:** 1.353 V/s*
- **Cycle:** 1
- **Set Voltage:** 1.10 V

Set success, but at v low voltage of 1.2V. Therefore weak filament.

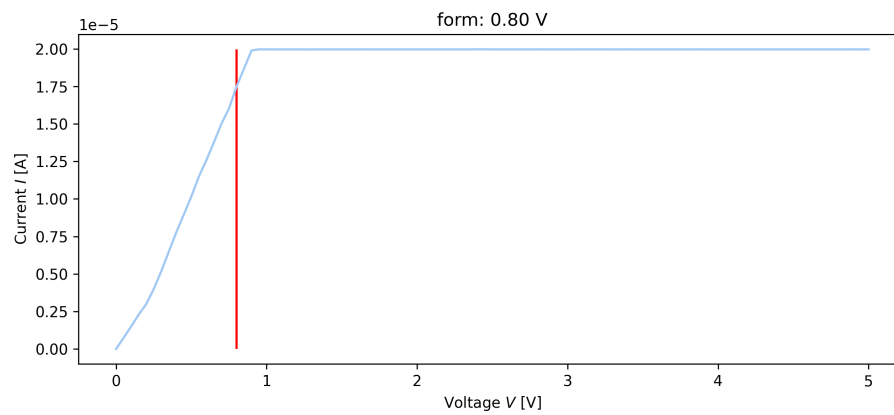
form

- **Time:** 04:06:40PM
- **Icc:** 20.0uA
- **Voltage Range:** 0V \rightarrow 5V
- **Target Ramp Rate:** 1V/s
- **True Ramp Rate:** 1.429 V/s*
- **Cycle:** 2
- **Set Voltage:** 0.80 V

shows ohmic pattern. Short maybe present.
