# (wafer2,2,0,-1,-1,0,1) Characteristics

- **Cell Size:** 15um
- **Times Accessed:** 6
- **Last Measurement:** 2022/March/23 at 04:09:35PM

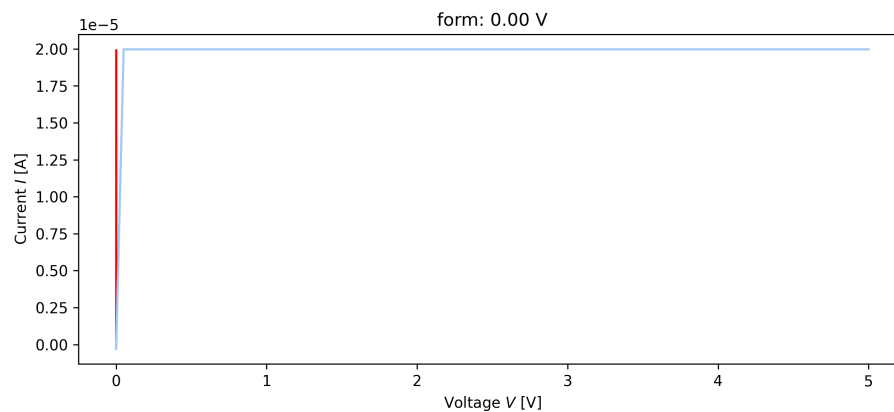
## form

- **Time:** 04:01:03PM
- **Icc:** 20.0uA
- **Voltage Range:** 0V  $\rightarrow$  5V
- **Target Ramp Rate:** 1V/s
- **True Ramp Rate:** 1.836 V/s\*
- **Cycle:** 1
- **Error:** Set failed

Probe A on copper, B on platinum. Already set. Possibly due to minor layer short in wafer, around countour edge of bottom platinum layer.

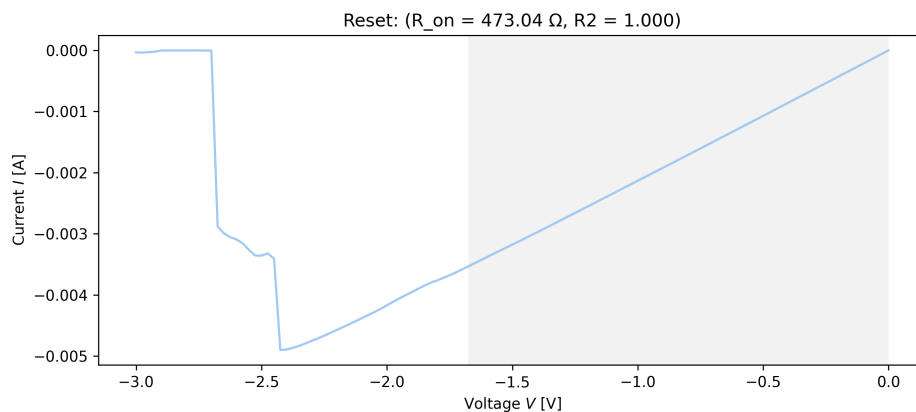
## reset

- **Time:** 04:03:36PM
- **I<sub>cc</sub>:** 6.0mA
- **Voltage Range:** 0V → -3V
- **Target Ramp Rate:** 1V/s
- **True Ramp Rate:** -0.765 V/s\*
- **Cycle:** 1
- **Resistance:** 473.04 Ω
- **Linear Fit R2:** 1.000

reset success
