Image Tearing Causes and Solutions

Technical Application Note TAN2010003

Revised November 18, 2011

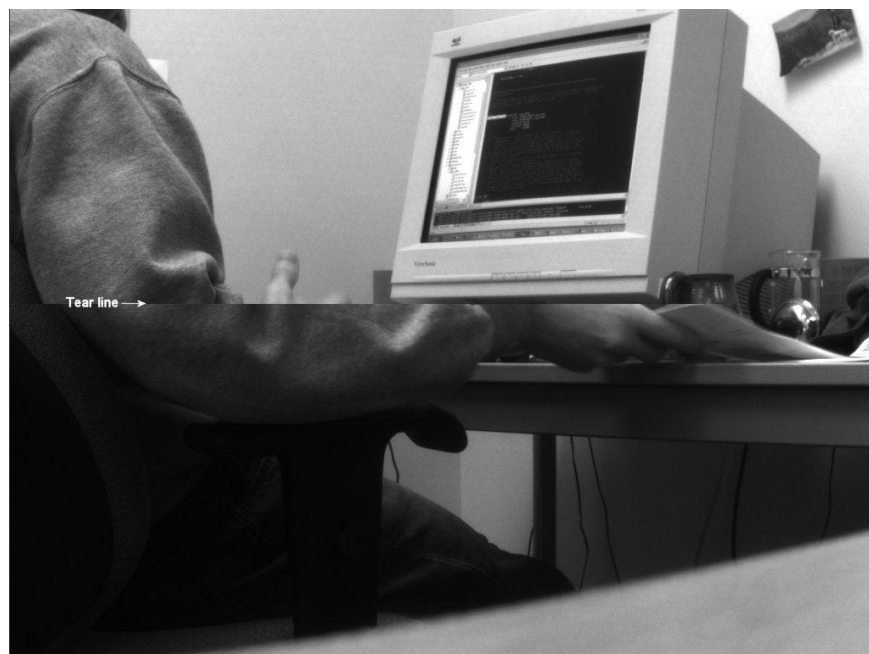
Figure 1

The following images show examples of image tearing. The first example shows an offset between the top and bottom halves of the image:

Horizontal tearing, such as the example shown in Figure 1, is often a video display issue, rather than a problem with the actual image data. To verify that the image data is not corrupted, run the SaveToAVI example available with the FlyCapture SDK, and analyze each frame of the AVI. If the image data is, in fact, corrupt, refer to the sections below.

If the image data is not corrupt, the most likely reason is that the frame rate of the image display is not synchronized with the refresh rate of the monitor. The monitor video display buffer fills with data, then gets displayed. However, sometimes the display buffer only partially fills before the monitor grabs it and displays it to the screen. This causes the tearing effect, and is more noticeable if the camera is being panned and there is a significant difference in image content between frames. For recommendations on how to reduce this image tearing, [contact our Technical Support team](#).
