Thermopile Support: FAQs, Troubleshooting, Care & Maintenance

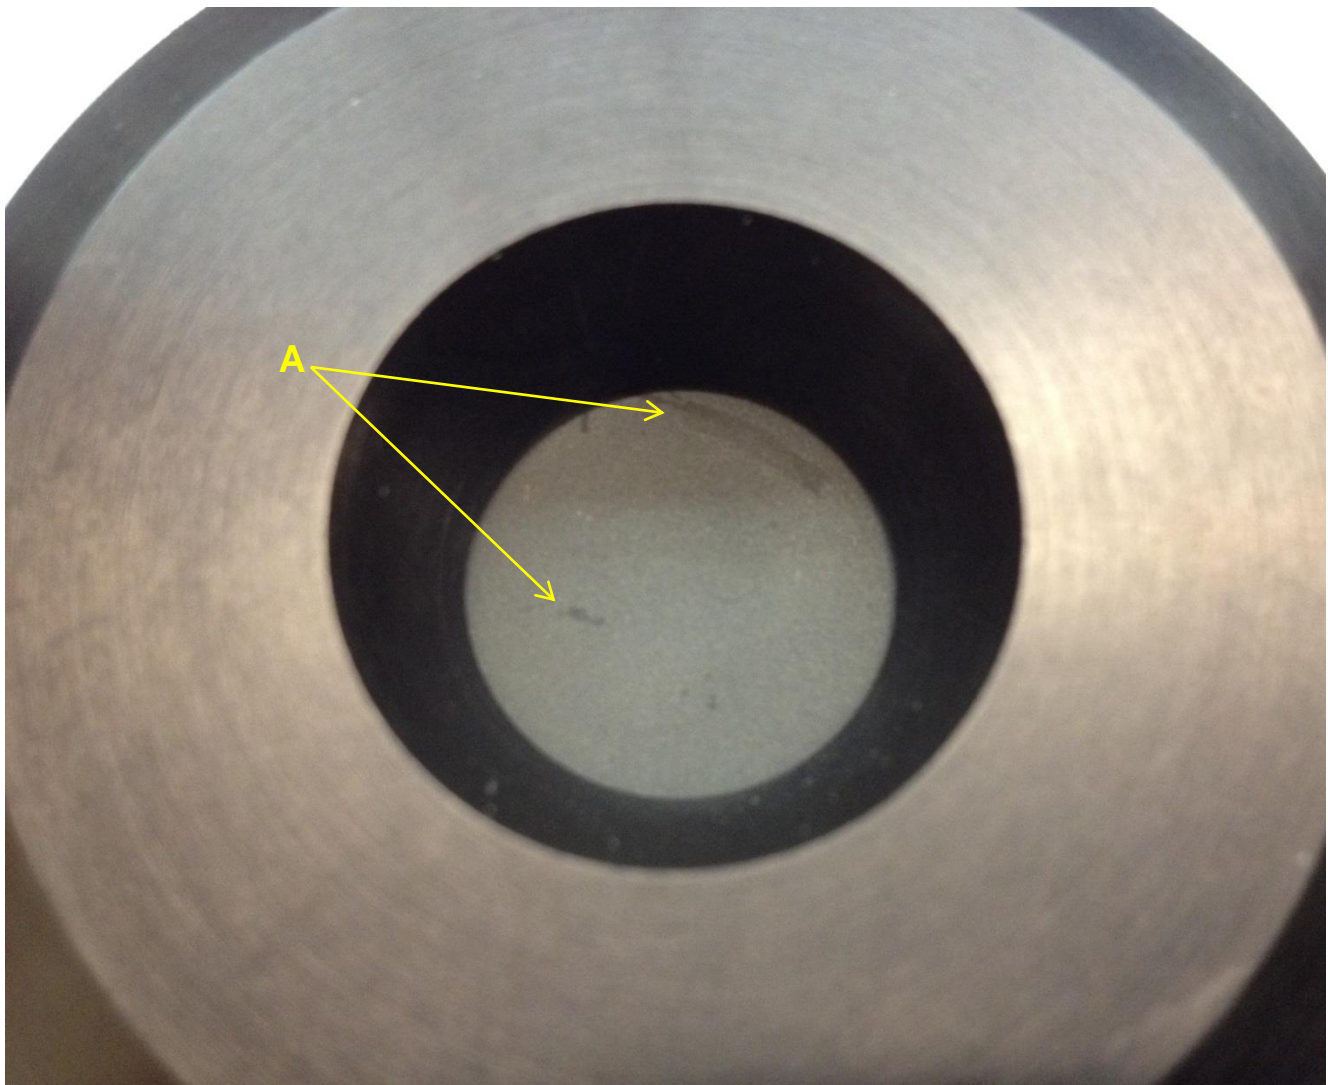
Figure 7: Streaks on Thermopile Caused by Contamination

This is an example of a sensor that has some marks on it that are most likely not affecting the performance of the product.

- A. The black streaks on this sensor surface were most likely caused by a small amount of grease or dirt that smeared across the sensor surface. Marks like this typically won't cause problems with a sensor, especially since they are not in the very center of the sensor area. There is a chance that marks can burn onto the sensor disk if a laser beam hits them. However, if the marks do not get larger or worse with time, a sensor in this condition will most likely continue to work properly and may not need a disk replacement during recalibration.

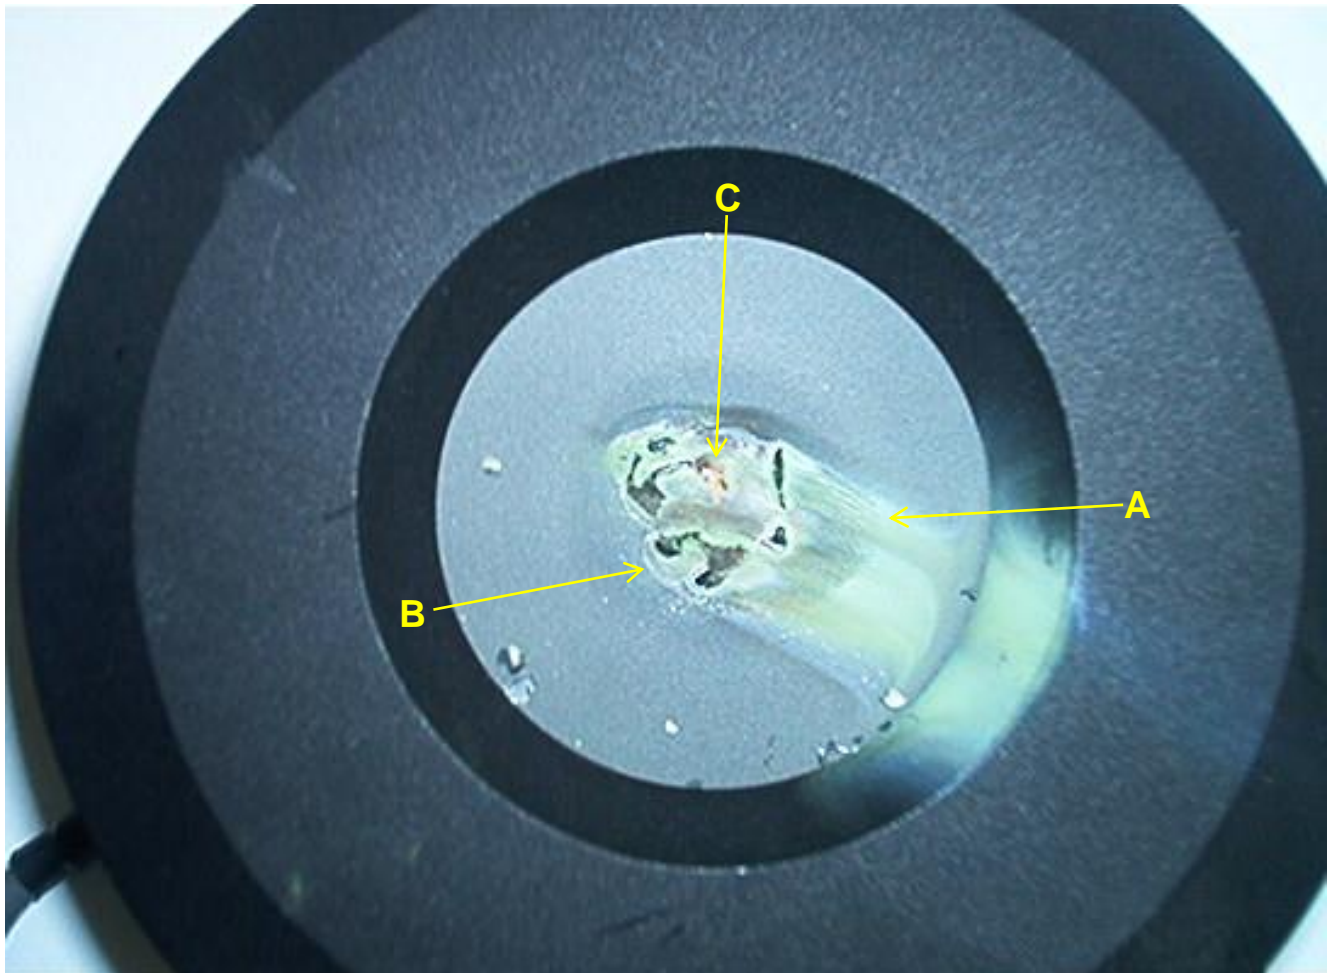
Figure 10: Significant Damage to kW Level Power Sensor Due to Too High of a Power Density or Insufficient Water-Cooling

- A. In this area a green color is present which indicates that the sensor coating has melted. In addition, there is green smoke in this damaged region.
- B. Black charring marks are present in this area.
- C. The copper thermopile disk is exposed near the center of the sensor

This sensor is an extreme case, but illustrates key things to watch for on the kW level sensors. Any time that a green melted spot, black charring, or exposed metal show up, the sensor has been significantly damaged and should not continue to be used in that condition. Damage like this can be the result of too high of a power density or from the sensor getting too hot, like what can happen without sufficient water-cooling.
