Each board is hand assembled, all solder joints are checked via microscope and tested on the road for at least an hour- so you can rest assured the hardware is in working condition. There are some things we should note about the Batch 1 boards, so I would like to highlight the details in this document.

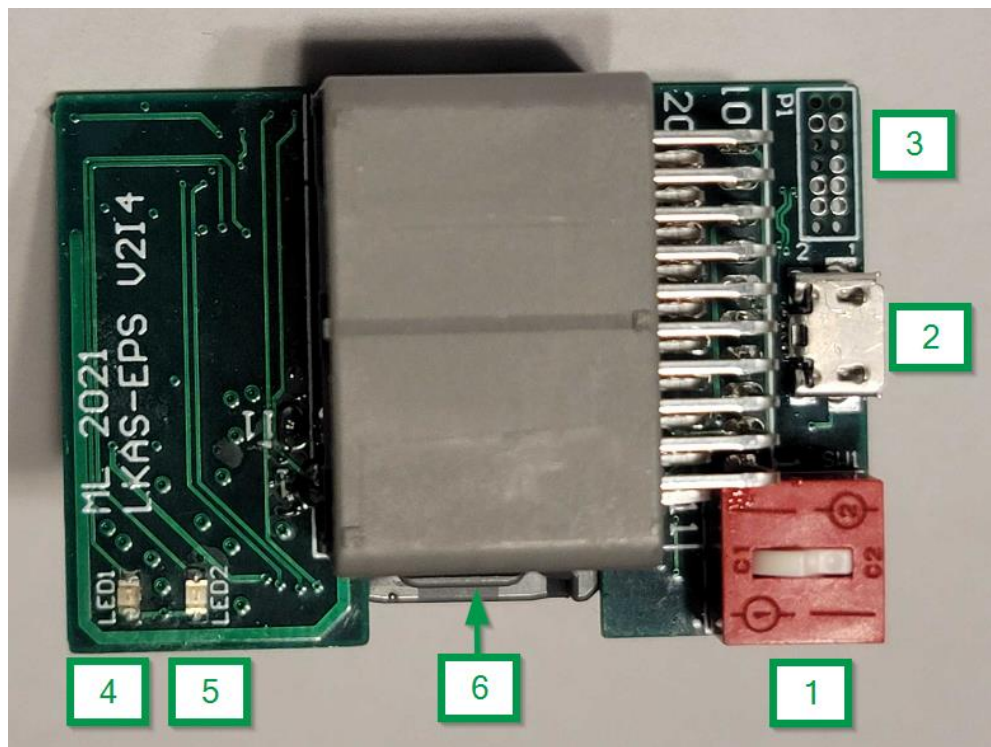
1. **SPDT DIP SWITCH:** Controls if the serial steering lines are bypassed or not.
  - a. Flipped towards the passenger (flat side towards C2) allowed the board to manipulate the EPStoLKAS and LKAS to EPS line.

- b. Flipped towards the driver (flat side towards C1) is bypassed and the board does not manipulate the signals.
2. **USB Micro B Connector:** Used to update board firmware.

- a. **Note:** The board can only be programmed when either vehicle power is off OR when not connected to the vehicle.
  - b. Refer to programming guide (coming soon).

3. **SWD Header:** Used to program bootloader.
  - a. STLINK-V3MINI and GRPB072VWVN-RC header required.
4. **BLUE LED:** Used as a heartbeat to validate the board is receiving power, CAN and makes it through the main loop.

- a. When first booted, there will be 6 flashes. This is “bootloader mode” and allows the board to be programmed.
  - b. After the first 6 flashes, the board should enter the main program and have a 250ms heartbeat (at the time of this writing).

5. **FAULT (RED) LED:** Used to indicate fault based on various conditions in the code. The fault is viewable on CAN, via message 0x18F (STEER\_STATUS).

- a. This can only be reset by restarting the vehicle and will not allow OP to engage.
6. **Locking Tab:** Allows (relatively) easy removal from the multipurpose camera unit (MCU).

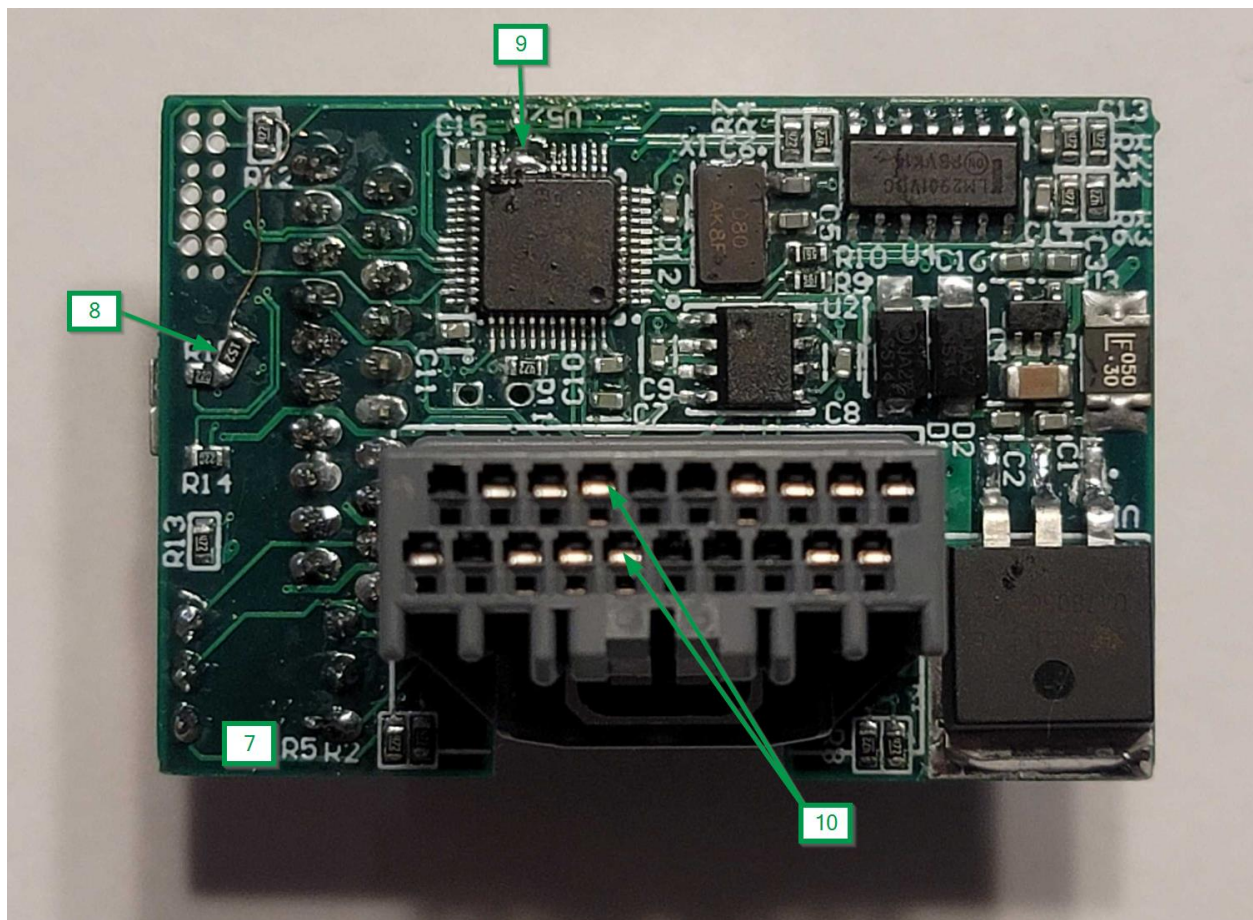
7. **Flux Residue:** As you can probably tell, the board is hand soldered. And with hand soldering comes no-clean flux! So, the flux residue on the board isn't a concern, while it may not be visually ideal.
8. **Bodge #1:** It was noticed that a pullup resistor was needed on the USB D+ line after PCB fabrication, therefore the resistor and wire were added after the fact. Handle with care to avoid damage!
9. **Solder "Glob":** It was noticed that the internal pulldown of BOOT1 was not strong enough in cold temperatures which would result in erratic bootup. Therefore, the pin has been manually shorted to ground to resolve this issue. This solder joint is not a cause for concern.
10. **B-CAN** (pin 6 and pin 17): While not noted on the schematic, the B-CAN lines were added post process and should pass through without any problems.
