# VINTAGE COMPUTER FEDERATION FORUMS

## How to upgrade Tektronix 4052 or 4054 with latest v5.1 firmware

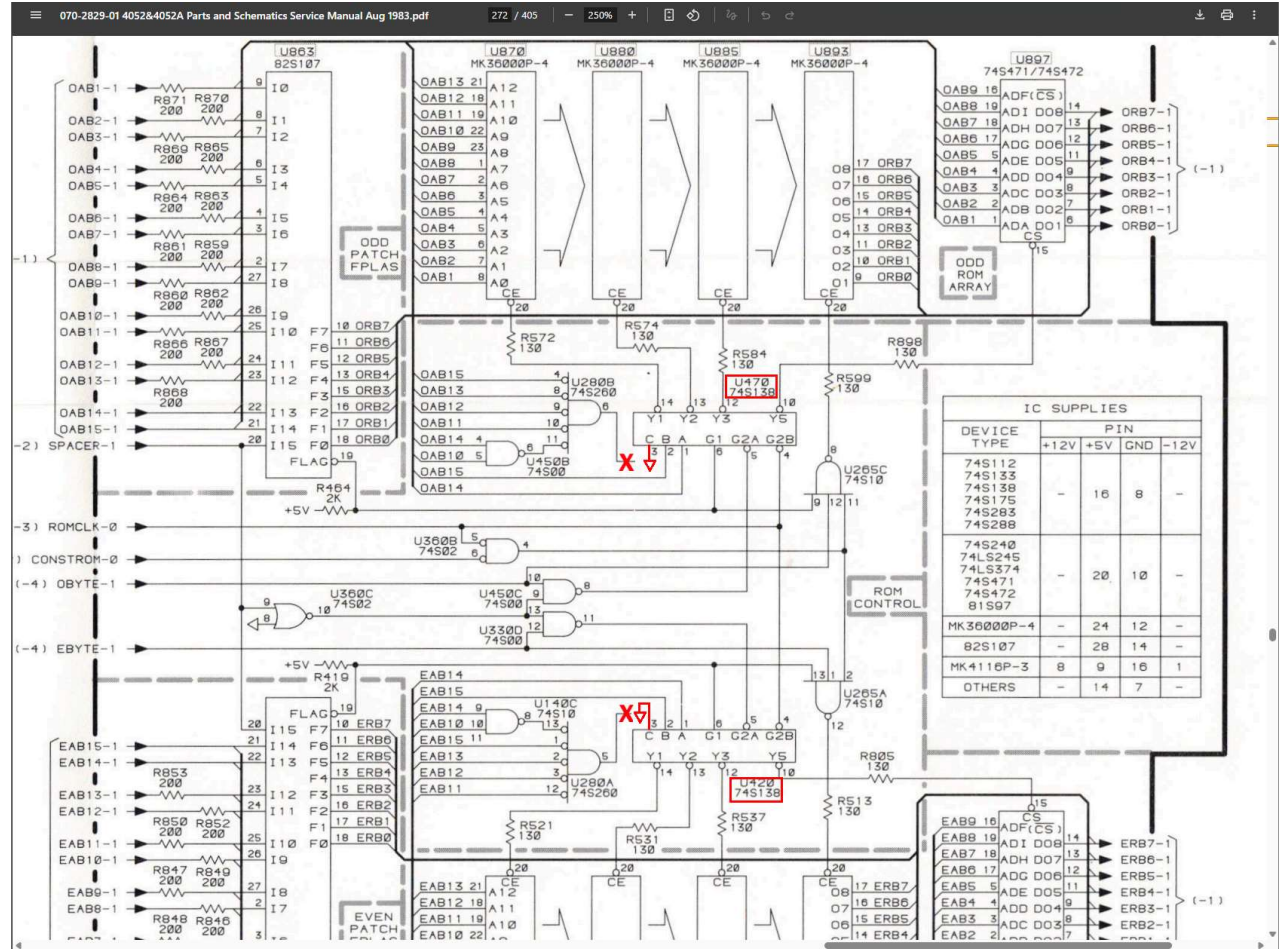
The schematic is marked in RED X for the cut and the GROUND is a RED TRIANGLE for the mod at U420 and U470. These are both 16-pin 74S138 with the PIN 8 ground on the same side as the cut on PIN 3.

This modification is needed on the MAS board for v5.1 firmware upgrade because v5.1 firmware is the ONLY 4052-4054 version with code in the 4400-47FF PATCH ROM address range as I discovered in my post 132 in the tektronix-4052-repair thread authored by [@RolexTM](#)

Both [@RolexTM](#) and [@jbstan](#) encountered SYSTEM ERRORS on their MAS boards with v5.1 firmware upgrades after they only grounded the C inputs of U420 and U470.

After also cutting the U280 PINs 5 and 6 - they had no SYSTEM ERRORS running BASIC programs including DATA statements and running the Diagnostic ROM Pack from [@jdreesen](#) they both got the exact same results as Jos reported in his first post on his 4052 Diagnostic ROM Pack Remade thread - which also duplicated the Tektronix service note on 4052-4054 ROM CRCs:  
**[4052-4054 FW Info July 1983](#)**

3. Remove the U845 and U863 FPLA ROMs if present on your MAS board
4. Remove the U805 and U897 PATCH ROMs if present on your MAS board
5. Replace all eight ROMs - one at a time with your 57C49 EPROM based on the EPROM with the same U# as the ROM you are replacing
6. Carefully cut U420 (74S138) PIN 3 from the PCB and solder a jumper wire from U420 PIN 3 to U470 PIN 8 to ground PIN 3 as shown in schematic below the table.
7. Carefully cut U470 (74S138) PIN 3 from the PCB and solder a jumper wire from U470 PIN 3 to U470 PIN 8 to ground PIN 3 as shown in schematic below the table.

6. Carefully cut U420 (74S138) PIN 3 from the PCB and solder a jumper wire from U420 PIN 3 to [U420](#) PIN 8 to ground PIN 3 as shown in schematic below the table.
