[how-to-upgrade-tektronix-4052-or-4054-with-latest-v5-1-firmware](#)

Firmware v5.1 Upgrade Instructions for Tektronix 4052 and 4054 vector graphics computers:

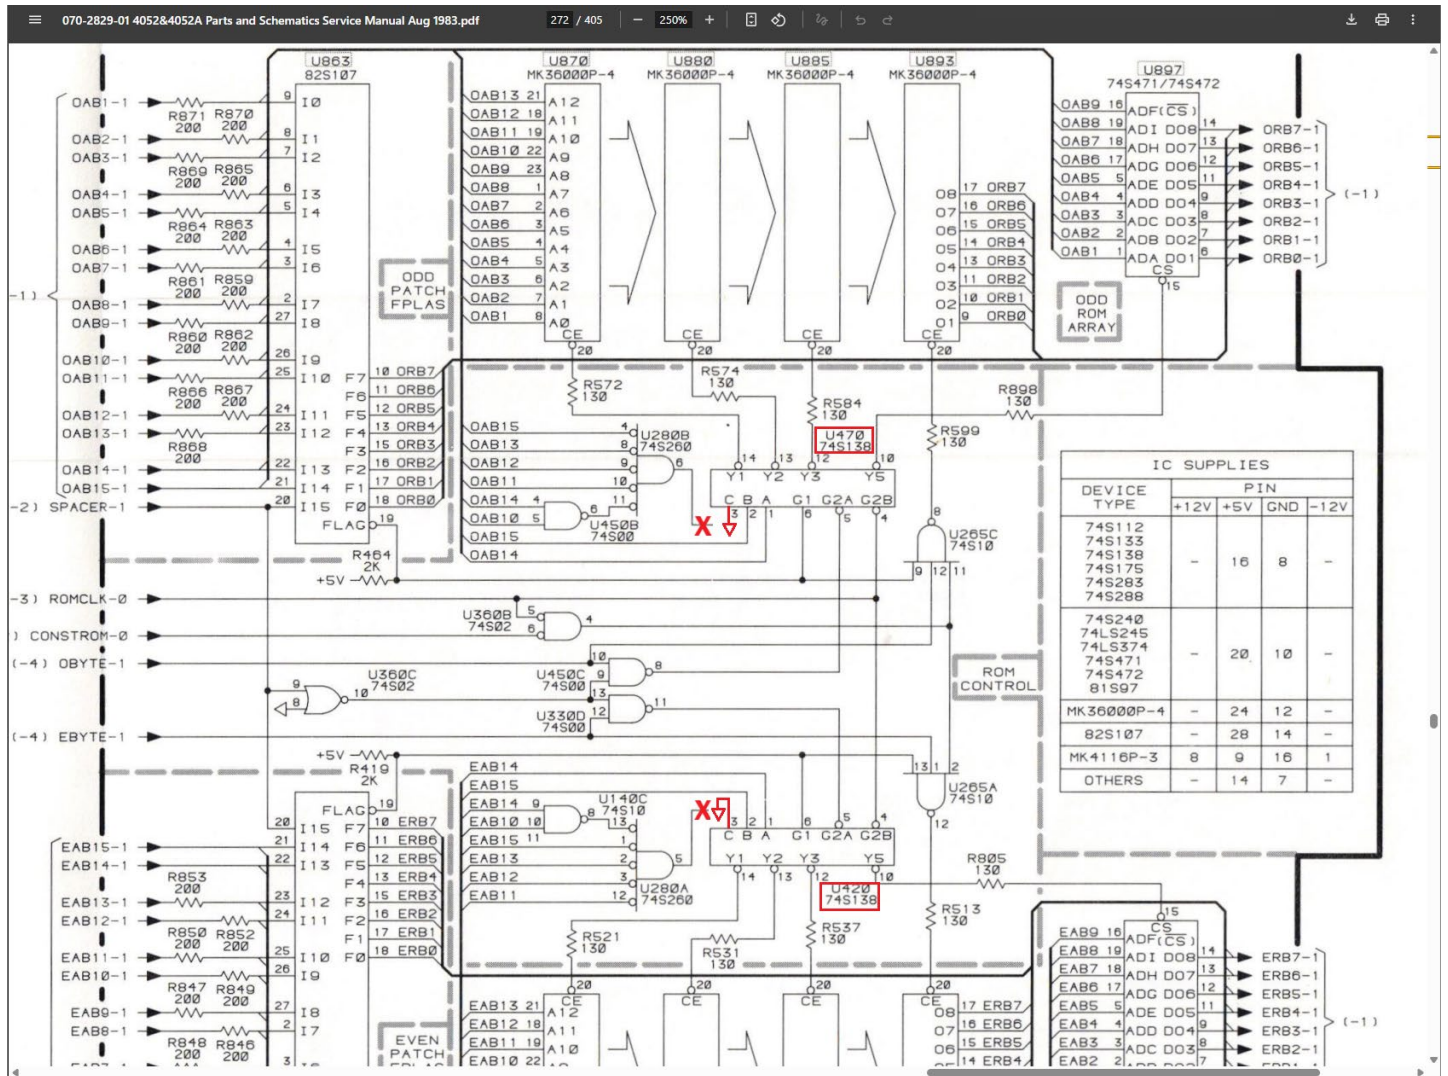
The schematic is marked in RED X for the cut and the GROUND is a RED TRIANGLE for the mod at U420 and U470. These are both 16-pin 74S138 with the PIN 8 ground on the same side as the cut on PIN 3.

This modification is needed on the MAS board for v5.1 firmware upgrade because v5.1 firmware is the ONLY 4052-4054 version with code in the 4400-47FF PATCH ROM address range as I discovered in my post 132 in the tektronix-4052-repair thread authored by [@RolexTM](#)

Both [@RolexTM](#) and [@jbstan](#) encountered SYSTEM ERRORS on their MAS boards with v5.1 firmware upgrades after they only grounded the C inputs of U420 and U470.

6. Carefully cut U420 (74S138) PIN 3 from the PCB and solder a jumper wire from U420 PIN 3 to U420 PIN 8 to ground PIN 3 as shown in schematic below the table.

7. Carefully cut U470 (74S138) PIN 3 from the PCB and solder a jumper wire from U470 PIN 3 to U470 PIN 8 to ground PIN 3 as shown in schematic below the table.

After also cutting the U280 PINs 5 and 6 - they had no SYSTEM ERRORS running BASIC programs including DATA statements and running the Diagnostic ROM Pack from [@jdreesen](#) they both got the exact same results as Jos reported in his first post on his 4052 Diagnostic ROM Pack Remade thread - which also duplicated the Tektronix service note on 4052-4054 ROM CRCs: [4052-4054 FW Info July 1983](#)
