Makeup Not Adding 1000 Series

Makeup cartridge is written down to zero when there is a considerable volume of makeup left in it.

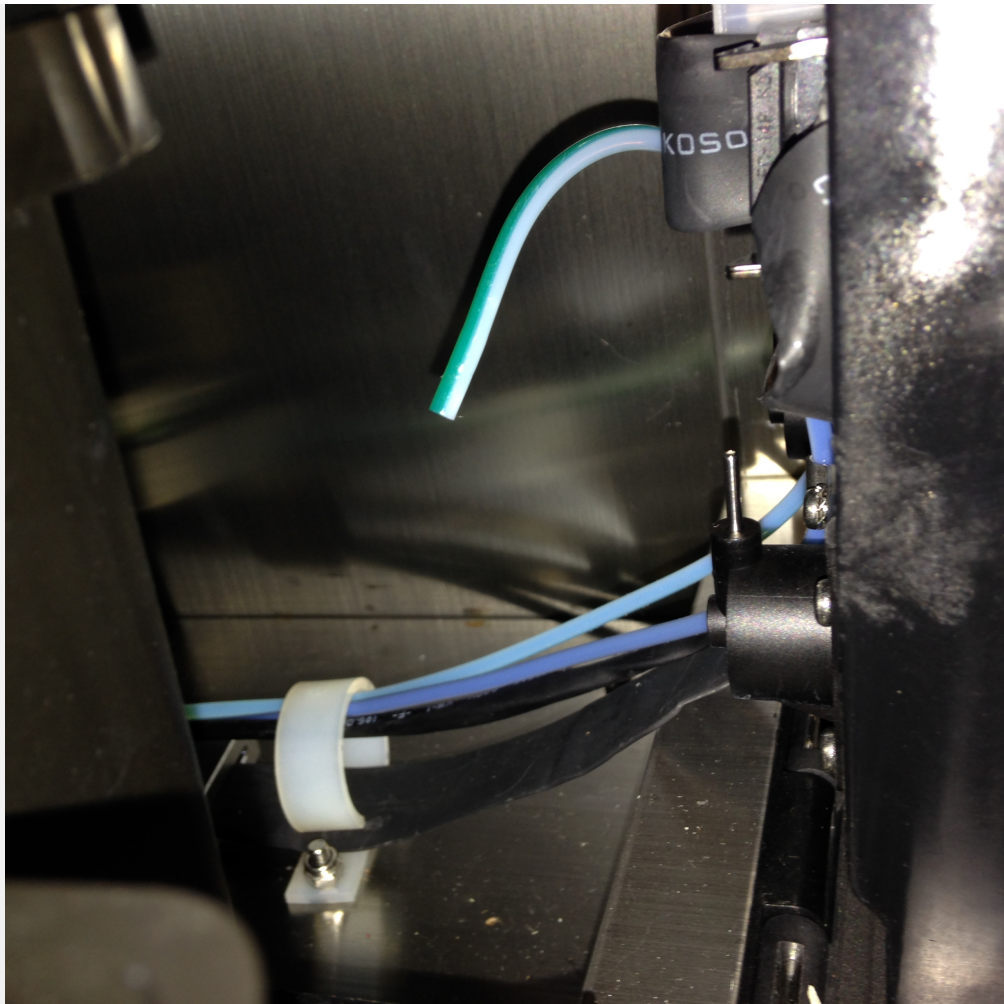
1. With the jet OFF, disconnect the green stripe tube form the makeup septum.

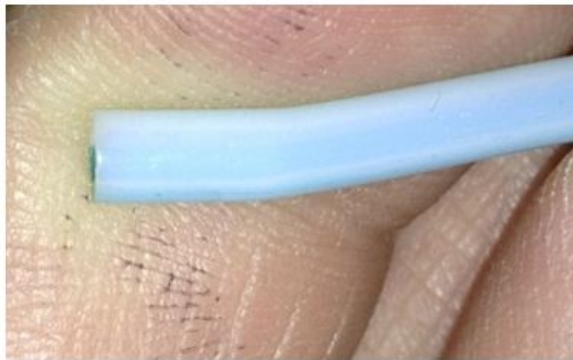
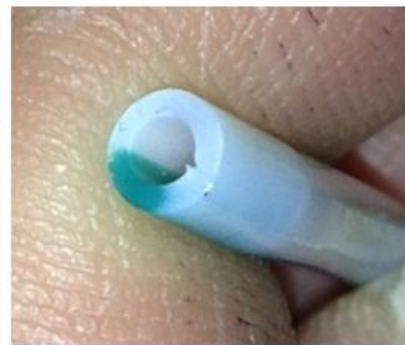
2. Check for any cracks on the tube. At the tip, inside, and side wall.

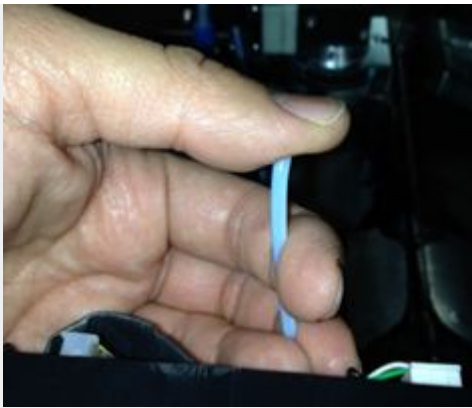
4. While the sequence is running, cover the tube opening with your finger.

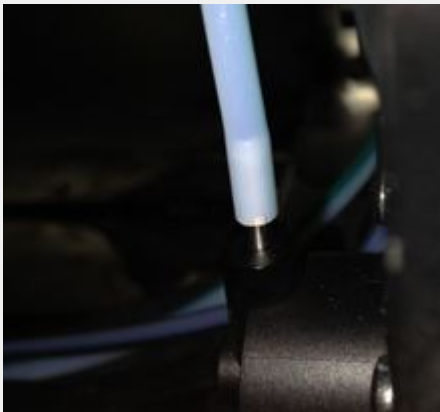
8. Repeat covering the tube and watch for vacuum to rise greater than 600, then uncover and see vacuum drop less than 50.
9. If the vacuum values are as expected, check the path between the metal barb from the septum to the septum needle.
10. When testing is done, cut a small portion from the end of the tube, about 1/16" from the tip of the tube, to ensure the tube makes a tight fit into the metal barb.
