Agilent Thermal Conductivity Detector Troubleshooting

This Information Applies To: *Agilent 8890/8860/7890/7820/6850/6890 GC Systems with TCD (Thermal Conductivity Detector)*

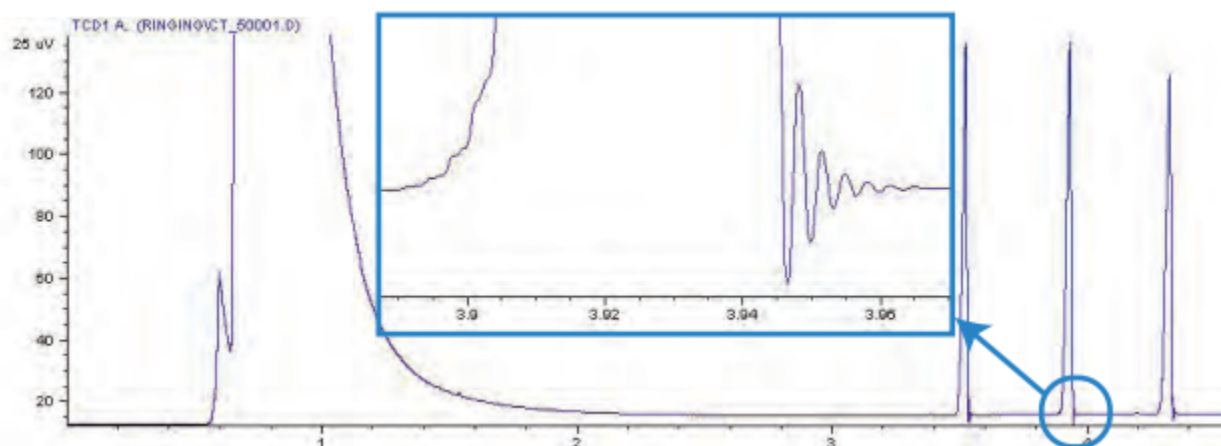
Ringing on Peak Tail

Figure 1. Ringing at peak tail

Cause: The sampling rate for the detector is set to equal to or less than 5 Hz (which is the switching rate of the solenoid valve). For more information on sampling rate see [Agilent GC Detector Sampling \(Data\) Rate](#)

Fix: Change the sampling rate to greater than 5 Hz.

Tip: Calibration curves must be re-established after any changes to the sampling rate. In some cases, methods may require re-validation.
