TODD:
TEST IF R9 FIXES THE "ALWAYS TO ISP AFTER RESET" ISSUE
BY SOLDERING A 10K PULL-UP

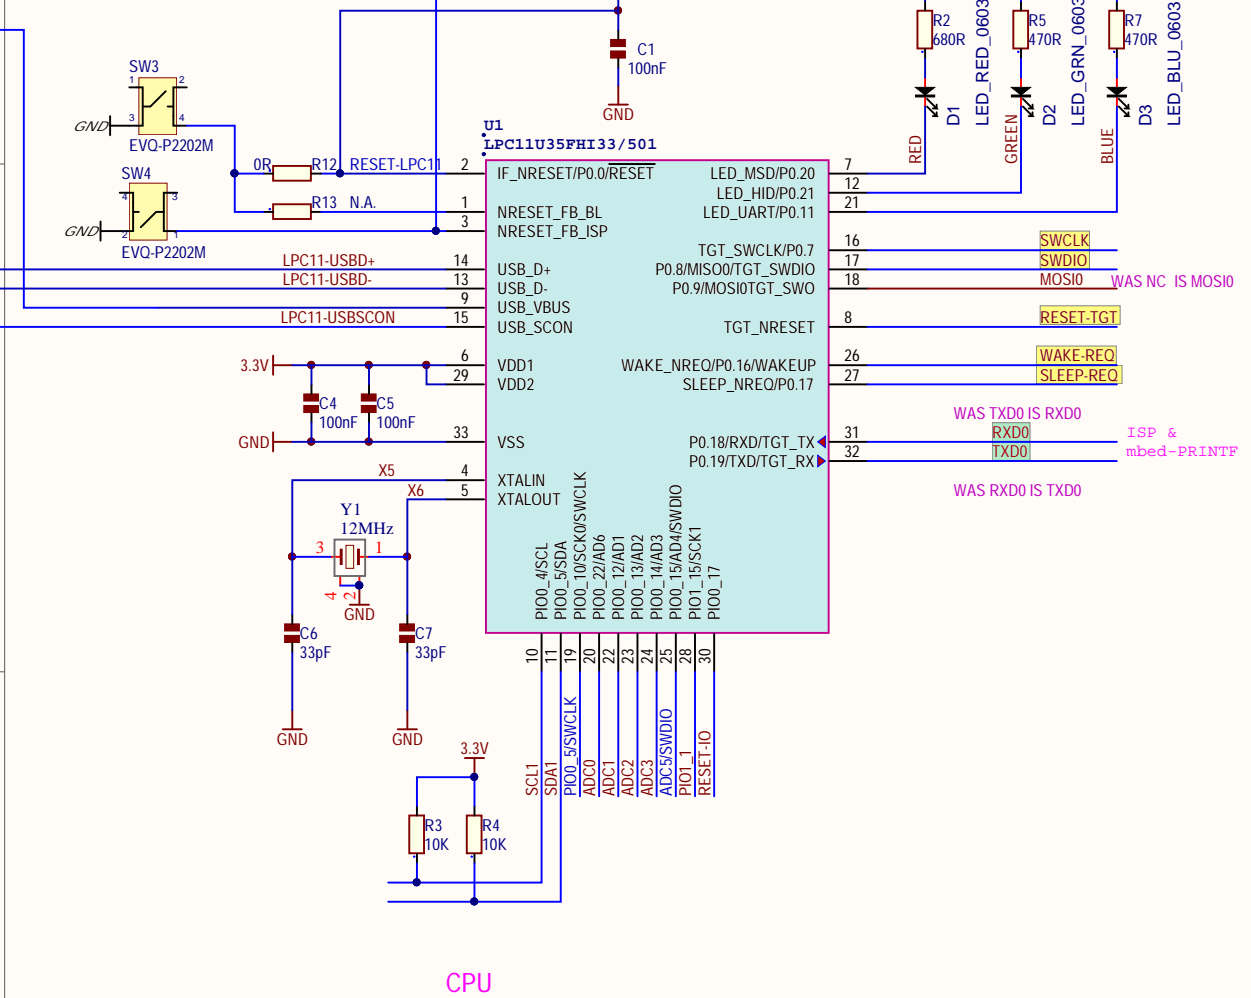
Pressing SWx while powering Interface:
N_RESET_FB_BL - mbed bootloader
N_RESET_FB_ISP - ROM MSC bootloader
