JoSDC'24

Qualifying Phase Report - JoSDC'24

Team Name		
minimum electric design		
Team Members		
#	Name	Email
1	Feras Mohammad	fra0208687@ju.edu.jo
2	Omar Sweiss	amr0215904@ju.edu.jo
3	Amr Abuzayyad	amr0214597@ju.edu.jo
4	Abdallah Shbilat	abd0205000@ju.edu.jo
5	Marlo Rizkallah	mar2211499@ju.edu.jo

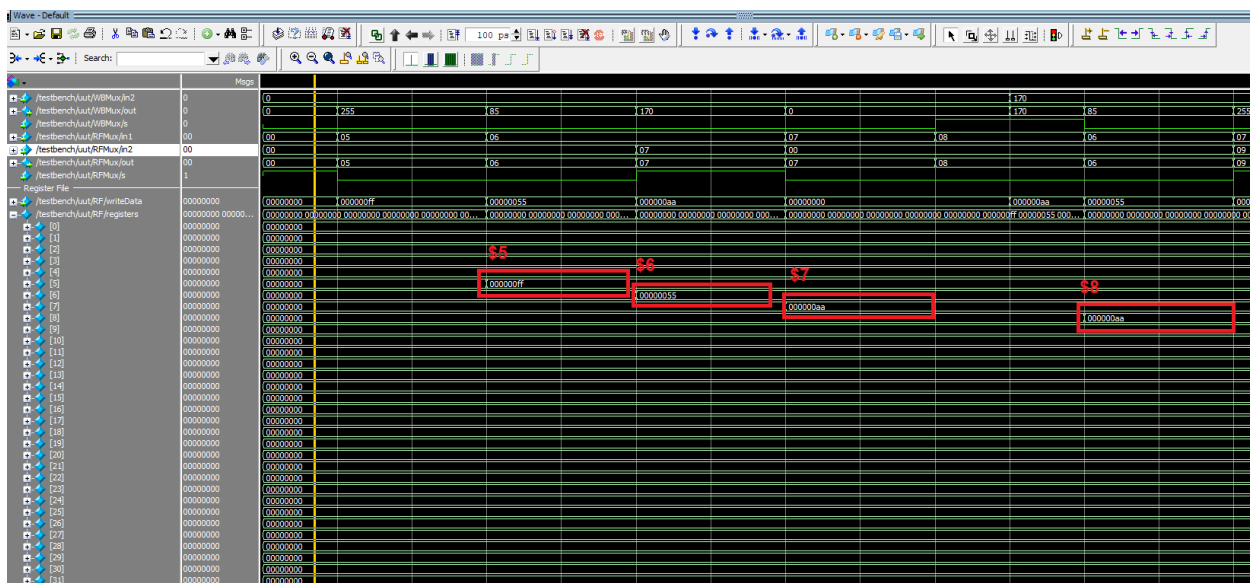
First, we can see the results of the first five instructions reflected on the registers \$5, \$6, \$7 and \$8.

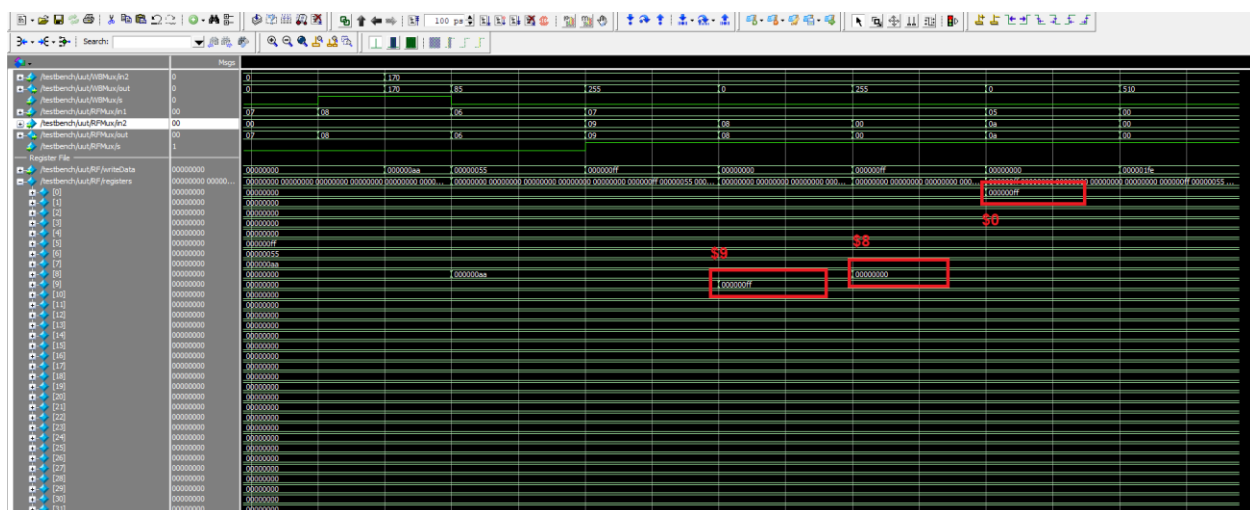
Second, after the instruction on \$8 register, we can observe that the beq instruction was indeed not taken; due to the \$9's value changing to 0xFF as previously expected.
