## Report about TweakScale 2.3 issue when cloning scaled parts using ALT button.

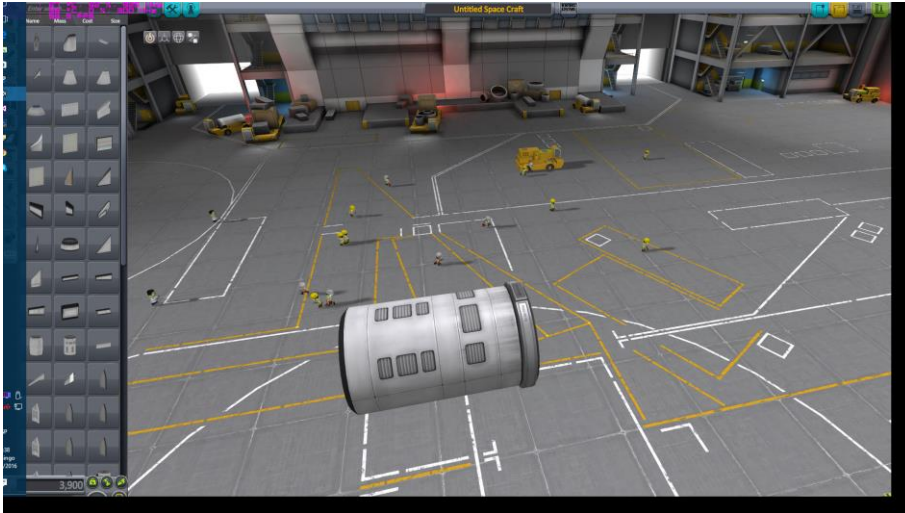
1. Attach an engine pre-cooler.

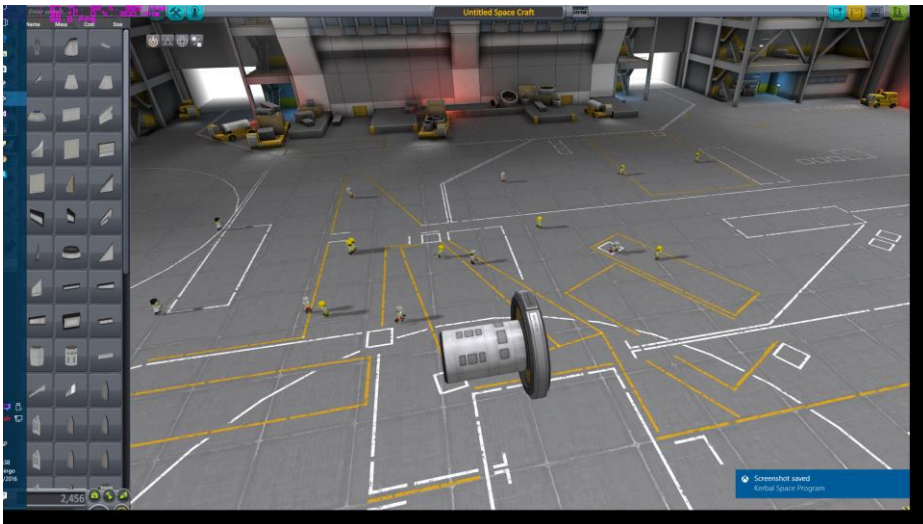
2. Downscale it to 0.625.

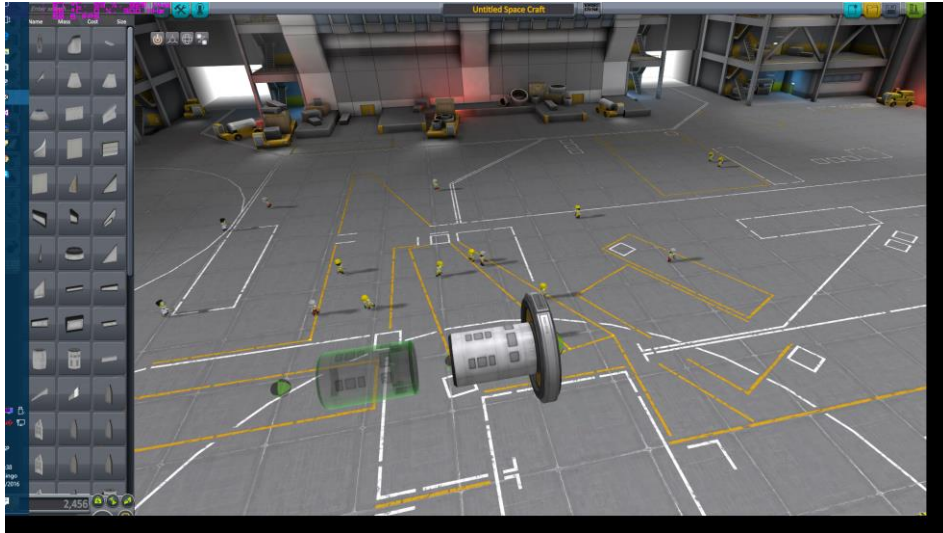
3. Clone the part pressing Alt button and the attach nodes are not updated correctly.
