Trouble Shooting

File No : TS31103

SOP名稱: SOP名稱: Adjustment of Backlash for GXA-S series GXA-S背隙調整

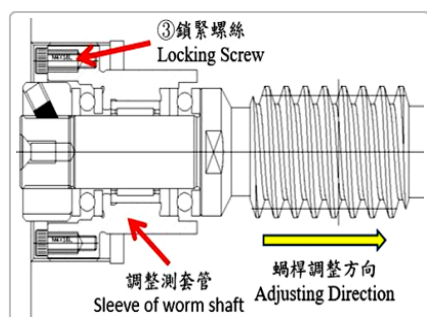
Step 6

If the backlash is too large, rotate M6x50L * 2 pcs on part ④ clockwise to reduce backlash. 若背隙過大時，在套管座上的M6x50L螺絲2只以順時針旋轉調整側套管來減少蝸桿蝸輪背隙。

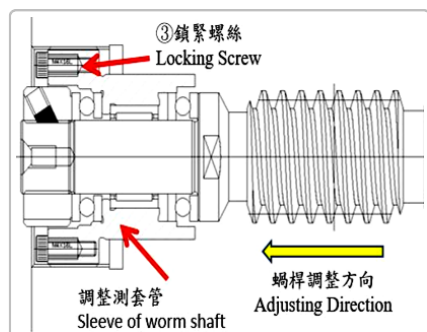
Step 7

If the backlash is too small, rotate M6x50L * 2 pcs on part ④ anti-clockwise to increase backlash. 若背隙過小時，在套管座上的M6x50L螺絲2只以逆時針旋轉調整側套管來增加蝸桿蝸輪背隙。

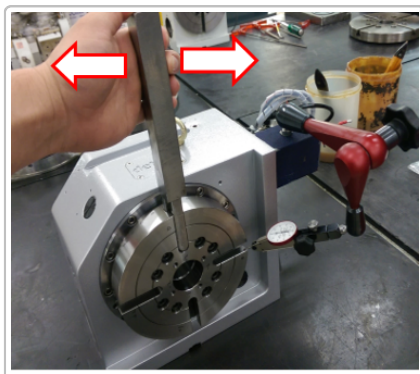
Step 9

* Standard value/標準值 : 0.005~0.01mm * The indication of dial gauge/千分錶示意 : (1) A: Backlash/背隙值 (2) B: Flexible Deformation/彈性變形量

1.將千分錶吸附在本體上,錶針量測在盤面一處T型溝側邊2.使用治具T溝板手插入盤面其他T型溝,使用推拉力計距離盤面外緣約100mm左右,順時針施力約10~15Kg後放鬆觀察千分錶數值.3.使用治具T溝板手插入盤面其他T型溝,使用推拉力計距離盤面中心半徑約100mm左右,逆時針施力約10~15Kg後放鬆觀察千分錶數值.4.間隙須在0.005~0.01mm,如果太大或太小需重複操作調整至範圍1.The dial indicator is adsorbed on the body, and the dial needle is measured on the side of T-slot ditch on the table plate surface. 2. Insert the T - slot wrench of the jig into other T-slot of the table plate, use the tensiometer to distance about 100mm from the outer edge of the table plate, apply about 10~15Kg clockwise force, then loose and observe the value of the dial indicator. 3. Insert the T slot wrench of the jig into other T-slot of the disk surface, use the tensiometer to distance about 100mm from the center radius of the disk surface, apply about 10~15Kg counter clockwise force, then loose and observe the value of the dial indicator. 4. The clearance must be 0.005~0.01mm. If it is too large or too small, repeat the operation to adjust it to the range.
