Week 11:**Date:** 11/04/2022**Total hours:** 12**Description of Design Efforts:**

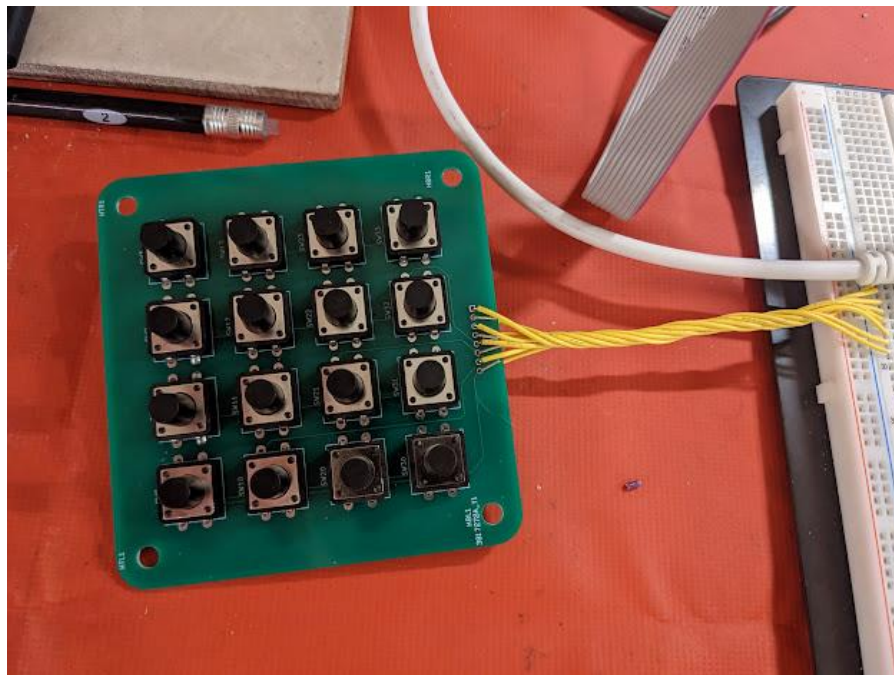
I started with soldering the button matrix PCB, since it is less important, and I can warm up soldering “skills”. It took about an hour since everything was through hole and easy to do in general. The only parts that go on it are button, diodes and a 1x8 connector. However, we made our connectors 2mm apart rather than 2.54mm apart. So, we ordered connectors from DigiKey on 11/3. So for now, we are carefully testing connector related problems with wires through the vias.

Fig. 1: Front side of button matrix PCB.

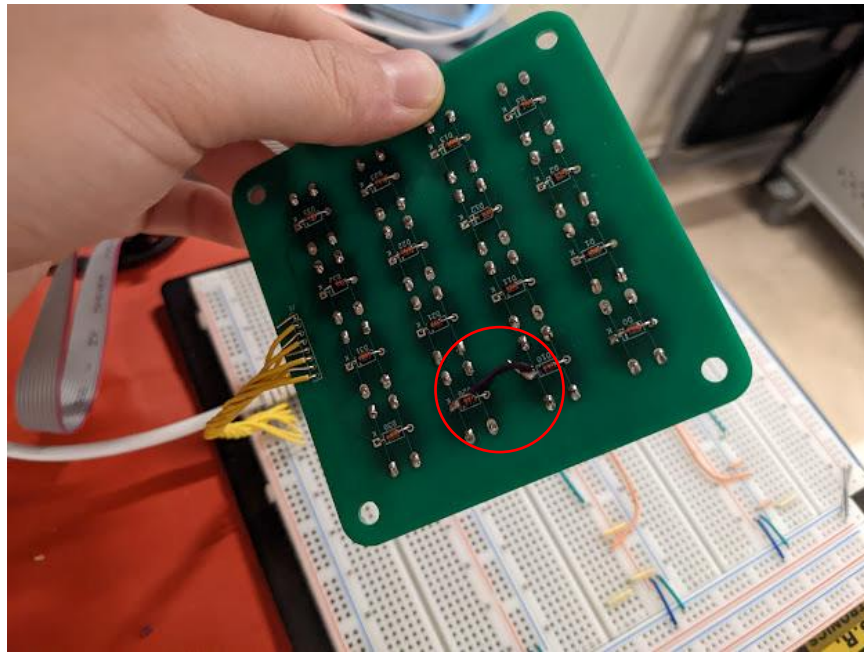
One of the other problems we ran into is that the silicone cover we designed the button matrix to fit in... does not fit. So, we will need another way to cover the PCB in our packaging. Another small issue we ran in is we flipped the rows and columns in the PCB. Fixing the software would not just require flipping some variables, but also flip all interrupts. Therefore, we will just twist the wires, just as in Figure 1. Lastly, the largest problem we encountered is after completely soldering the PCB, one of the traces doesn't work. We should have checked prior to soldering, and we also should have ordered enough button to populate a second board. However, this is what we are stuck with. Luckily for now, I just soldered on a wire to ends of what the trace should be connected to.

Fig. 2: Backside of PCB. Circled in red is the fix to the manufacture error.

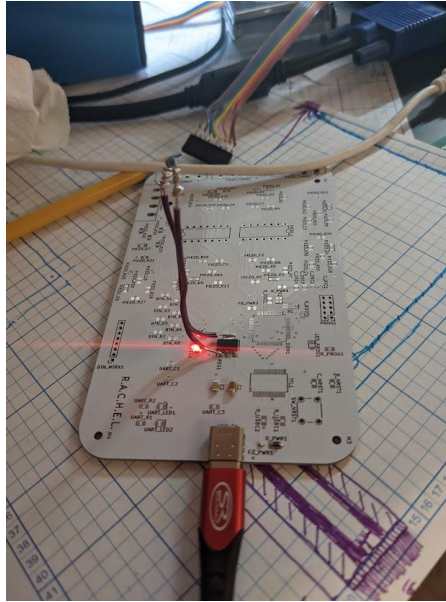
Starting on the main PCB, we continuity checked most traces before soldering. There were manufacturing defects on most of our boards, however. 50% of all our vias on all of our boards were filled (not covered). Meaning, we can get readings from the vias but not stick any wire through them. We picked a board with the least amount of filled vias and proceeded to solder the power circuit parts to it. Once that was accomplished, we measured 3.25 volts coming out of our regulator. For a more of an endurance test, we shorted 3.3V and ground on our voltage regulator with a 220 Ohm resistor and let it take in voltage for a few hours. The voltage remained at 3.25V in the end.

Fig. 3: Power running through PCB in endurance test.

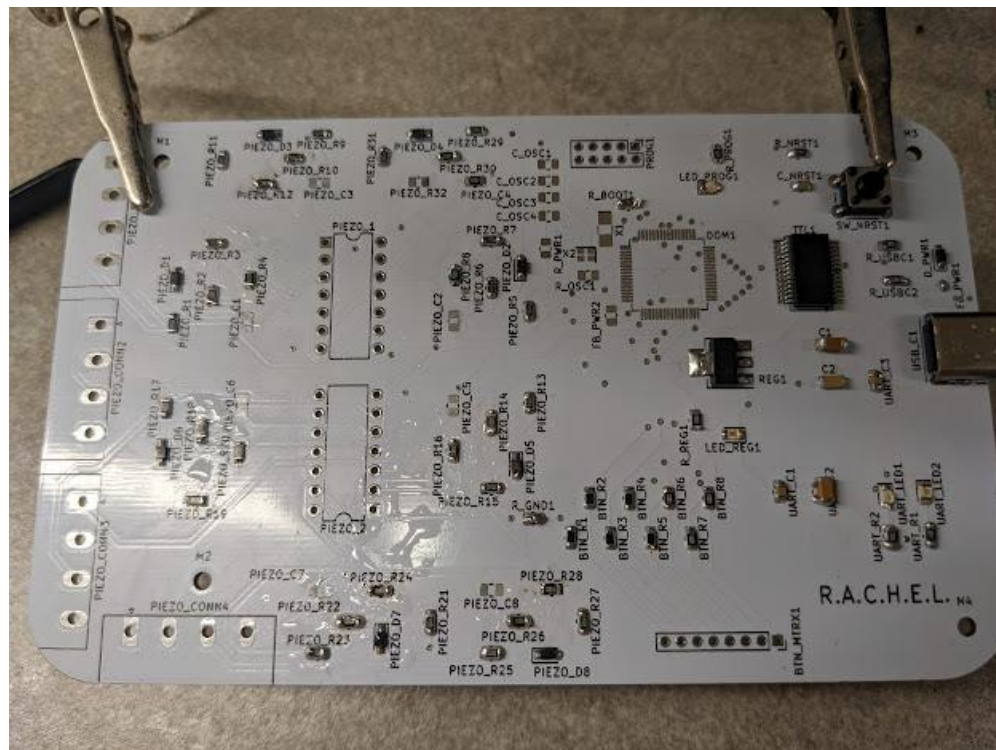
Lastly, I have just been soldering and testing continuity for the remainder of the week. The last problem I ran into was a trace for a ferrite bead was too small. For now, we just have a solder bridge going through the pads as a temporary solution. This ferrite bead is for the 5V rail before power gets to the regulator. So hopefully, spikes are mitigated by caps and the regulator itself. There is another ferrite bead for the analog power. In figure 4, the PCB is about 60% done with soldering.

Fig. 4: PCB solder progress.
