PRIVATE PROPERTY TREE REMOVAL/REPLACEMENT PERMIT APPLICATION

PERMIT NO. 25378

Job Site: 1108 Diamond Ave South Pasadena CA 91030

Tree Risk Assessment and Arborist Report

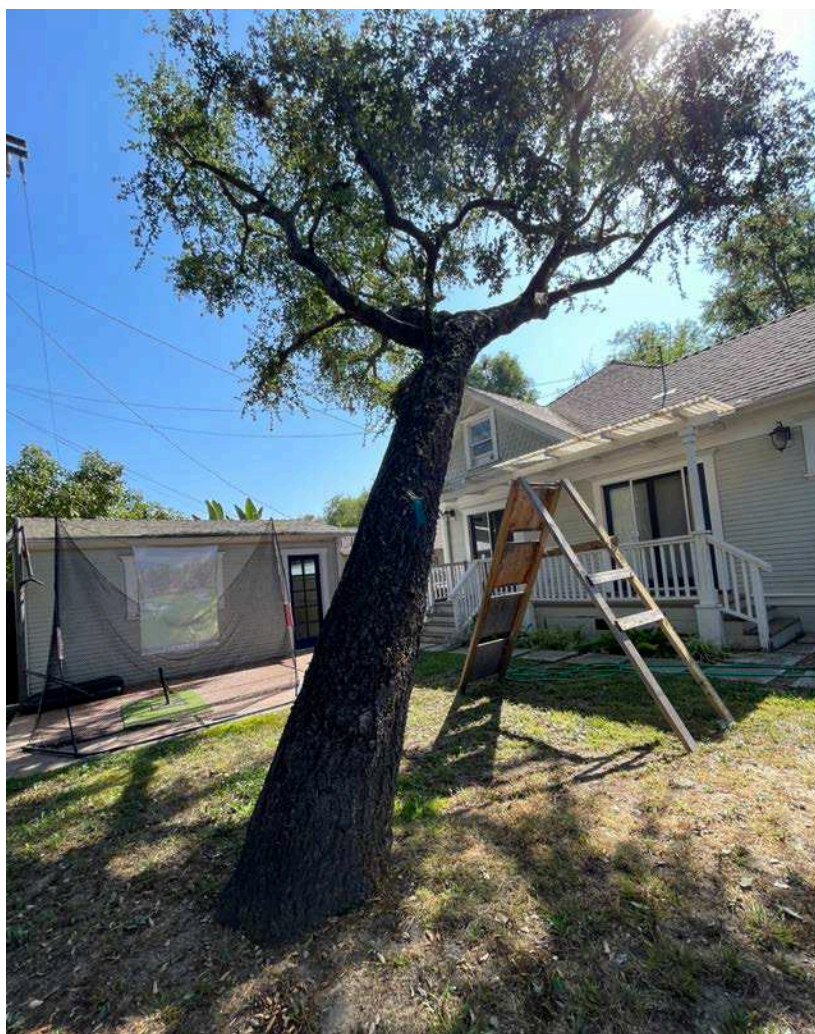
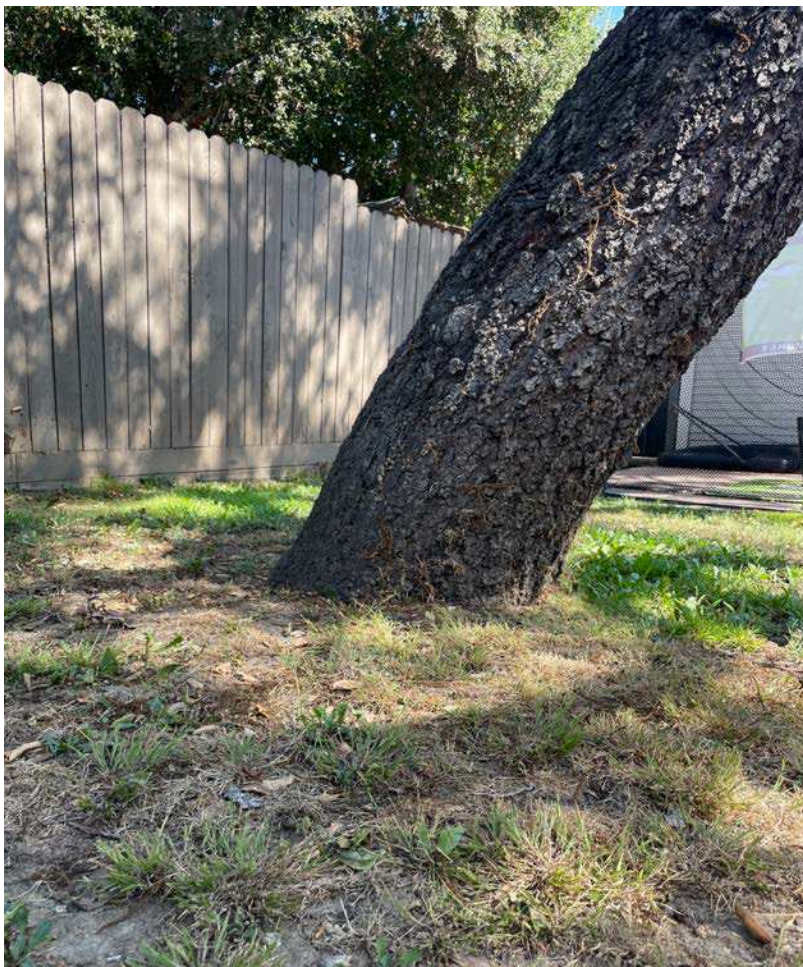
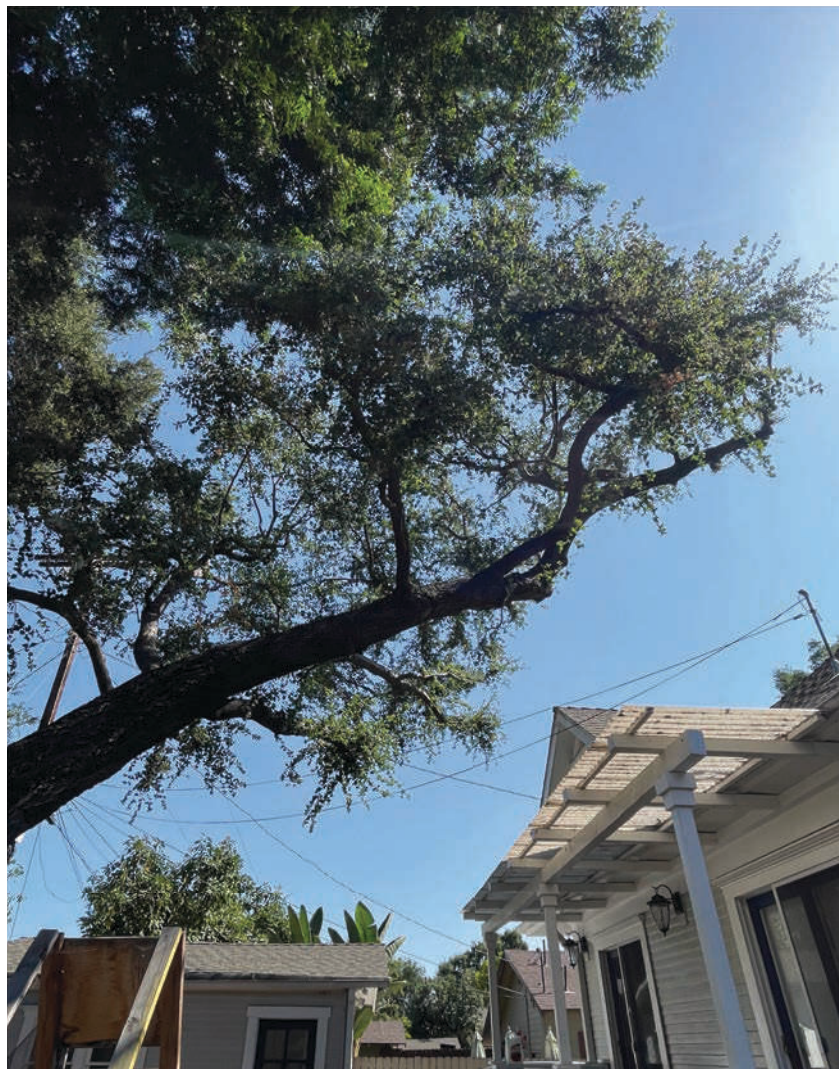
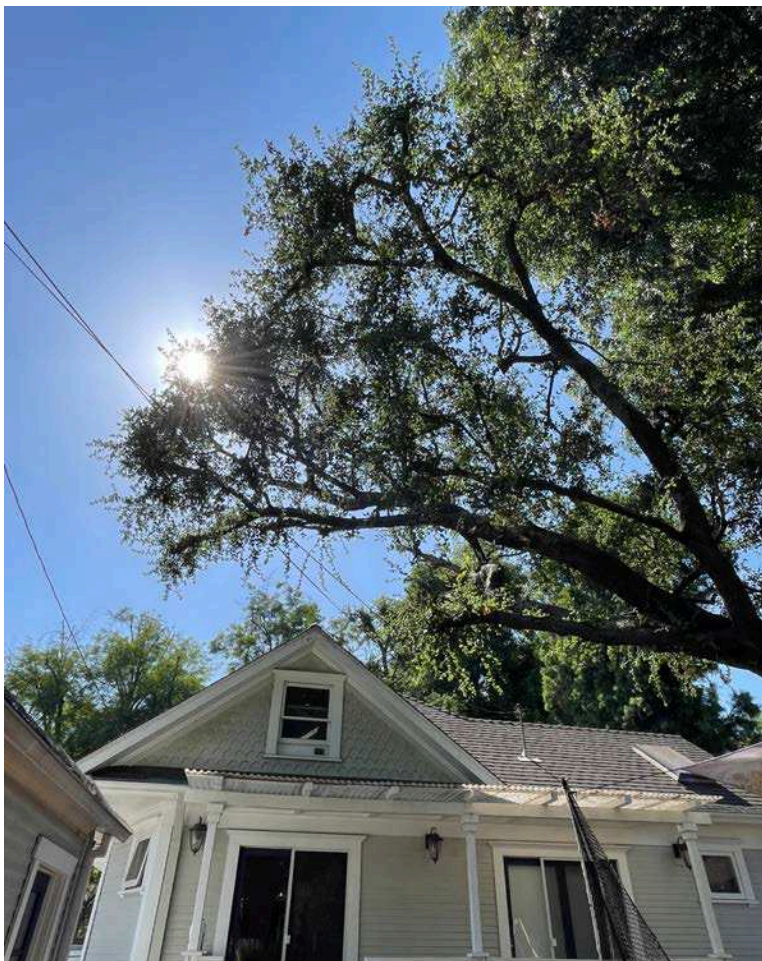
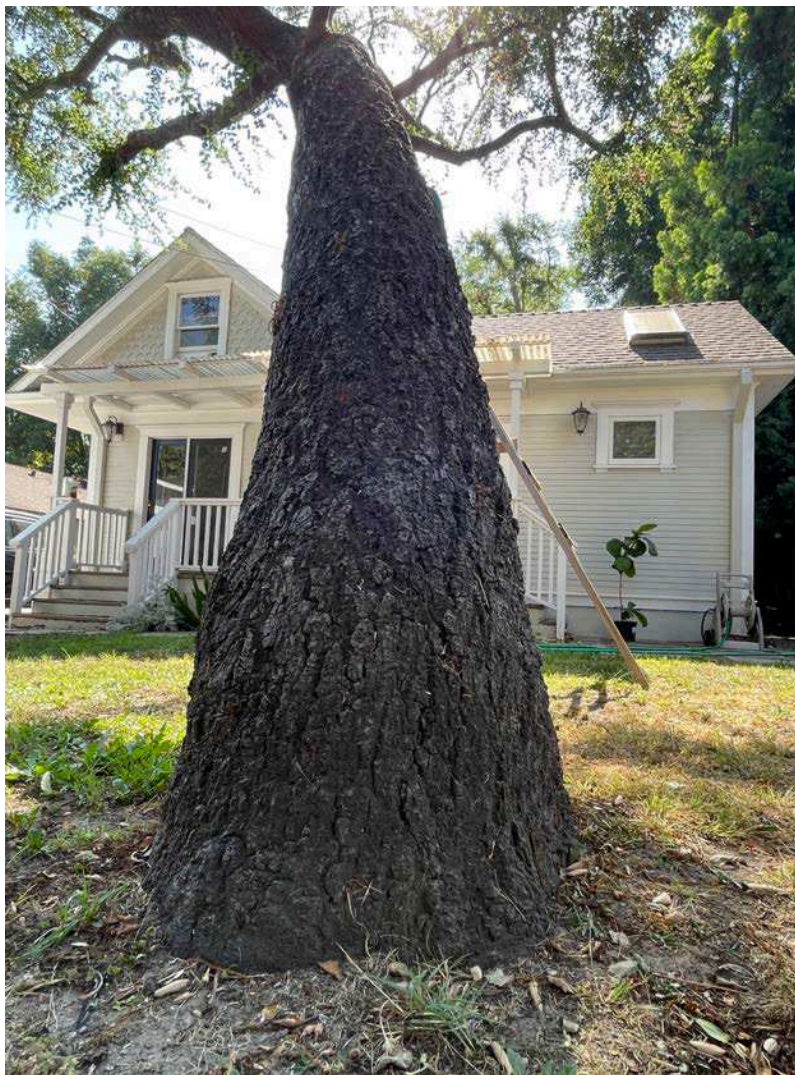
Tree Species: #1 Coast live Oak (*Quercus agrifolia*)
DBH: 25"
Height: 30'-40'
Crown Spread Diameter: 30'-40'
Crown Density: Sparse ☒ Normal ☐ Dense ☐ N/A ☐
Relative Crown Size: Small ☐ Medium ☒ Large ☐ N/A ☐
Vigor: Low ☒ Normal ☐ High ☐ N/A ☐
Failure Profile: Branches ☐ Trunk ☐ Roots ☐ N/A ☒

Unbalanced Crown ☒ Crack ☐
Lightning damage ☐ Dead Twigs/fronds 20 % overall
Broken/ Hangers ☐ Weak attachment ☐
Pruning history: Crown clean ☐ Thinned ☒ Topped ☐ Flush cut ☐ N/A ☐
Main concern: Whole tree leaning.
Likelihood of failure: Improbable ☐ Possible ☐ Probable ☐ Imminent ☒ N/A ☐

Above named client requested a tree risk assessment and arborist report for the Oak tree that is located in the backyard. The tree is about 6 feet away from the East side of the house. The Oak tree canopy leaning over the roof of the back side of the house. It has a strong lean that begins at the base. Signs of stress observed at the base on the tension side of the tree. The base of the tree and surrounding soil were probed, soil is loose and is no longer giving anchor to support the tree from falling. This confirmed that the tree lean has been causing instability issues at the base and the root system. Significant amount of damage to targets (people, properties) within the target zone will occur if the tree splits or breaks down further. Given the weak base of the Oak tree and the sign of roots uplifting the soil area, and for safety reasons, the Oak tree is recommended to be removed to eliminate further failures and damages.

Overall Tree Risk Rating: Low ☐ Moderate ☐ High ☐ Extreme ☒ N/A ☐

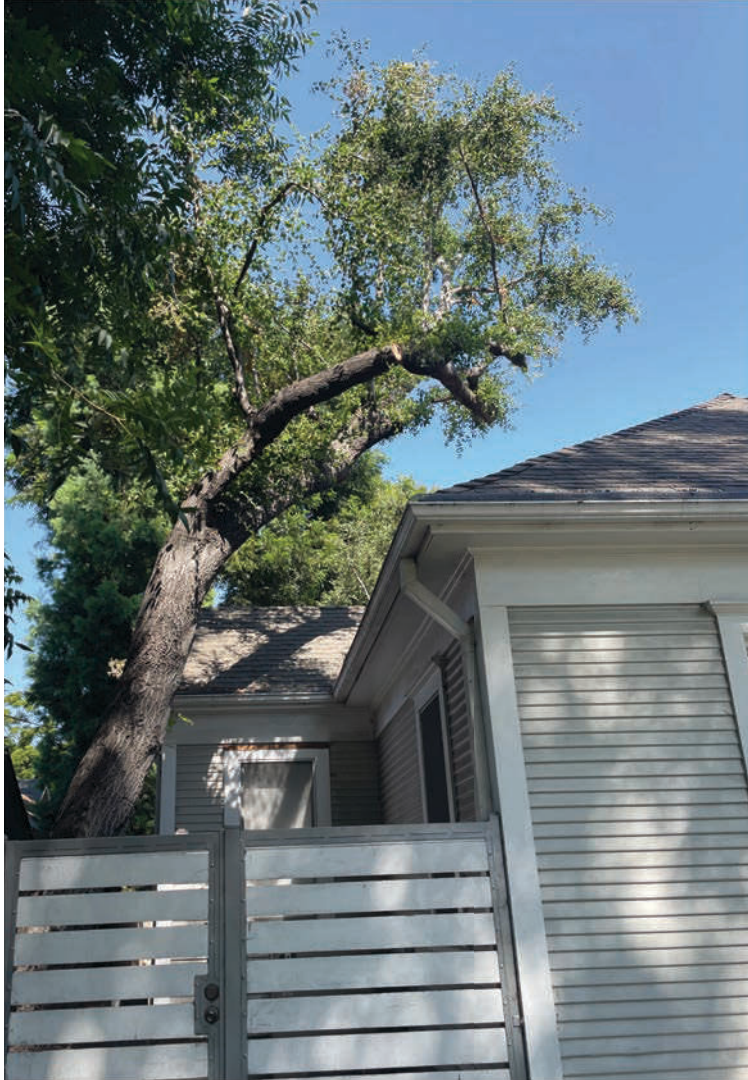
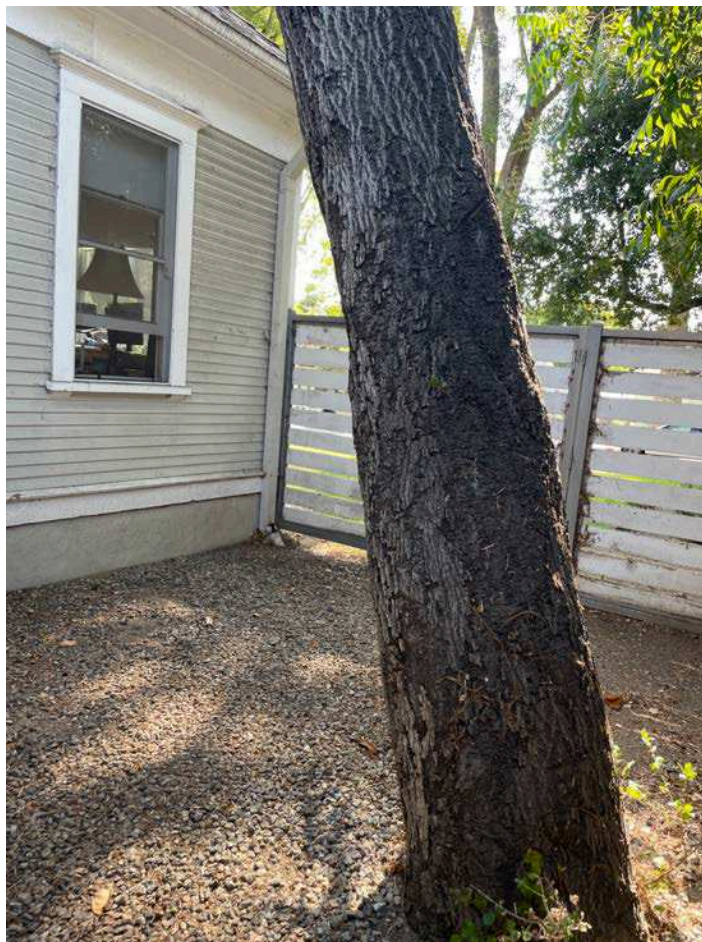
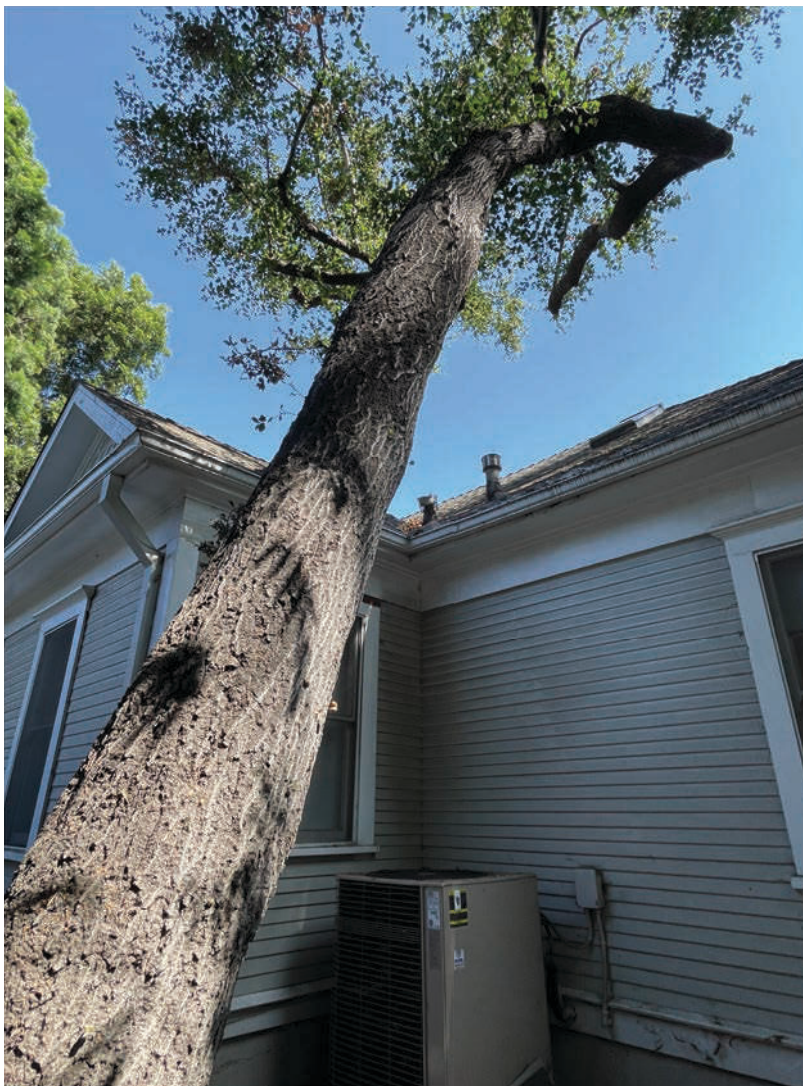
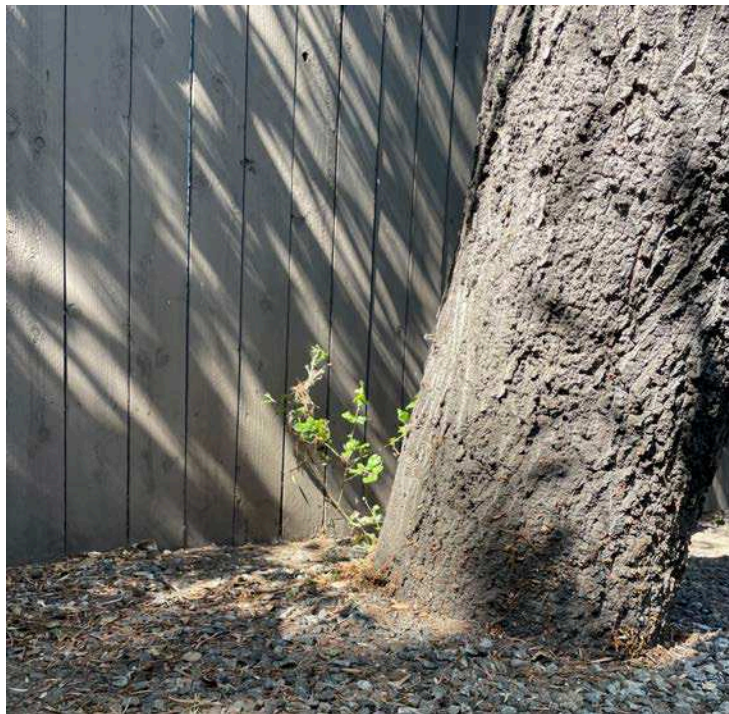
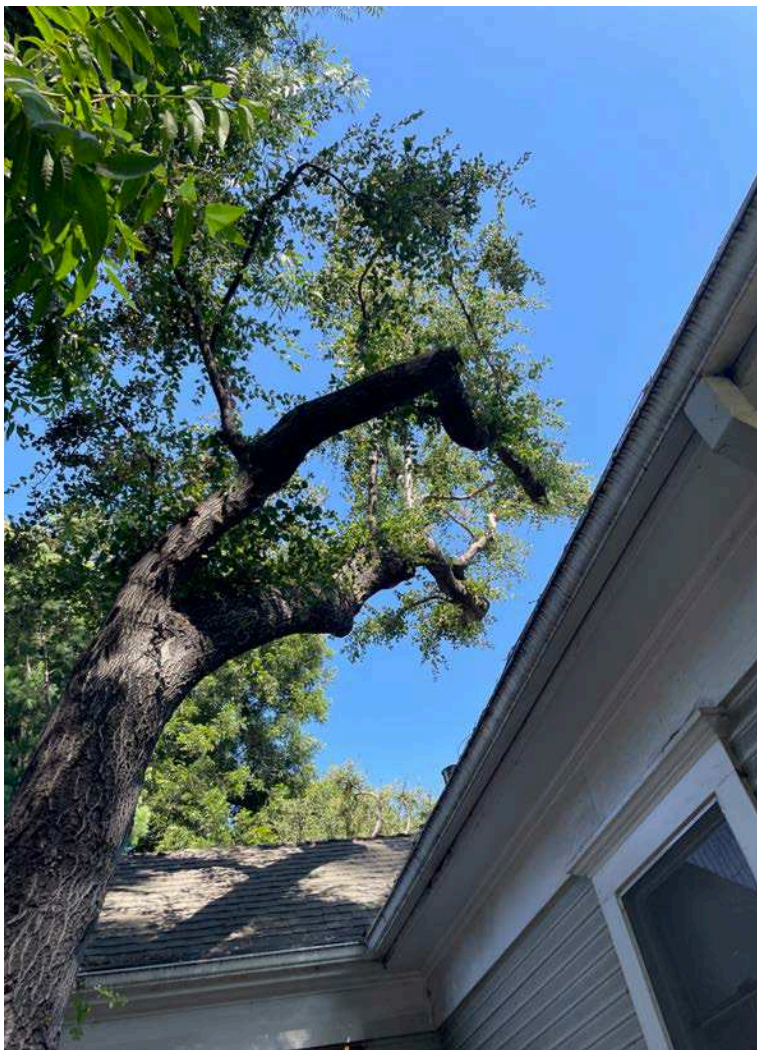
Tree Species:	#2 Coast live Oak (<i>Quercus agrifolia</i>)
DBH	23"
Height:	30'-40'
Crown Spread Diameter:	30'-40'
Crown Density:	Sparse <input checked="" type="checkbox"/> Normal <input type="checkbox"/> Dense <input type="checkbox"/> N/A <input type="checkbox"/>
Relative Crown Size:	Small <input type="checkbox"/> Medium <input checked="" type="checkbox"/> Large <input type="checkbox"/> N/A <input type="checkbox"/>
Vigor:	Low <input checked="" type="checkbox"/> Normal <input type="checkbox"/> High <input type="checkbox"/> N/A <input type="checkbox"/>
Failure Profile:	Branches <input type="checkbox"/> Trunk <input type="checkbox"/> Roots <input type="checkbox"/> N/A <input checked="" type="checkbox"/>

Unbalanced Crown <input checked="" type="checkbox"/>	Crack <input type="checkbox"/>
Lightning damage <input type="checkbox"/>	Dead Twigs/fronds <u>20 % overall</u>
Broken/ Hangers <input type="checkbox"/>	Weak attachment <input type="checkbox"/>
Pruning history: Crown clean <input type="checkbox"/> Thinned <input checked="" type="checkbox"/> Topped <input type="checkbox"/> Flush cut <input type="checkbox"/> N/A <input type="checkbox"/>	
Main concern: Whole tree leaning.	
Likelihood of failure: Improbable <input type="checkbox"/> Possible <input type="checkbox"/> Probable <input type="checkbox"/> Imminent <input checked="" type="checkbox"/> N/A <input type="checkbox"/>

Above named client requested a tree risk assessment and arborist report for the Oak tree that is located in the backyard. The tree is about 4 feet away from the south side of the house.

The Oak tree canopy leaning over the roof of the side of the house. It has a strong lean that begins at the base. Signs of stress observed at the base on the tension side of the tree. The base of the tree and surrounding soil were probed, soil is loose and is no longer giving anchor to support the tree from falling. This confirmed that the tree lean has been causing instability issues at the base and the root system. Leaves show signs of aphids that also reduce photosynthesis, that increase the chance of the tree to decline.

Significant amount of damage to targets (people, properties) within the target zone will occur if the tree splits or breaks down further. Given the weak base of the Oak tree and the sign of roots uplifting the soil area, and for safety reasons, the Oak tree is recommended to be removed to eliminate further failures and damages.

Overall Tree Risk Rating: Low ☐ Moderate ☐ High ☐ Extreme ☒ N/A ☐
