Normal and abnormal trans-oxygenator pressure gradients during cardiopulmonary bypass

A prospective study was conducted with the aims of 1) determining the normal trans-oxygenator pressure gradient characteristics for a range of oxygenators and 2) determining the characteristics, incidence and outcome of abnormally raised gradients. The trans-oxygenator pressure gradient was monitored in 3684 patients undergoing open-heart surgery in eight different hospitals. When the normal pressure gradient was measured during cardiopulmonary bypass in mmHg/L blood flow, a constant figure was obtained which was specific for each oxygenator. This gradient was abnormally raised in 16 cases (one in every 230 cases) and was raised to such an extent in three of these cases that an emergency oxyge-

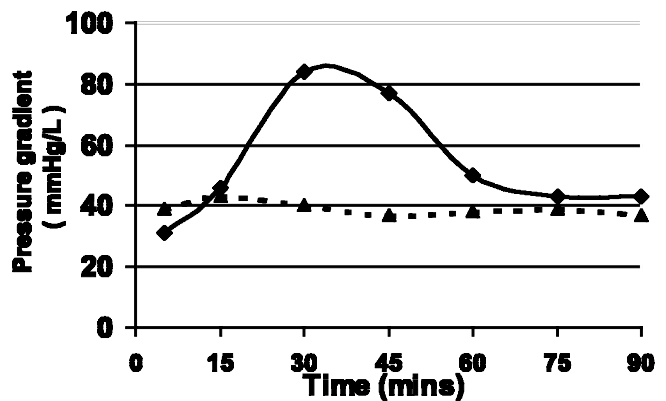
When analysed, nine of the 16 cases followed the same pattern: immediately after going on bypass, the pressure gradient was normal, but rose rapidly to a maximum value in an average of 16 minutes (range 5–25 minutes). This raised gradient eventually returned to the normal baseline over an average time of 40 minutes (range 25–60 minutes). Figures 2 and 3 demonstrate examples. We have classified these as Type I gradients. In addition, the three cases that resulted in emergency oxygenator changeovers also started as Type I gradients.

Figure 2 Type I raised trans-oxygenator pressure gradient in a Bard Quantum Oxygenator. Solid line = raised gradient event, dotted line = normal baseline reading for Bard Quantum.

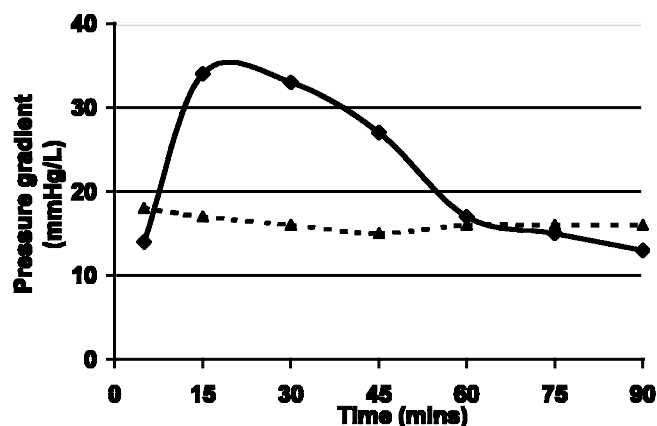
Figure 3 Type I raised trans-oxygenator pressure gradient with a Terumo SX25 Oxygenator. Solid line = raised gradient event, dotted line = normal baseline reading for Terumo SX25.

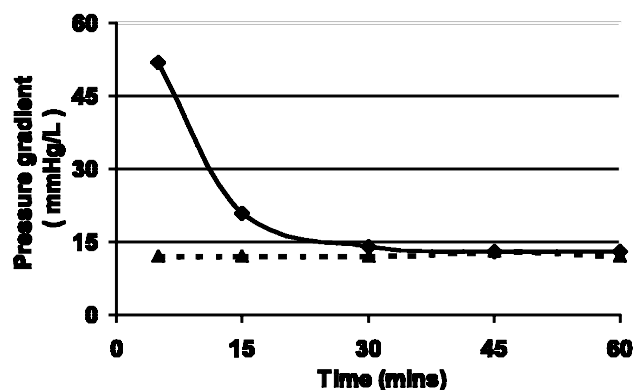
Three of the 16 cases followed a different pattern, as shown in Figure 4. In these cases, the pressure gradient was maximal immediately on going on bypass, being up to five times greater than normal. The gradient rapidly returned back to baseline within a mean of 20 minutes (range 15–30 minutes). We have classified these as Type II gradients.

Figure 4 Type II raised trans-oxygenator pressure gradient in a Sorin Monolyth Pro Oxygenator. Solid line = raised gradient event, dotted line = normal baseline reading for Sorin Monolyth Pro Oxygenator.

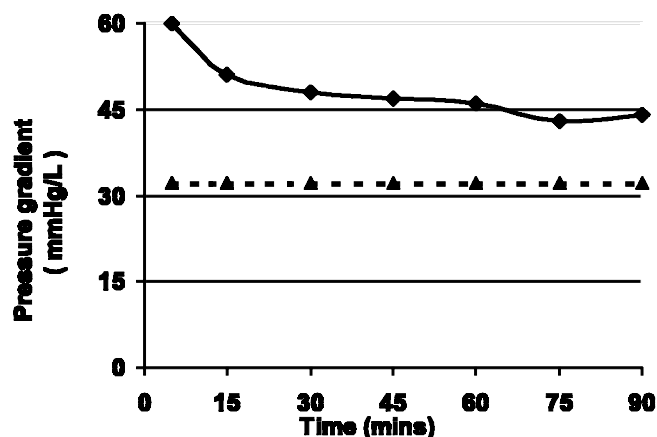
One case followed a third pattern, as shown in Figure 5. As with Type II gradients, immediately upon going on bypass the gradient was raised.

Figure 5 Type III raised trans-oxygenator pressure gradient in a Cobe Duo Oxygenator. Solid line = raised gradient event, dotted line = normal baseline reading for Cobe Duo Oxygenator.

However, unlike Type II, the event was not reversible and the gradient remained raised for the duration of the bypass. We have classified this case as a Type III gradient.

appeared to be a non-reversible thrombus. It is reasonable to presume that this may have been caused by a small quantity of unheparinized blood being sucked into the bypass circuit. This is supported by the circumstantial evidence that only one Type III event occurred in this study, giving an incidence of about one in 4000 cases and this incidence rate is in the same order as the reported appearance of blood clots in the CPB circuit.^{9–11}
